Punjab Municipal Development Fund Company

Hiring of Consulting Services for Preparation of Integrated Development and Asset Management Plan (IDAMP) for 16 selected MCs In Punjab under Punjab Cities Program (PCP)

IDAMP – Municipal Committee Okara
May 2024

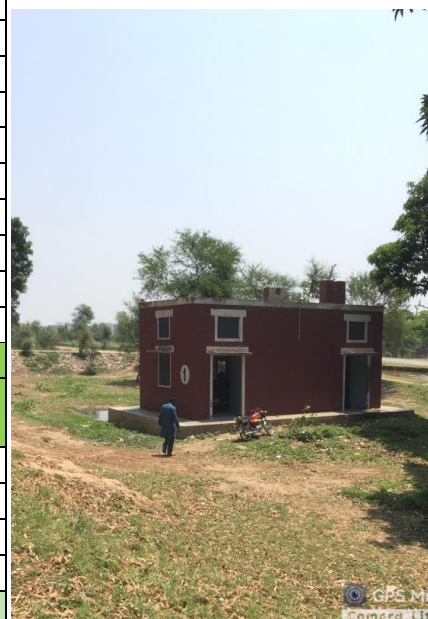
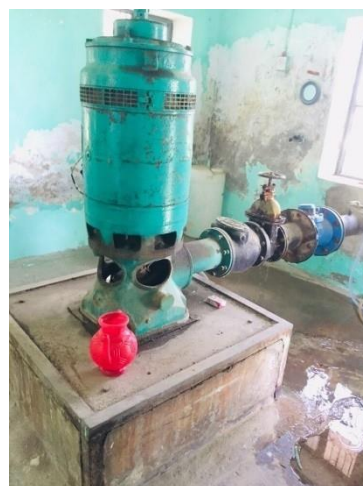
Integrated Development and Asset Management Plan (IDAMP)				
Municipal Committee Okara				
Form: IDAMP-A1	Tube Well Asset Condition Assessment		Asset Code: _____ Date: 06-05-2023	
Asset Detail			Pictures	
Name			Tube Well-1	
Location	Latitude	30.8317		
	Longitude	73.4588		
Address				
Area (Marla/Kanal/Acres)			1	
Working Status			Functional	Non- Functional
Installation Year of Tube Well			1998	
Installation Year of Pump			1998	
Capital Cost of Machinery				
Operational Hours			5	
Delivery Pipe	Dia	6"		
	Material	Mild Steel		
Chlorinator			Yes	No
Chlorination Schedule			Once in a Year	After 6 Months
Apron Around Pump House			Yes	No
Hoisting Girder			Yes	No
Civil Structure Condition			Good	Fair
Approach to Pump House			Good	Fair
Pump Details				
Pump Type			Turbine	
Pump Make			PECO	
Discharge Capacity (Cusec)			1	
Rotational Speed (RPM)			1460	
Housing Dia (inches)			12"	
Bore Depth (ft.)			350	
Head (ft.)			200	
Impeller Installation Depth (ft.)			120

Paint of Pumping Unit			OK	
Number of Valves	Gate Valve		1	
	Non-Returning Valve		1	
Base Plate			Yes	No
Electro-Mechanical Equipment Details				
Transformer Capacity (kVA)			50	
Sanctioned Load (Kwh)			30	
Motor Power (HP)			40	
Motor Make			PECO	
MCU			Yes	No
Earthing of Motor			Yes	No
Power Wiring			Yes	No
Service Cable			Yes	No
Earthing of MCU			Yes	No
Energy Meter			Yes	No
Water Meter			Yes	No
PFI Equipment			Yes	No

Integrated Development and Asset Management Plan (IDAMP)					
Municipal Committee Okara					
Form: IDAMP-A1	Tube Well Asset Condition Assessment			Asset Code: _____ Date: 06-05-2023	
Generator	Yes	No			
Change Over	Yes	No			
Overall Rating					
Average Score	1	2	3	4	5
Asset Condition	Excellent	Good	Fair	Poor	Failing
Category	A	B	C	D	E
Remarks / Requirements					
<ul style="list-style-type: none"> No remarks 					
Data Collected By: Mr. Haroon		Designation: Team Member

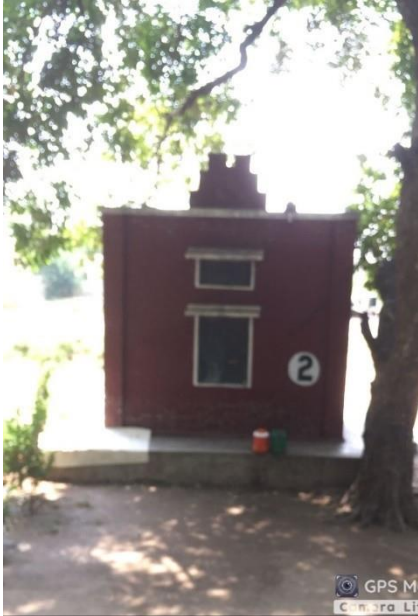
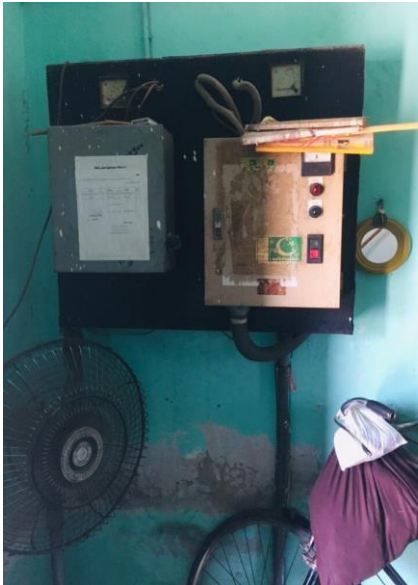
Integrated Development and Asset Management Plan (IDAMP)					
Municipal Committee Okara					
Form: IDAMP-A1	Tube Well Asset Condition Assessment			Asset Code: _____ Date: 06-05-2023	
Asset Detail				Pictures	
Name		Tube Well-2			
Location	Latitude	30.8317			
	Longitude	73.4585			
Address					
Area (Marla/Kanal/Acres)		1			
Working Status		Functional	Non- Functional		
Installation Year of Tube Well		1998			
Installation Year of Pump		1998			
Capital Cost of Machinery					
Operational Hours		5			
Delivery Pipe	Dia	8"			
	Material	Mild Steel			
Chlorinator		Yes	No		
Chlorination Schedule		Once in a Year	After 6 Months	No Schedule	
Apron Around Pump House		Yes	No		
Hoisting Girder		Yes	No		
Civil Structure Condition		Good	Fair	Bad	
Approach to Pump House		Good	Fair	Bad	
Pump Details					
Pump Type		Turbine			
Pump Make		PECO			
Discharge Capacity (Cusec)		1			
Rotational Speed (RPM)		1460			
Housing Dia (inches)		12"

Bore Depth (ft.)		350			
Head (ft.)		200			
Impeller Installation Depth (ft.)		120			
Paint of Pumping Unit		OK			
Number of Valves	Gate Valve	1			
	Non-Returning Valve	1			
Base Plate		Yes	No		
Electro-Mechanical Equipment Details					
Transformer Capacity (kVA)		50			
Sanctioned Load (Kwh)		30			
Motor Power (HP)		40			
Motor Make		PECO			
MCU		Yes	No		
Earthing of Motor		Yes	No		
Power Wiring		Yes	No		
Service Cable		Yes	No		
Earthing of MCU		Yes	No		
Energy Meter		Yes	No		
Water Meter		Yes	No		
PFI Equipment		Yes	No

Integrated Development and Asset Management Plan (IDAMP)					
Municipal Committee Okara					
Form: IDAMP-A1	Tube Well Asset Condition Assessment			Asset Code: _____ Date: 06-05-2023	
Generator	Yes	No			
Change Over	Yes	No			
Overall Rating					
Average Score	1	2	3	4	5
Asset Condition	Excellent	Good	Fair	Poor	Failing
Category	A	B	C	D	E
Remarks / Requirements					
<ul style="list-style-type: none"> No remarks 					
Data Collected By: Mr. Haroon		Designation: Team Member

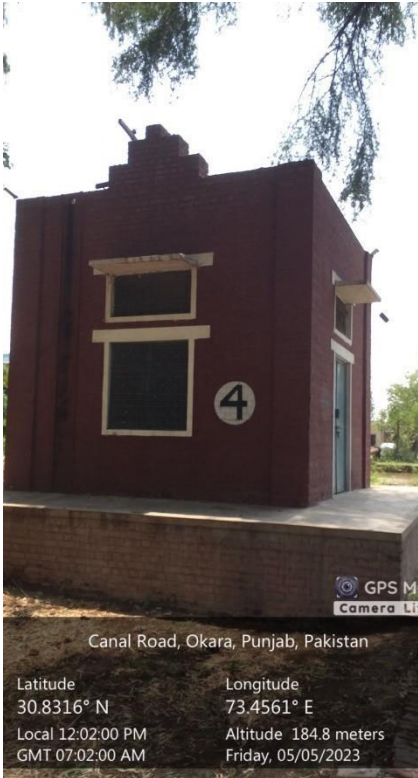
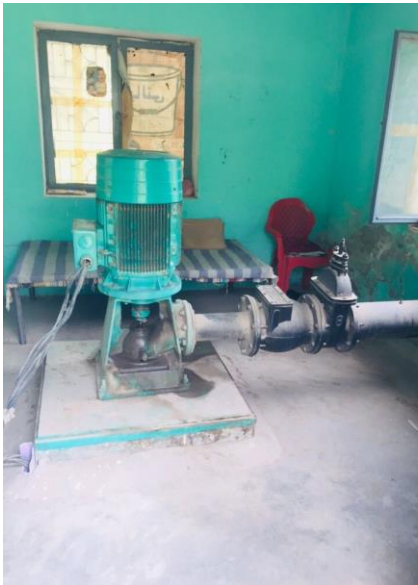
Integrated Development and Asset Management Plan (IDAMP)					
Municipal Committee Okara					
Form: IDAMP-A1	Tube Well Asset Condition Assessment		Asset Code: _____ Date: 06-05-2023		
Asset Detail			Pictures		
Name			Tube Well-4		
Location	Latitude		30.8316		
	Longitude		73.4561		
Address					
Area (Marla/Kanal/Acres)			1		
Working Status			Functional	Non- Functional	
Installation Year of Tube Well			2008		
Installation Year of Pump			2008		
Capital Cost of Machinery					
Operational Hours			5		
Delivery Pipe	Dia		8"		
	Material		Mild Steel		
Chlorinator			Yes	No	
Chlorination Schedule			Once in a Year	After 6 Months No Schedule	
Apron Around Pump House			Yes	No	
Hoisting Girder			Yes	No	
Civil Structure Condition			Good	Fair	Bad
Approach to Pump House			Good	Fair	Bad
Pump Details					
Pump Type			Turbine		
Pump Make			HMA Grundfos		
Discharge Capacity (Cusec)			1		
Rotational Speed (RPM)			1460		
Housing Dia (inches)			12"

Bore Depth (ft.)			350		
Head (ft.)			200		
Impeller Installation Depth (ft.)			120		
Paint of Pumping Unit			OK		
Number of Valves	Gate Valve		1		
	Non-Returning Valve		1		
Base Plate			Yes	No	
Electro-Mechanical Equipment Details					
Transformer Capacity (kVA)			50		
Sanctioned Load (Kwh)			30		
Motor Power (HP)			40		
Motor Make			SIEMENS		
MCU			Yes	No	
Earthing of Motor			Yes	No	
Power Wiring			Yes	No	
Service Cable			Yes	No	
Earthing of MCU			Yes	No	
Energy Meter			Yes	No	
Water Meter			Yes	No	
PFI Equipment			Yes	No

Integrated Development and Asset Management Plan (IDAMP)					
Municipal Committee Okara					
Form: IDAMP-A1	Tube Well Asset Condition Assessment			Asset Code: _____ Date: 06-05-2023	
Generator	Yes	No			
Change Over	Yes	No			
Overall Rating					
Average Score	1	2	3	4	5
Asset Condition	Excellent	Good	Fair	Poor	Failing
Category	A	B	C	D	E
Remarks / Requirements					
<ul style="list-style-type: none"> No remarks 					
Data Collected By: Mr. Haroon		Designation: Team Member

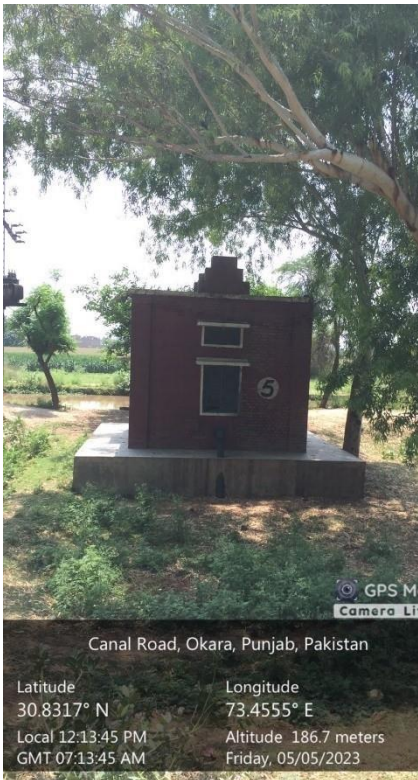
Integrated Development and Asset Management Plan (IDAMP)					
Municipal Committee Okara					
Form: IDAMP-A1	Tube Well Asset Condition Assessment			Asset Code: _____ Date: 06-05-2023	
Asset Detail				Pictures	
Name		Tube Well-5			
Location	Latitude	30.8313			
	Longitude	73.4598			
Address					
Area (Marla/Kanal/Acres)		1			
Working Status		Functional	Non- Functional		
Installation Year of Tube Well		1998			
Installation Year of Pump		1998			
Capital Cost of Machinery					
Operational Hours					
Delivery Pipe	Dia	6"			
	Material	Mild Steel			
Chlorinator		Yes	No		
Chlorination Schedule		Once in a Year	After 6 Months	No Schedule	
Apron Around Pump House		Yes		No	
Hoisting Girder		Yes		No	
Civil Structure Condition		Good	Fair	Bad	
Approach to Pump House		Good	Fair	Bad	
Pump Details					
Pump Type		Turbine			
Pump Make		HMA Grundfos			
Discharge Capacity (Cusec)		1			
Rotational Speed (RPM)		1460			
Housing Dia (inches)		12"

Bore Depth (ft.)		350			
Head (ft.)		200			
Impeller Installation Depth (ft.)		120			
Paint of Pumping Unit		OK			
Number of Valves	Gate Valve	1			
	Non-Returning Valve	1			
Base Plate		Yes		No	
Electro-Mechanical Equipment Details					
Transformer Capacity (kVA)		50			
Sanctioned Load (Kwh)		30			
Motor Power (HP)		40			
Motor Make		SIEMENS			
MCU		Yes		No	
Earthing of Motor		Yes		No	
Power Wiring		Yes		No	
Service Cable		Yes		No	
Earthing of MCU		Yes		No	
Energy Meter		Yes		No	
Water Meter		Yes		No	
PFI Equipment		Yes		No

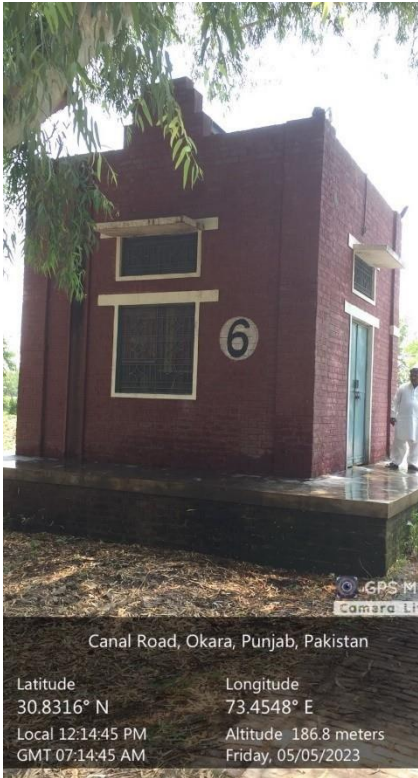
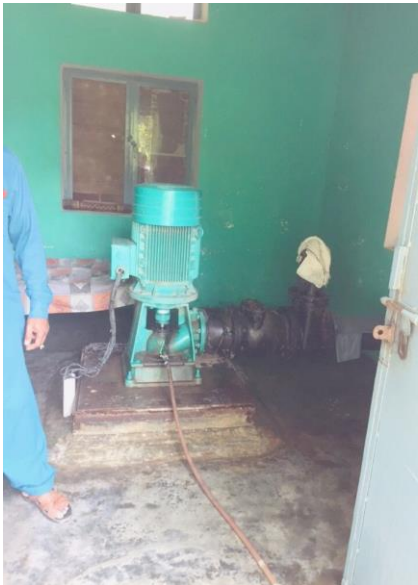
Integrated Development and Asset Management Plan (IDAMP)				
Municipal Committee Okara				
Form: IDAMP-A1	Tube Well Asset Condition Assessment	Asset Code: _____ Date: 06-05-2023		
Asset Detail			Pictures	
Name		Tube Well-6		
Location	Latitude	30.8316		
	Longitude	73.4548		
Address				
Area (Marla/Kanal/Acres)		1		
Working Status		Functional	Non- Functional	
Installation Year of Tube Well		2008		
Installation Year of Pump		2008		
Capital Cost of Machinery				
Operational Hours		5		
Delivery Pipe	Dia	8"		
	Material	Mild Steel		
Chlorinator		Yes	No	
Chlorination Schedule		Once in a Year	After 6 Months	No Schedule
Apron Around Pump House		Yes	No	
Hoisting Girder		Yes	No	
Civil Structure Condition		Good	Fair	Bad
Approach to Pump House		Good	Fair	Bad
Pump Details				
Pump Type		Turbine		
Pump Make		HMA Grundfos		
Discharge Capacity (Cusec)		1		
Rotational Speed (RPM)		1460		
Housing Dia (inches)		12"		
Bore Depth (ft.)		350

Head (ft.)		200		
Impeller Installation Depth (ft.)		120		
Paint of Pumping Unit		OK		
Number of Valves	Gate Valve	1		
	Non-Returning Valve	1		
Base Plate		Yes	No	
Electro-Mechanical Equipment Details				
Transformer Capacity (kVA)		50		
Sanctioned Load (Kwh)		30		
Motor Power (HP)		40		
Motor Make		SIEMENS		
MCU		Yes	No	
Earthing of Motor		Yes	No	
Power Wiring		Yes	No	
Service Cable		Yes	No	
Earthing of MCU		Yes	No	
Energy Meter		Yes	No	
Water Meter		Yes	No	
PFI Equipment		Yes	No

Integrated Development and Asset Management Plan (IDAMP)					
Municipal Committee Okara					
Form: IDAMP-A1	Tube Well Asset Condition Assessment			Asset Code: _____ Date: 06-05-2023	
Generator	Yes	No			
Change Over	Yes	No			
Overall Rating					
Average Score	1	2	3	4	5
Asset Condition	Excellent	Good	Fair	Poor	Failing
Category	A	B	C	D	E
Remarks / Requirements					
<ul style="list-style-type: none"> No remarks 					
Data Collected By: Mr. Haroon		Designation: Team Member

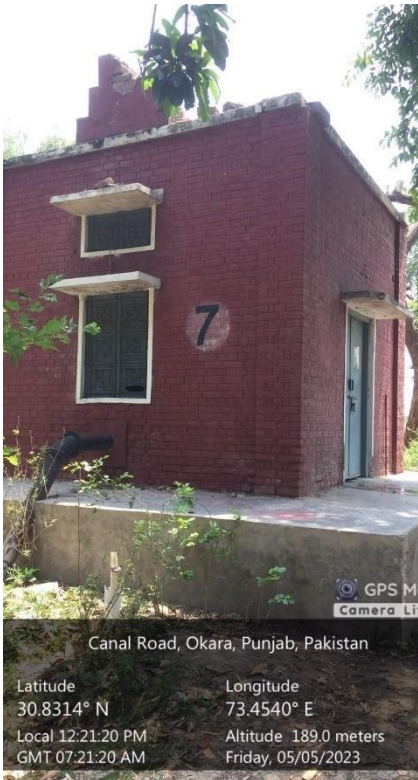
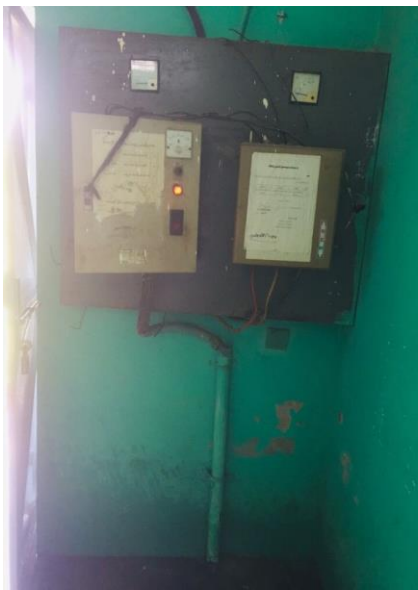
Integrated Development and Asset Management Plan (IDAMP)					
Municipal Committee Okara					
Form: IDAMP-A1	Tube Well Asset Condition Assessment			Asset Code: _____ Date: 06-05-2023	
Asset Detail				Pictures	
Name		Tube Well-7			
Location	Latitude	30.8314			
	Longitude	73.4540			
Address					
Area (Marla/Kanal/Acres)					
Working Status		Functional	Non- Functional		
Installation Year of Tube Well		1998			
Installation Year of Pump		1998			
Capital Cost of Machinery					
Operational Hours					
Delivery Pipe	Dia				
	Material	Mild Steel			
Chlorinator		Yes	No		
Chlorination Schedule		Once in a Year	After 6 Months	No Schedule	
Apron Around Pump House		Yes		No	
Hoisting Girder		Yes		No	
Civil Structure Condition		Good	Fair	Bad	
Approach to Pump House		Good	Fair	Bad	
Pump Details					
Pump Type		Turbine			
Pump Make					
Discharge Capacity (Cusec)		1			
Rotational Speed (RPM)		1460			
Housing Dia (inches)		12"			
Bore Depth (ft.)		350

Head (ft.)		200			
Impeller Installation Depth (ft.)		120			
Paint of Pumping Unit		OK			
Number of Valves	Gate Valve	1			
	Non-Returning Valve	1			
Base Plate		Yes		No	
Electro-Mechanical Equipment Details					
Transformer Capacity (kVA)					
Sanctioned Load (Kwh)		30			
Motor Power (HP)		40			
Motor Make					
MCU		Yes		No	
Earthing of Motor		Yes		No	
Power Wiring		Yes		No	
Service Cable		Yes		No	
Earthing of MCU		Yes		No	
Energy Meter		Yes		No	
Water Meter		Yes		No	
PFI Equipment		Yes		No

Integrated Development and Asset Management Plan (IDAMP)					
Municipal Committee Okara					
Form: IDAMP-A1	Tube Well Asset Condition Assessment			Asset Code: _____ Date: 06-05-2023	
Generator	Yes	No			
Change Over	Yes	No			
Overall Rating					
Average Score	1	2	3	4	5
Asset Condition	Excellent	Good	Fair	Poor	Failing
Category	A	B	C	D	E
Remarks / Requirements					
Non-Functional due to choked bore					
<i>Data Collected By: Mr. Haroon</i>		<i>Designation: Team Member</i>

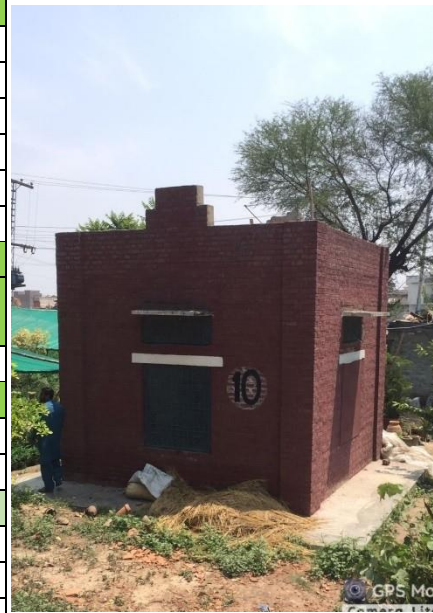
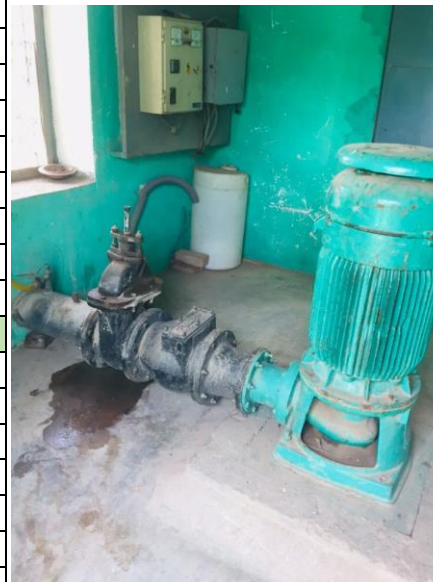
Integrated Development and Asset Management Plan (IDAMP)					
Municipal Committee Okara					
Form: IDAMP-A1		Tube Well Asset Condition Assessment			Asset Code: _____ Date: 06-05-2023
Asset Detail				Pictures	
Name		Tube Well-10			
Location	Latitude	30.8313			
	Longitude	73.4504			
Address					
Area (Marla/Kanal/Acres)		1			
Working Status		Functional	Non- Functional		
Installation Year of Tube Well		2008			
Installation Year of Pump		2008			
Capital Cost of Machinery					
Operational Hours					
Delivery Pipe	Dia	8"			
	Material	Mild Steel			
Chlorinator		Yes	No		
Chlorination Schedule		Once in a Year	After 6 Months	No Schedule	
Apron Around Pump House		Yes	No		
Hoisting Girder		Yes	No		
Civil Structure Condition		Good	Fair	Bad	
Approach to Pump House		Good	Fair	Bad	
Pump Details					
Pump Type		Turbine			
Pump Make		MECO			
Discharge Capacity (Cusec)		1			
Rotational Speed (RPM)		1460			
Housing Dia (inches)		12"

Bore Depth (ft.)		350			
Head (ft.)		200			
Impeller Installation Depth (ft.)		120			
Paint of Pumping Unit		OK			
Number of Valves	Gate Valve	1			
	Non-Returning Valve	1			
Base Plate		Yes	No		
Electro-Mechanical Equipment Details					
Transformer Capacity (kVA)		100			
Sanctioned Load (Kwh)		30			
Motor Power (HP)		40			
Motor Make		Siemens			
MCU		Yes	No		
Earthing of Motor		Yes	No		
Power Wiring		Yes	No		
Service Cable		Yes	No		
Earthing of MCU		Yes	No		
Energy Meter		Yes	No		
Water Meter		Yes	No		
PFI Equipment		Yes	No

Integrated Development and Asset Management Plan (IDAMP)					
Municipal Committee Okara					
Form: IDAMP-A1	Tube Well Asset Condition Assessment			Asset Code: _____ Date: 06-05-2023	
Generator	Yes	No			
Change Over	Yes	No			
Overall Rating					
Average Score	1	2	3	4	5
Asset Condition	Excellent	Good	Fair	Poor	Failing
Category	A	B	C	D	E
Remarks / Requirements					
<ul style="list-style-type: none"> • Motor needs repair 					
<i>Data Collected By: Mr. Haroon</i>		<i>Designation: Team Member</i>

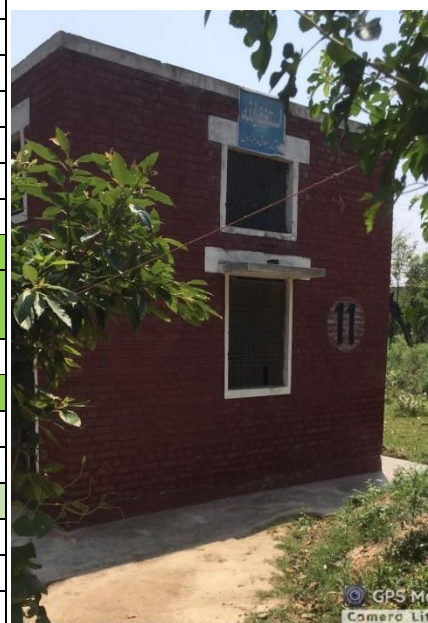
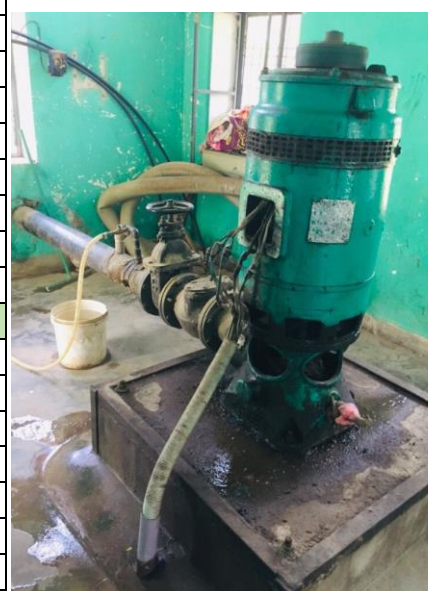
Integrated Development and Asset Management Plan (IDAMP)					
Municipal Committee Okara					
Form: IDAMP-A1	Tube Well Asset Condition Assessment			Asset Code: _____ Date: 06-05-2023	
Asset Detail				Pictures	
Name		Tube Well-11			
Location	Latitude	30.8310			
	Longitude	73.4494			
Address					
Area (Marla/Kanal/Acres)		1			
Working Status		Functional	Non- Functional		
Installation Year of Tube Well		1998			
Installation Year of Pump		1998			
Capital Cost of Machinery					
Operational Hours		5			
Delivery Pipe	Dia	6"			
	Material	Mild Steel			
Chlorinator		Yes	No		
Chlorination Schedule		Once in a Year	After 6 Months	No Schedule	
Apron Around Pump House		Yes	No		
Hoisting Girder		Yes	No		
Civil Structure Condition		Good	Fair	Bad	
Approach to Pump House		Good	Fair	Bad	
Pump Details					
Pump Type		Turbine			
Pump Make		PECO			
Discharge Capacity (Cusec)		1			
Rotational Speed (RPM)		1460			
Housing Dia (inches)		12"

Bore Depth (ft.)		350			
Head (ft.)		200			
Impeller Installation Depth (ft.)		120			
Paint of Pumping Unit		OK			
Number of Valves	Gate Valve	1			
	Non-Returning Valve	1			
Base Plate		Yes	No		
Electro-Mechanical Equipment Details					
Transformer Capacity (kVA)		100			
Sanctioned Load (Kwh)		30			
Motor Power (HP)		40			
Motor Make		PECO			
MCU		Yes	No		
Earthing of Motor		Yes	No		
Power Wiring		Yes	No		
Service Cable		Yes	No		
Earthing of MCU		Yes	No		
Energy Meter		Yes	No		
Water Meter		Yes	No		
PFI Equipment		Yes	No

Integrated Development and Asset Management Plan (IDAMP)					
Municipal Committee Okara					
Form: IDAMP-A1	Tube Well Asset Condition Assessment			Asset Code: _____ Date: 06-05-2023	
Generator	Yes	No			
Change Over	Yes	No			
Overall Rating					
Average Score	1	2	3	4	5
Asset Condition	Excellent	Good	Fair	Poor	Failing
Category	A	B	C	D	E
Remarks / Requirements					
<ul style="list-style-type: none"> • No remarks 					
Data Collected By: Mr. Haroon		Designation: Team Member

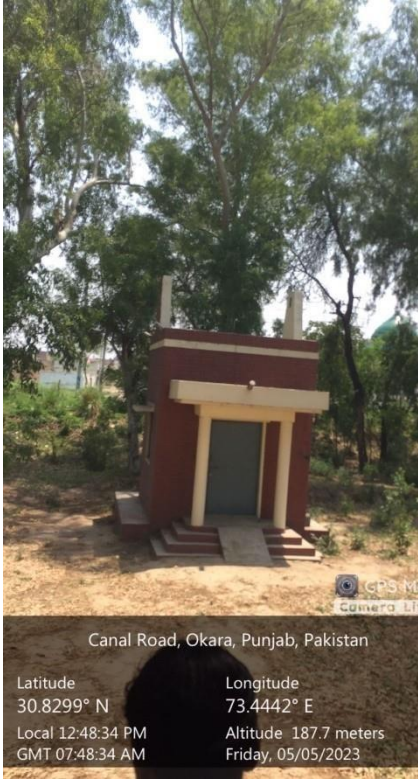
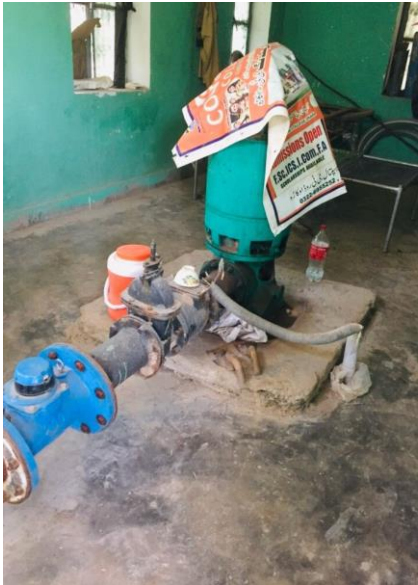
Integrated Development and Asset Management Plan (IDAMP)					
Municipal Committee Okara					
Form: IDAMP-A1	Tube Well Asset Condition Assessment			Asset Code: _____ Date: 06-05-2023	
Asset Detail				Pictures	
Name		Tube Well-13 new			
Location	Latitude	30.8299			
	Longitude	73.4442			
Address					
Area (Marla/Kanal/Acres)		1			
Working Status		Functional	Non- Functional		
Installation Year of Tube Well		2022			
Installation Year of Pump		2022			
Capital Cost of Machinery					
Operational Hours					
Delivery Pipe	Dia				
	Material	Mild Steel			
Chlorinator		Yes	No		
Chlorination Schedule		Once in a Year	After 6 Months	No Schedule	
Apron Around Pump House		Yes		No	
Hoisting Girder		Yes		No	
Civil Structure Condition		Good	Fair	Bad	
Approach to Pump House		Good	Fair	Bad	
Pump Details					
Pump Type		Turbine			
Pump Make		KSB			
Discharge Capacity (Cusec)		1			
Rotational Speed (RPM)		1460			
Housing Dia (inches)		12"

Bore Depth (ft.)		350			
Head (ft.)		200			
Impeller Installation Depth (ft.)		120			
Paint of Pumping Unit		OK			
Number of Valves	Gate Valve	1			
	Non-Returning Valve	1			
Base Plate		Yes		No	
Electro-Mechanical Equipment Details					
Transformer Capacity (kVA)					
Sanctioned Load (Kwh)		30			
Motor Power (HP)		40			
Motor Make		SIEMENS			
MCU		Yes		No	
Earthing of Motor		Yes		No	
Power Wiring		Yes		No	
Service Cable		Yes		No	
Earthing of MCU		Yes		No	
Energy Meter		Yes		No	
Water Meter		Yes		No	
PFI Equipment		Yes		No

Integrated Development and Asset Management Plan (IDAMP)					
Municipal Committee Okara					
Form: IDAMP-A1	Tube Well Asset Condition Assessment			Asset Code: _____ Date: 06-05-2023	
Generator	Yes	No			
Change Over	Yes	No			
Overall Rating					
Average Score	1	2	3	4	5
Asset Condition	Excellent	Good	Fair	Poor	Failing
Category	A	B	C	D	E
Remarks / Requirements					
<ul style="list-style-type: none"> Non-functional due to old transformer and breakage of electric wire 					
Data Collected By: Mr. Haroon		Designation: Team Member

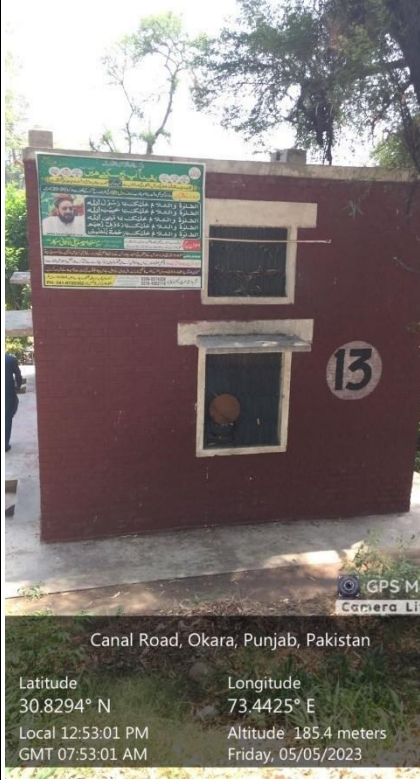
Integrated Development and Asset Management Plan (IDAMP)					
Municipal Committee Okara					
Form: IDAMP-A1	Tube Well Asset Condition Assessment			Asset Code: _____ Date: 06-05-2023	
Asset Detail				Pictures	
Name		Tube Well-13 Old			
Location	Latitude	30.8294			
	Longitude	73.4425			
Address					
Area (Marla/Kanal/Acres)		1			
Working Status		Functional	Non- Functional		
Installation Year of Tube Well		1998			
Installation Year of Pump		1998			
Capital Cost of Machinery					
Operational Hours					
Delivery Pipe	Dia				
	Material	Mild Steel			
Chlorinator		Yes	No		
Chlorination Schedule		Once in a Year	After 6 Months	No Schedule	
Apron Around Pump House		Yes		No	
Hoisting Girder		Yes		No	
Civil Structure Condition		Good	Fair	Bad	
Approach to Pump House		Good	Fair	Bad	
Pump Details					
Pump Type		Turbine			
Pump Make		PECO			
Discharge Capacity (Cusec)		1			
Rotational Speed (RPM)		1460			
Housing Dia (inches)		12"

Bore Depth (ft.)		350			
Head (ft.)		200			
Impeller Installation Depth (ft.)		120			
Paint of Pumping Unit		OK			
Number of Valves	Gate Valve	1			
	Non-Returning Valve	1			
Base Plate		Yes		No	
Electro-Mechanical Equipment Details					
Transformer Capacity (kVA)					
Sanctioned Load (Kwh)		30			
Motor Power (HP)		40			
Motor Make		PECO			
MCU		Yes		No	
Earthing of Motor		Yes		No	
Power Wiring		Yes		No	
Service Cable		Yes		No	
Earthing of MCU		Yes		No	
Energy Meter		Yes		No	
Water Meter		Yes		No	
PFI Equipment		Yes		No

Integrated Development and Asset Management Plan (IDAMP)					
Municipal Committee Okara					
Form: IDAMP-A1	Tube Well Asset Condition Assessment			Asset Code: _____ Date: 06-05-2023	
Generator	Yes	No			
Change Over	Yes	No			
Overall Rating					
Average Score	1	2	3	4	5
Asset Condition	Excellent	Good	Fair	Poor	Failing
Category	A	B	C	D	E
Remarks / Requirements					
<ul style="list-style-type: none"> Non- Functional due to choked bore 					
Data Collected By: Mr. Haroon		Designation: Team Member

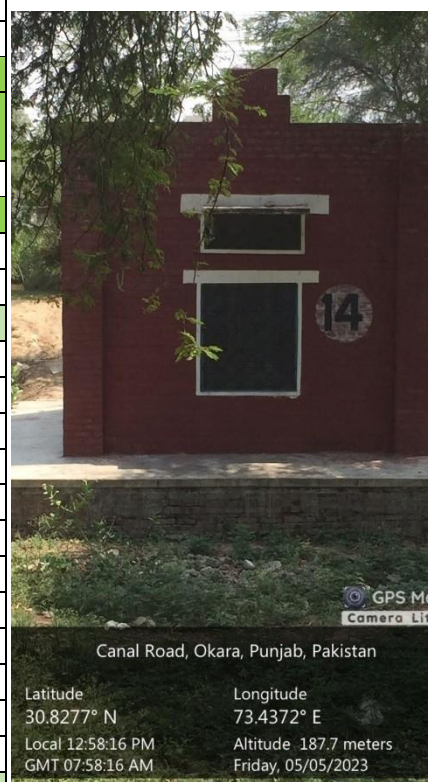
Integrated Development and Asset Management Plan (IDAMP)					
Municipal Committee Okara					
Form: IDAMP-A1	Tube Well Asset Condition Assessment	Asset Code: _____ Date: 06-05-2023			
Asset Detail			Pictures		
Name		Tube Well-14			
Location	Latitude	30.8277			
	Longitude	73.4372			
Address					
Area (Marla/Kanal/Acres)		1			
Working Status		Functional	Non- Functional		
Installation Year of Tube Well		1998			
Installation Year of Pump		1998			
Capital Cost of Machinery					
Operational Hours					
Delivery Pipe	Dia				
	Material	Mild Steel			
Chlorinator		Yes	No		
Chlorination Schedule		Once in a Year	After 6 Months	No Schedule	
Apron Around Pump House		Yes	No		
Hoisting Girder		Yes	No		
Civil Structure Condition		Good	Fair	Bad	
Approach to Pump House		Good	Fair	Bad	
Pump Details					
Pump Type		Turbine			
Pump Make		MECO			
Discharge Capacity (Cusec)		1			
Rotational Speed (RPM)		1460			
Housing Dia (inches)		12"			
Bore Depth (ft.)		350

Head (ft.)		200			
Impeller Installation Depth (ft.)		120			
Paint of Pumping Unit		OK			
Number of Valves	Gate Valve	1			
	Non-Returning Valve	1			
Base Plate		Yes	No		
Electro-Mechanical Equipment Details					
Transformer Capacity (kVA)					
Sanctioned Load (Kwh)		30			
Motor Power (HP)		40			
Motor Make		SIEMENS			
MCU		Yes	No		
Earthing of Motor		Yes	No		
Power Wiring		Yes	No		
Service Cable		Yes	No		
Earthing of MCU		Yes	No		
Energy Meter		Yes	No		
Water Meter		Yes	No		
PFI Equipment		Yes	No

Integrated Development and Asset Management Plan (IDAMP)					
Municipal Committee Okara					
Form: IDAMP-A1	Tube Well Asset Condition Assessment			Asset Code: _____ Date: 06-05-2023	
Generator	Yes	No			
Change Over	Yes	No			
Overall Rating					
Average Score	1	2	3	4	5
Asset Condition	Excellent	Good	Fair	Poor	Failing
Category	A	B	C	D	E
Remarks / Requirements					
<ul style="list-style-type: none"> No remarks 					
Data Collected By: Mr. Haroon		Designation: Team Member

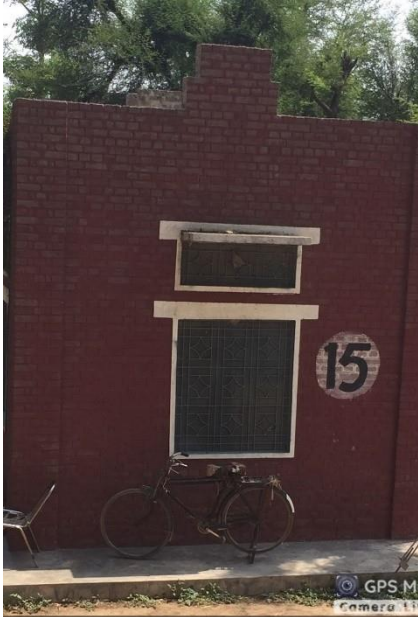
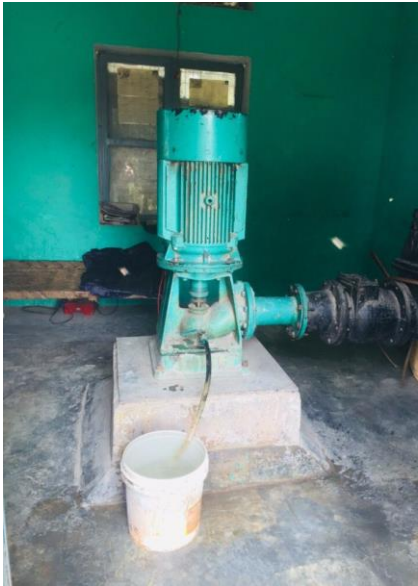
Canal Road, Okara, Punjab, Pakistan

Integrated Development and Asset Management Plan (IDAMP)					
Municipal Committee Okara					
Form: IDAMP-A1	Tube Well Asset Condition Assessment			Asset Code: _____ Date: 06-05-2023	
Asset Detail				Pictures	
Name		Tube Well-15			
Location	Latitude	30.8251			
	Longitude	73.4306			
Address					
Area (Marla/Kanal/Acres)		1			
Working Status		Functional	Non- Functional		
Installation Year of Tube Well		2008			
Installation Year of Pump		2008			
Capital Cost of Machinery					
Operational Hours		5			
Delivery Pipe	Dia	8"			
	Material	Mild Steel			
Chlorinator		Yes	No		
Chlorination Schedule		Once in a Year	After 6 Months	No Schedule	
Apron Around Pump House		Yes	No		
Hoisting Girder		Yes	No		
Civil Structure Condition		Good	Fair	Bad	
Approach to Pump House		Good	Fair	Bad	
Pump Details					
Pump Type		Turbine			
Pump Make		HMA Grundfos			
Discharge Capacity (Cusec)		1			
Rotational Speed (RPM)		1460			
Housing Dia (inches)		12"

Bore Depth (ft.)		350			
Head (ft.)		200			
Impeller Installation Depth (ft.)		120			
Paint of Pumping Unit		OK			
Number of Valves	Gate Valve	1			
	Non-Returning Valve	1			
Base Plate		Yes	No		
Electro-Mechanical Equipment Details					
Transformer Capacity (kVA)		50			
Sanctioned Load (Kwh)		30			
Motor Power (HP)		40			
Motor Make		SIEMENS			
MCU		Yes	No		
Earthing of Motor		Yes	No		
Power Wiring		Yes	No		
Service Cable		Yes	No		
Earthing of MCU		Yes	No		
Energy Meter		Yes	No		
Water Meter		Yes	No		
PFI Equipment		Yes	No

Integrated Development and Asset Management Plan (IDAMP)					
Municipal Committee Okara					
Form: IDAMP-A1	Tube Well Asset Condition Assessment			Asset Code: _____ Date: 06-05-2023	
Generator	Yes	No			
Change Over	Yes	No			
Overall Rating					
Average Score	1	2	3	4	5
Asset Condition	Excellent	Good	Fair	Poor	Failing
Category	A	B	C	D	E
Remarks / Requirements					
<ul style="list-style-type: none"> • No remarks 					
<i>Data Collected By: Mr. Haroon</i>		<i>Designation: Team Member</i>

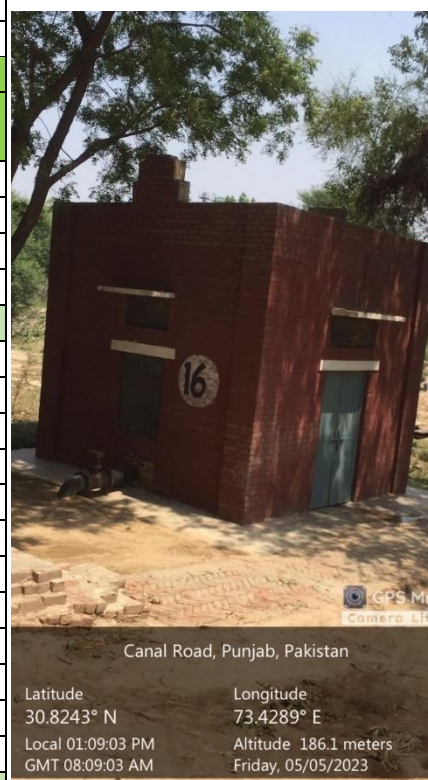
Integrated Development and Asset Management Plan (IDAMP)					
Municipal Committee Okara					
Form: IDAMP-A1	Tube Well Asset Condition Assessment	Asset Code: _____ Date: 06-05-2023			
Asset Detail			Pictures		
Name		Tube Well-16			
Location	Latitude	30.8243			
	Longitude	73.4289			
Address					
Area (Marla/Kanal/Acres)		1			
Working Status		Functional	Non- Functional		
Installation Year of Tube Well		1998			
Installation Year of Pump		1998			
Capital Cost of Machinery					
Operational Hours					
Delivery Pipe	Dia				
	Material	Mild Steel			
Chlorinator		Yes	No		
Chlorination Schedule		Once in a Year	After 6 Months	No Schedule	
Apron Around Pump House		Yes	No		
Hoisting Girder		Yes	No		
Civil Structure Condition		Good	Fair	Bad	
Approach to Pump House		Good	Fair	Bad	
Pump Details					
Pump Type		Turbine			
Pump Make		MECO			
Discharge Capacity (Cusec)		1			
Rotational Speed (RPM)		1460			
Housing Dia (inches)		12"			
Bore Depth (ft.)		350

Head (ft.)		200			
Impeller Installation Depth (ft.)		120			
Paint of Pumping Unit		OK			
Number of Valves	Gate Valve	1			
	Non-Returning Valve	1			
Base Plate		Yes	No		
Electro-Mechanical Equipment Details					
Transformer Capacity (kVA)					
Sanctioned Load (Kwh)		30			
Motor Power (HP)		40			
Motor Make		SIEMENS			
MCU		Yes	No		
Earthing of Motor		Yes	No		
Power Wiring		Yes	No		
Service Cable		Yes	No		
Earthing of MCU		Yes	No		
Energy Meter		Yes	No		
Water Meter		Yes	No		
PFI Equipment		Yes	No

Integrated Development and Asset Management Plan (IDAMP)					
Municipal Committee Okara					
Form: IDAMP-A1	Tube Well Asset Condition Assessment			Asset Code: _____ Date: 06-05-2023	
Generator	Yes	No			
Change Over	Yes	No			
Overall Rating					
Average Score	1	2	3	4	5
Asset Condition	Excellent	Good	Fair	Poor	Failing
Category	A	B	C	D	E
Remarks / Requirements					
<ul style="list-style-type: none"> Non-Functional due to unavailability of transformer 					
Data Collected By: Mr. Haroon		Designation: Team Member

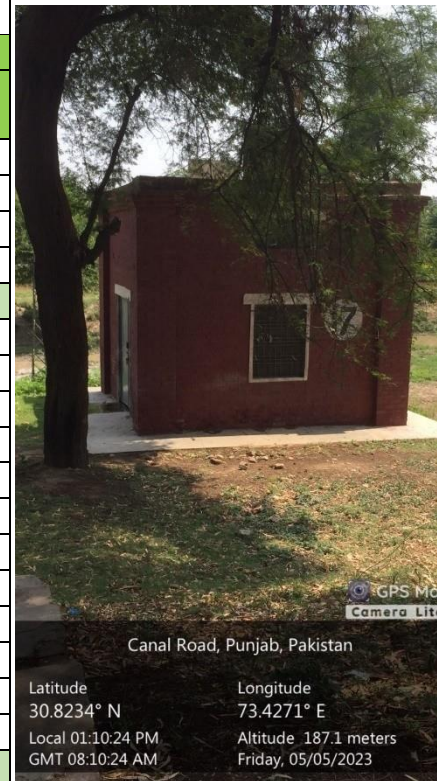
Integrated Development and Asset Management Plan (IDAMP)				
Municipal Committee Okara				
Form: IDAMP-A1	Tube Well Asset Condition Assessment	Asset Code: _____ Date: 06-05-2023		
Asset Detail			Pictures	
Name		Tube Well-17		
Location	Latitude	30.8234		
	Longitude	73.4271		
Address				
Area (Marla/Kanal/Acres)		1		
Working Status		Functional	Non- Functional	
Installation Year of Tube Well		1998		
Installation Year of Pump		1998		
Capital Cost of Machinery				
Operational Hours				
Delivery Pipe	Dia			
	Material	Mild Steel		
Chlorinator		Yes	No	
Chlorination Schedule		Once in a Year	After 6 Months	No Schedule
Apron Around Pump House		Yes	No	
Hoisting Girder		Yes	No	
Civil Structure Condition		Good	Fair	Bad
Approach to Pump House		Good	Fair	Bad
Pump Details				
Pump Type		Turbine		
Pump Make		KSB		
Discharge Capacity (Cusec)		1		
Rotational Speed (RPM)		1460		
Housing Dia (inches)		12"		
Bore Depth (ft.)		350		
Head (ft.)		200

Impeller Installation Depth (ft.)		120		
Paint of Pumping Unit		OK		
Number of Valves	Gate Valve	1		
	Non-Returning Valve	1		
Base Plate		Yes	No	
Electro-Mechanical Equipment Details				
Transformer Capacity (kVA)				
Sanctioned Load (Kwh)		30		
Motor Power (HP)		40		
Motor Make		SIEMENS		
MCU		Yes	No	
Earthing of Motor		Yes	No	
Power Wiring		Yes	No	
Service Cable		Yes	No	
Earthing of MCU		Yes	No	
Energy Meter		Yes	No	
Water Meter		Yes	No	
PFI Equipment		Yes	No

Integrated Development and Asset Management Plan (IDAMP)					
Municipal Committee Okara					
Form: IDAMP-A1	Tube Well Asset Condition Assessment			Asset Code: _____ Date: 06-05-2023	
Generator	Yes	No			
Change Over	Yes	No			
Overall Rating					
Average Score	1	2	3	4	5
Asset Condition	Excellent	Good	Fair	Poor	Failing
Category	A	B	C	D	E
Remarks / Requirements					
<ul style="list-style-type: none"> Non-Functional due to unavailability of transformer 					
Data Collected By: Mr. Haroon		Designation: Team Member

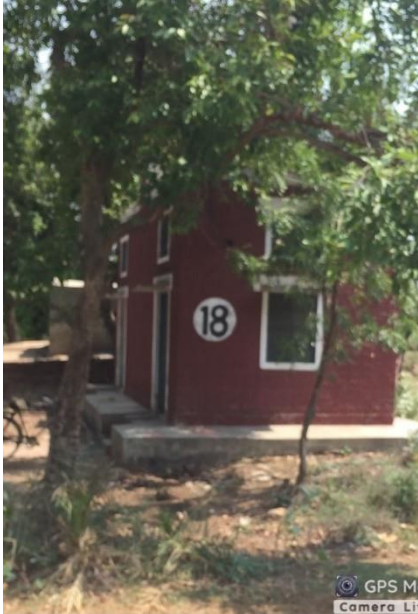
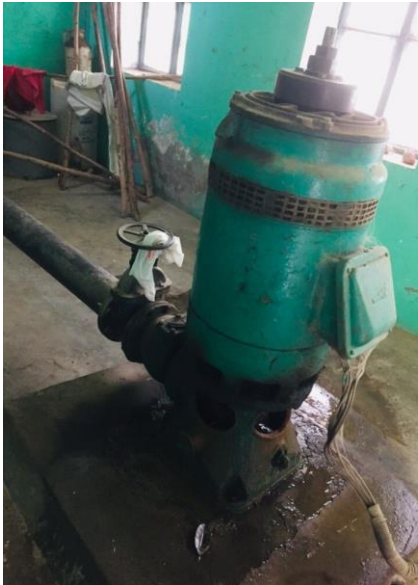
Canal Road, Punjab, Pakistan

Integrated Development and Asset Management Plan (IDAMP)					
Municipal Committee Okara					
Form: IDAMP-A1	Tube Well Asset Condition Assessment			Asset Code: _____ Date: 06-05-2023	
Asset Detail				Pictures	
Name		Tube Well-18			
Location	Latitude	30.8214			
	Longitude	73.4238			
Address					
Area (Marla/Kanal/Acres)		1			
Working Status		Functional	Non- Functional		
Installation Year of Tube Well		1998			
Installation Year of Pump		1998			
Capital Cost of Machinery					
Operational Hours		5			
Delivery Pipe	Dia	6"			
	Material	Mild Steel			
Chlorinator		Yes	No		
Chlorination Schedule		Once in a Year	After 6 Months	No Schedule	
Apron Around Pump House		Yes	No		
Hoisting Girder		Yes	No		
Civil Structure Condition		Good	Fair	Bad	
Approach to Pump House		Good	Fair	Bad	
Pump Details					
Pump Type		Turbine			
Pump Make		PECO			
Discharge Capacity (Cusec)		1			
Rotational Speed (RPM)		1460			
Housing Dia (inches)		12"

Bore Depth (ft.)		350			
Head (ft.)		200			
Impeller Installation Depth (ft.)		120			
Paint of Pumping Unit		OK			
Number of Valves	Gate Valve	1			
	Non-Returning Valve	1			
Base Plate		Yes	No		
Electro-Mechanical Equipment Details					
Transformer Capacity (kVA)					
Sanctioned Load (Kwh)		30			
Motor Power (HP)		40			
Motor Make		PECO			
MCU		Yes	No		
Earthing of Motor		Yes	No		
Power Wiring		Yes	No		
Service Cable		Yes	No		
Earthing of MCU		Yes	No		
Energy Meter		Yes	No		
Water Meter		Yes	No		
PFI Equipment		Yes	No

Integrated Development and Asset Management Plan (IDAMP)					
Municipal Committee Okara					
Form: IDAMP-A1	Tube Well Asset Condition Assessment			Asset Code: _____ Date: 06-05-2023	
Generator	Yes	No			
Change Over	Yes	No			
Overall Rating					
Average Score	1	2	3	4	5
Asset Condition	Excellent	Good	Fair	Poor	Failing
Category	A	B	C	D	E
Remarks / Requirements					
<ul style="list-style-type: none"> No remarks 					
Data Collected By: Mr. Haroon		Designation: Team Member

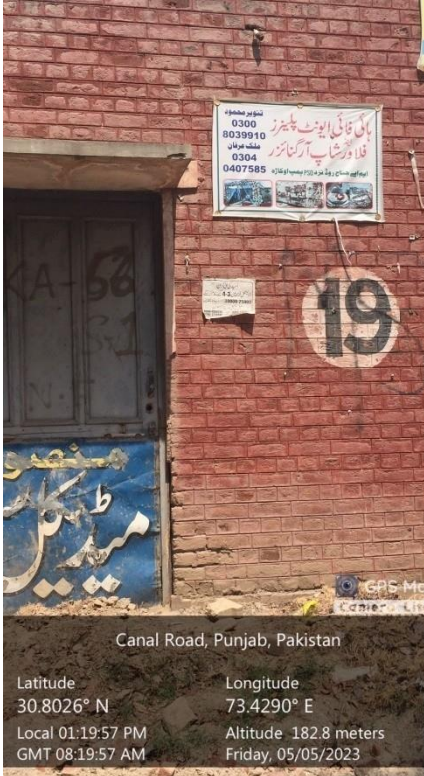
Canal Road, Punjab, Pakistan

Integrated Development and Asset Management Plan (IDAMP)					
Municipal Committee Okara					
Form: IDAMP-A1	Tube Well Asset Condition Assessment			Asset Code: _____ Date: 06-05-2023	
Asset Detail				Pictures	
Name		Tube Well-19 Old			
Location	Latitude	30.8026			
	Longitude	73.4290			
Address					
Area (Marla/Kanal/Acres)		1			
Working Status		Functional	Non- Functional		
Installation Year of Tube Well		1998			
Installation Year of Pump		1998			
Capital Cost of Machinery					
Operational Hours					
Delivery Pipe	Dia				
	Material	Mild Steel			
Chlorinator		Yes	No		
Chlorination Schedule		Once in a Year	After 6 Months	No Schedule	
Apron Around Pump House		Yes		No	
Hoisting Girder		Yes		No	
Civil Structure Condition		Good	Fair	Bad	
Approach to Pump House		Good	Fair	Bad	
Pump Details					
Pump Type		Turbine			
Pump Make		PECO			
Discharge Capacity (Cusec)		1			
Rotational Speed (RPM)		1460			
Housing Dia (inches)		12"

Bore Depth (ft.)		350			
Head (ft.)		200			
Impeller Installation Depth (ft.)		120			
Paint of Pumping Unit		OK			
Number of Valves	Gate Valve	1			
	Non-Returning Valve	1			
Base Plate		Yes		No	
Electro-Mechanical Equipment Details					
Transformer Capacity (kVA)					
Sanctioned Load (Kwh)		30			
Motor Power (HP)		40			
Motor Make		PECO			
MCU		Yes		No	
Earthing of Motor		Yes		No	
Power Wiring		Yes		No	
Service Cable		Yes		No	
Earthing of MCU		Yes		No	
Energy Meter		Yes		No	
Water Meter		Yes		No	
PFI Equipment		Yes		No

Integrated Development and Asset Management Plan (IDAMP)					
Municipal Committee Okara					
Form: IDAMP-A1	Tube Well Asset Condition Assessment			Asset Code: _____ Date: 06-05-2023	
Generator	Yes	No			
Change Over	Yes	No			
Overall Rating					
Average Score	1	2	3	4	5
Asset Condition	Excellent	Good	Fair	Poor	Failing
Category	A	B	C	D	E
Remarks / Requirements					
<ul style="list-style-type: none"> No remarks 					
Data Collected By: Mr. Haroon		Designation: Team Member

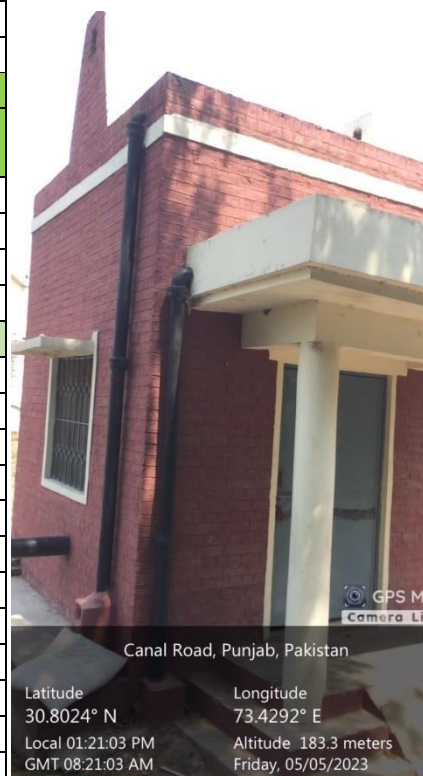
Integrated Development and Asset Management Plan (IDAMP)					
Municipal Committee Okara					
Form: IDAMP-A1		Tube Well Asset Condition Assessment		Asset Code: _____ Date: 06-05-2023	
Asset Detail				Pictures	
Name		Tube Well-19 new			
Location	Latitude	30.8024			
	Longitude	73.4292			
Address					
Area (Marla/Kanal/Acres)		1			
Working Status		Functional	Non- Functional		
Installation Year of Tube Well		2022			
Installation Year of Pump		2022			
Capital Cost of Machinery					
Operational Hours					
Delivery Pipe	Dia				
	Material	Mild Steel			
Chlorinator		Yes	No		
Chlorination Schedule		Once in a Year	After 6 Months	No Schedule	
Apron Around Pump House		Yes	No		
Hoisting Girder		Yes	No		
Civil Structure Condition		Good	Fair	Bad	
Approach to Pump House		Good	Fair	Bad	
Pump Details					
Pump Type		Turbine			
Pump Make		KSB			
Discharge Capacity (Cusec)		1			
Rotational Speed (RPM)		1460			
Housing Dia (inches)		12"

Bore Depth (ft.)		350			
Head (ft.)		200			
Impeller Installation Depth (ft.)		120			
Paint of Pumping Unit		OK			
Number of Valves	Gate Valve	1			
	Non-Returning Valve	1			
Base Plate		Yes	No		
Electro-Mechanical Equipment Details					
Transformer Capacity (kVA)					
Sanctioned Load (Kwh)		30			
Motor Power (HP)		40			
Motor Make		SIEMENS			
MCU		Yes	No		
Earthing of Motor		Yes	No		
Power Wiring		Yes	No		
Service Cable		Yes	No		
Earthing of MCU		Yes	No		
Energy Meter		Yes	No		
Water Meter		Yes	No		
PFI Equipment		Yes	No

Integrated Development and Asset Management Plan (IDAMP)					
Municipal Committee Okara					
Form: IDAMP-A1	Tube Well Asset Condition Assessment			Asset Code: _____ Date: 06-05-2023	
Generator	Yes	No			
Change Over	Yes	No			
Overall Rating					
Average Score	1	2	3	4	5
Asset Condition	Excellent	Good	Fair	Poor	Failing
Category	A	B	C	D	E
Remarks / Requirements					
<ul style="list-style-type: none"> Non-Functional due to unavailability of electricity meter 					
Data Collected By: Mr. Haroon		Designation: Team Member

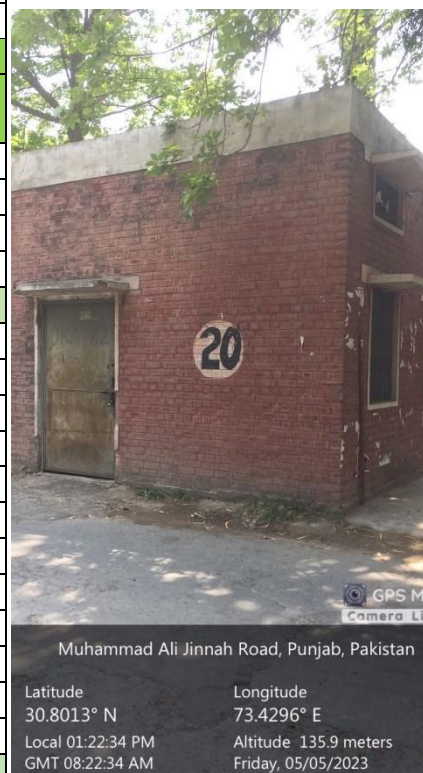
Integrated Development and Asset Management Plan (IDAMP)				
Municipal Committee Okara				
Form: IDAMP-A1		Tube Well Asset Condition Assessment		Asset Code: _____ Date: 06-05-2023
Asset Detail			Pictures	
Name		Tube Well-20		
Location	Latitude	30.8013		
	Longitude	73.4296		
Address				
Area (Marla/Kanal/Acres)		1		
Working Status		Functional	Non- Functional	
Installation Year of Tube Well		1998		
Installation Year of Pump		1998		
Capital Cost of Machinery				
Operational Hours				
Delivery Pipe	Dia			
	Material	Mild Steel		
Chlorinator		Yes	No	
Chlorination Schedule		Once in a Year	After 6 Months	No Schedule
Apron Around Pump House		Yes	No	
Hoisting Girder		Yes	No	
Civil Structure Condition		Good	Fair	Bad
Approach to Pump House		Good	Fair	Bad
Pump Details				
Pump Type		Turbine		
Pump Make		PECO		
Discharge Capacity (Cusec)		1		
Rotational Speed (RPM)		1460		
Housing Dia (inches)		12"		
Bore Depth (ft.)		350		
Head (ft.)		200

Impeller Installation Depth (ft.)		120		
Paint of Pumping Unit		OK		
Number of Valves	Gate Valve	1		
	Non-Returning Valve	1		
Base Plate		Yes	No	
Electro-Mechanical Equipment Details				
Transformer Capacity (kVA)				
Sanctioned Load (Kwh)		30		
Motor Power (HP)		40		
Motor Make		PECO		
MCU		Yes	No	
Earthing of Motor		Yes	No	
Power Wiring		Yes	No	
Service Cable		Yes	No	
Earthing of MCU		Yes	No	
Energy Meter		Yes	No	
Water Meter		Yes	No	
PFI Equipment		Yes	No

Integrated Development and Asset Management Plan (IDAMP)					
Municipal Committee Okara					
Form: IDAMP-A1	Tube Well Asset Condition Assessment			Asset Code: _____ Date: 06-05-2023	
Generator	Yes	No			
Change Over	Yes	No			
Overall Rating					
Average Score	1	2	3	4	5
Asset Condition	Excellent	Good	Fair	Poor	Failing
Category	A	B	C	D	E
Remarks / Requirements					
<ul style="list-style-type: none"> Due to choked bore 					
Data Collected By: Mr. Haroon		Designation: Team Member

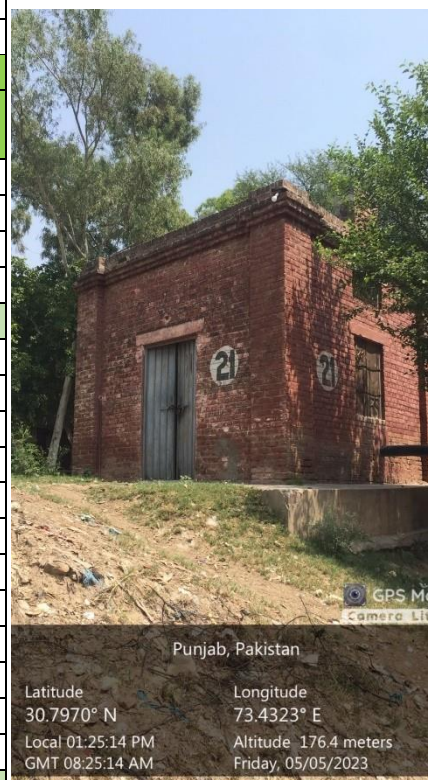
Integrated Development and Asset Management Plan (IDAMP)					
Municipal Committee Okara					
Form: IDAMP-A1	Tube Well Asset Condition Assessment			Asset Code: _____ Date: 06-05-2023	
Asset Detail				Pictures	
Name		Tube Well-21			
Location	Latitude	30.7970			
	Longitude	73.4323			
Address					
Area (Marla/Kanal/Acres)		1			
Working Status		Functional	Non- Functional		
Installation Year of Tube Well		1998			
Installation Year of Pump		1998			
Capital Cost of Machinery					
Operational Hours					
Delivery Pipe	Dia				
	Material	Mild Steel			
Chlorinator		Yes	No		
Chlorination Schedule		Once in a Year	After 6 Months	No Schedule	
Apron Around Pump House		Yes		No	
Hoisting Girder		Yes		No	
Civil Structure Condition		Good	Fair	Bad	
Approach to Pump House		Good	Fair	Bad	
Pump Details					
Pump Type		Turbine			
Pump Make		PECO			
Discharge Capacity (Cusec)		1			
Rotational Speed (RPM)		1460			
Housing Dia (inches)		12"			
Bore Depth (ft.)		350

Head (ft.)		200			
Impeller Installation Depth (ft.)		120			
Paint of Pumping Unit		OK			
Number of Valves	Gate Valve	1			
	Non-Returning Valve	1			
Base Plate		Yes		No	
Electro-Mechanical Equipment Details					
Transformer Capacity (kVA)					
Sanctioned Load (Kwh)		30			
Motor Power (HP)		40			
Motor Make		PECO			
MCU		Yes		No	
Earthing of Motor		Yes		No	
Power Wiring		Yes		No	
Service Cable		Yes		No	
Earthing of MCU		Yes		No	
Energy Meter		Yes		No	
Water Meter		Yes		No	
PFI Equipment		Yes		No

Integrated Development and Asset Management Plan (IDAMP)					
Municipal Committee Okara					
Form: IDAMP-A1	Tube Well Asset Condition Assessment			Asset Code: _____ Date: 06-05-2023	
Generator	Yes	No			
Change Over	Yes	No			
Overall Rating					
Average Score	1	2	3	4	5
Asset Condition	Excellent	Good	Fair	Poor	Failing
Category	A	B	C	D	E
Remarks / Requirements					
<ul style="list-style-type: none"> Non-functional due to unavailability of transformer also its bore is chocked 					
Data Collected By: Mr. Haroon		Designation: Team Member

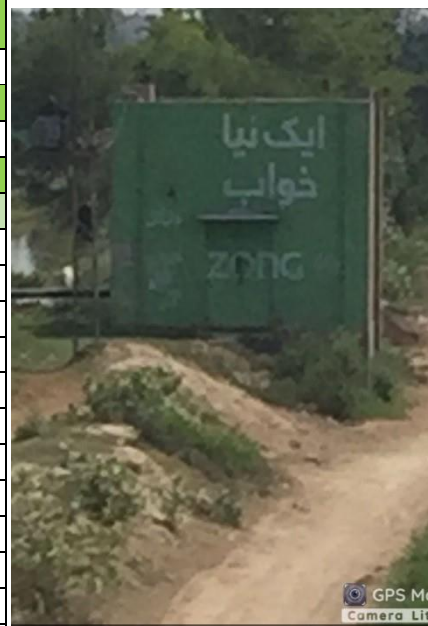
Integrated Development and Asset Management Plan (IDAMP)				
Municipal Committee Okara				
Form: IDAMP-A1	Tube Well Asset Condition Assessment			Asset Code: _____ Date: 06-05-2023
Asset Detail			Pictures	
Name		Tube Well-22		
Location	Latitude	30.7887		
	Longitude	73.4337		
Address				
Area (Marla/Kanal/Acres)		1		
Working Status		Functional	Non- Functional	
Installation Year of Tube Well		1998		
Installation Year of Pump		1998		
Capital Cost of Machinery				
Operational Hours		5		
Delivery Pipe	Dia	8"		
	Material	Mild Steel		
Chlorinator		Yes	No	
Chlorination Schedule		Once in a Year	After 6 Months	No Schedule
Apron Around Pump House		Yes	No	
Hoisting Girder		Yes	No	
Civil Structure Condition		Good	Fair	Bad
Approach to Pump House		Good	Fair	Bad
Pump Details				
Pump Type		Turbine		
Pump Make		PECO		
Discharge Capacity (Cusec)		1		
Rotational Speed (RPM)		1460		
Housing Dia (inches)		12"		
Bore Depth (ft.)		350		
Head (ft.)		200

Impeller Installation Depth (ft.)		120		
Paint of Pumping Unit		OK		
Number of Valves	Gate Valve	1		
	Non-Returning Valve	1		
Base Plate		Yes	No	
Electro-Mechanical Equipment Details				
Transformer Capacity (kVA)		25		
Sanctioned Load (Kwh)		30		
Motor Power (HP)		20		
Motor Make		PECO		
MCU		Yes	No	
Earthing of Motor		Yes	No	
Power Wiring		Yes	No	
Service Cable		Yes	No	
Earthing of MCU		Yes	No	
Energy Meter		Yes	No	
Water Meter		Yes	No	
PFI Equipment		Yes	No

Integrated Development and Asset Management Plan (IDAMP)					
Municipal Committee Okara					
Form: IDAMP-A1	Tube Well Asset Condition Assessment			Asset Code: _____ Date: 06-05-2023	
Generator	Yes	No			
Change Over	Yes	No			
Overall Rating					
Average Score	1	2	3	4	5
Asset Condition	Excellent	Good	Fair	Poor	Failing
Category	A	B	C	D	E
Remarks / Requirements					
<ul style="list-style-type: none"> No remarks 					
Data Collected By: Mr. Haroon		Designation: Team Member

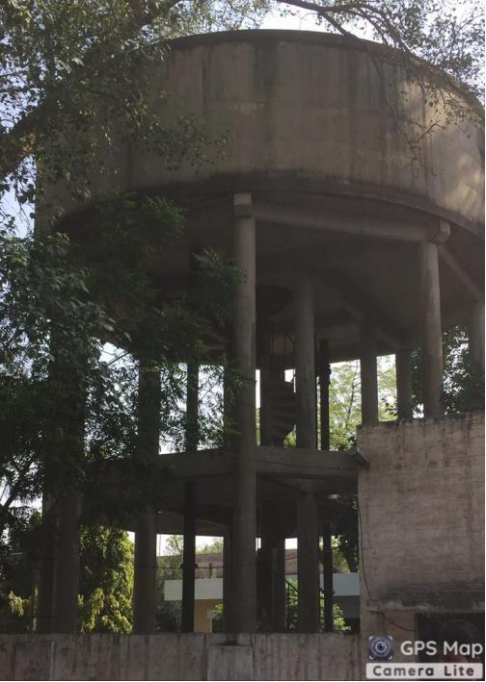
Integrated Development And Asset Management Plan (IDAMP)						
Municipal Committee Okara						
Form: IDAMP-A2	Over Head Reservoir Asset Condition Assessment			Asset Code: _____ Date: 05-05-2023		
Name		Old water works Tehsil Road		Pictures		
Location	Latitude	30.8110

Longitude	73.4445				
Address						
Year of Construction		1936				
Capacity (UK Gallons)		50,000				
Cleaning Frequency (Per Year)		1				
Type of Structure		RCC				
Structure Condition		Good	Fair			Poor
Tank Conditions		Good	Fair			Poor
Number of Valves	Sluice Valve	4				
	Non-Returning Valve	1				
Working Status		Functional	Non-Functional			
Rising Main	Dia	10"				
	Material	MS				
Delivery Main	Dia	10"				
	Material	MS				
Overflow & Scour Pipe	Dia	6"				
	Material	MS				
Sluice Valve	Rising Main	Yes	No			
	Delivery Main	Yes	No			
	Scour Pipe	Yes	No			
	Overflow Pipe	Yes	No			
Stair Case		Yes	No			
Apron Around OHR		Yes	No			
Tank Top Railing		Yes	No

Top Indication Light		Yes	No			
Lightening Arrester		Yes	No			
Boundary Wall & Gate		Yes	No			
Overflow Disposal Arrangements		Yes	No			
Approach to OHR		Good	Fair	Bad		
Overall Rating						
Average Score	1	2	3	4	5	
Asset Condition	Excellent	Good	Fair	Poor	Failing	
Category	A	B	C	D	E	
Remarks / Requirements						
<ul style="list-style-type: none"> No remarks 						
Data Collected By: Mr. Haroon		Designation: Team Member

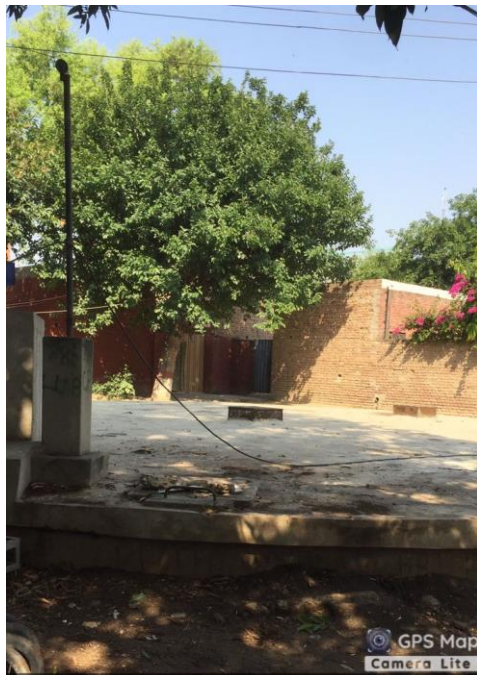
Integrated Development and Asset Management Plan (IDAMP)			
Municipal Committee Okara			
Form: IDAMP-A3	Ground Storage Reservoir Asset Condition Assessment		Asset Code: _____ Date: 05-05-2023
Name		Old water works Tehsil road	Pictures
Location	Latitude	30.8115

Longitude	73.4441	
Address			
Year of Construction		1936	
Capacity (UK Gallons)		100,000	
Cleaning Frequency (Per Year)		1	
Type of Structure		RCC	
Structure Condition		Good Fair Bad	
Number of Valves	Sluice Valve	5	
	Non-Returning Valve	5	
Working Status		Functional Non-Functional	
Incoming Main	Dia	6"	
	Material	GI	
Delivery Main	Dia	6" & 8"	
	Material	GI	
Cover Slab Condition		Good Fair Poor	
Approach Road Condition		Good Fair Poor	
Boundary Wall & Gate		Yes No	
Overall Rating

Average Score	1	2	3	4	5
Asset Condition	Excellent	Good	Fair	Poor	Failing
Category	A	B	C	D	E
Remarks / Requirements					
•					
Data Collected By: Mr. Haroon		Designation: Team Member

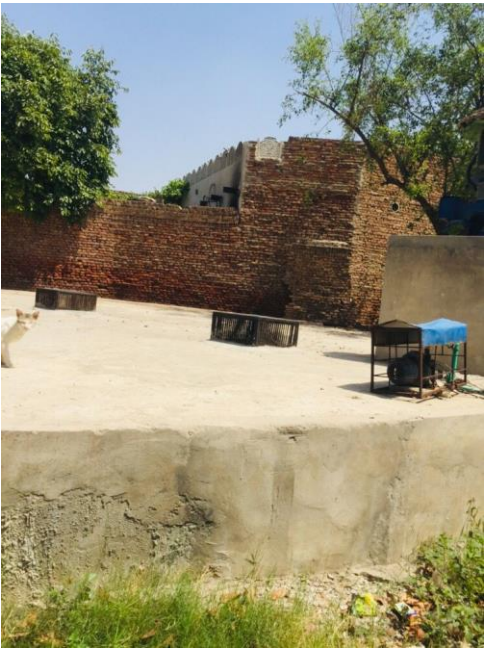
Integrated Development and Asset Management Plan (IDAMP)						
Municipal Committee Okara						
Form: IDAMP-A3	Ground Storage Reservoir Asset Condition Assessment			Asset Code: _____	Date: 05-05-2023	
Name		Akbar Tank Hadi jor hospital		Pictures		
Location	Latitude	30.8117

Longitude	73.4376				
Address						
Year of Construction		2021				
Capacity (UK Gallons)		100,000				
Cleaning Frequency (Per Year)		1				
Type of Structure		RCC				
Structure Condition		Good	Fair			Bad
Number of Valves	Sluice Valve	2				
	Non-Returning Valve	2				
Working Status		Functional	Non-Functional			
Incoming Main	Dia	6"				
	Material	GI				
Delivery Main	Dia	6" & 8"				
	Material	GI				
Cover Slab Condition		Good	Fair	Poor		
Approach Road Condition		Good	Fair	Poor		
Boundary Wall & Gate		Yes	No			
Overall Rating						
Average Score	1	2	3	4	5	
Asset Condition	Excellent	Good	Fair	Poor	Failing	
Category	A	B	C	D	E	
Remarks / Requirements

<ul style="list-style-type: none"> No remarks 						
<i>Data Collected By: Mr. Haroon</i>		<i>Designation: Team Member</i>

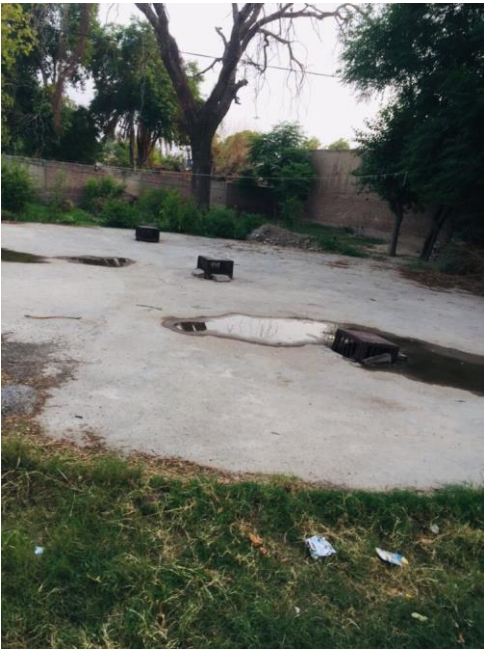
Integrated Development and Asset Management Plan (IDAMP)					
Municipal Committee Okara					
Form: IDAMP-A3		Ground Storage Reservoir Asset Condition Assessment			Asset Code: _____
					Date: 05-05-2023
Name		Chamra mandi			Pictures
Location	Latitude	30.8012

Longitude	73.4434			
Address					
Year of Construction		1983			
Capacity (UK Gallons)		100,000			
Cleaning Frequency (Per Year)		1			
Type of Structure		RCC			
Structure Condition		Good	Fair	Bad	
Number of Valves	Sluice Valve	2			
	Non-Returning Valve	2			
Working Status		Functional	Non-Functional		
Incoming Main	Dia	12"			
	Material	GI			
Delivery Main	Dia	6"			
	Material	GI			
Cover Slab Condition		Good	Fair	Poor	
Approach Road Condition		Good	Fair	Poor	
Boundary Wall & Gate		Yes	No		
Overall Rating					
Average Score	1	2	3	4	5
Asset Condition	Excellent	Good	Fair	Poor	Failing
Category	A	B	C	D	E
Remarks / Requirements					
<ul style="list-style-type: none"> No remarks No remarks No remarks
