Punjab Municipal Development Fund Company

Hiring of Consulting Services for Preparation of Integrated Development and Asset Management Plan (IDAMP) for 16 selected MCs In Punjab under Punjab Cities Program (PCP)

IDAMP – Municipal Committee Okara
May 2024

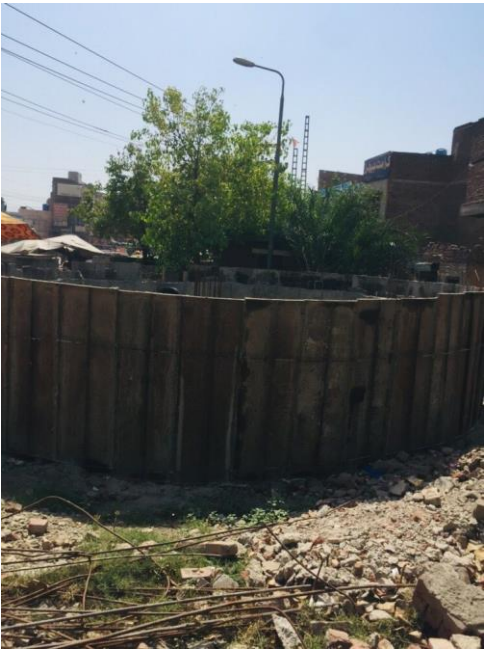
Integrated Development and Asset Management Plan (IDAMP)						
Municipal Committee Okara						
Form: IDAMP-A3	Ground Storage Reservoir Asset Condition Assessment			Asset Code: _____	Date: 05-05-2023	
Name		Ghaziabad		Pictures		
Location	Latitude	30.8071

Longitude	73.4566				
Address						
Year of Construction		Under Construction				
Capacity (UK Gallons)		100,000				
Cleaning Frequency (Per Year)						
Type of Structure		RCC				
Structure Condition		Good	Fair			Bad
Number of Valves	Sluice Valve					
	Non-Returning Valve					
Working Status		Functional	Non-Functional			
Incoming Main	Dia					
	Material					
Delivery Main	Dia					
	Material					
Cover Slab Condition		Good	Fair	Poor		
Approach Road Condition		Good	Fair	Poor		
Boundary Wall & Gate		Yes	No			
Overall Rating						
Average Score	1	2	3	4	5	
Asset Condition	Excellent	Good	Fair	Poor	Failing	
Category	A	B	C	D	E	
Remarks / Requirements						
<ul style="list-style-type: none"> • No remarks

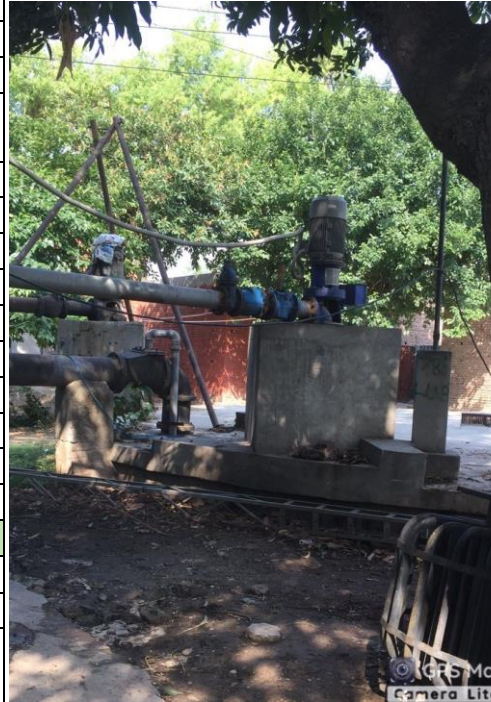
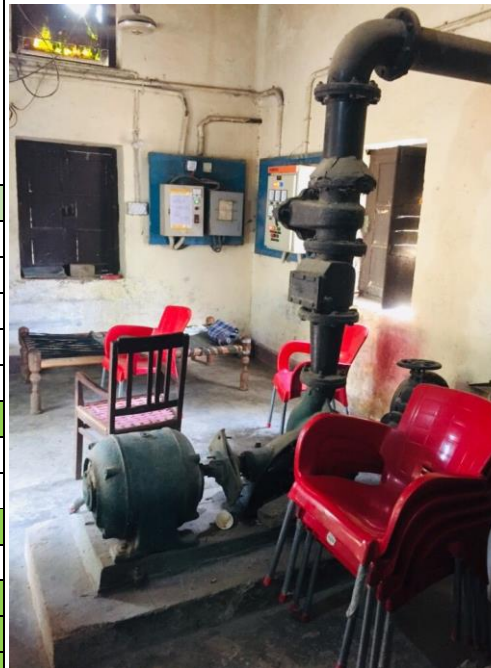
Integrated Development and Asset Management Plan (IDAMP)					
Municipal Committee Okara					
Form: IDAMP-A1		Intermediate Pumping Station Asset Condition Assessment		Asset Code: _____ Date: 05-05-2023	
Asset Detail			Pictures		
Name		Old Water Works			
Location	Latitude	30.8115			
	Longitude	73.4441			
Address					
Area (Acres)		0.8			
Working Status		Functional	Non-Functional		
Installation Year of Tube Well		1936			
Installation Year of Pump		1936			
Capital Cost of Machinery					
Operational Hours		7			
Delivery Pipe	Dia	6			
	Material	MS			
Apron Around Pump House		Yes	No		
Hoisting Girder		Yes	No		
Civil Structure Condition		Good	Fair	Poor	
Approach to Pump House		Good	Fair	Poor	
Pump Details					
Pump Type		Turbine	Centrifugal		
Nos. of Pumps		1	3		
Pump Make		KSB			
Discharge Capacity (Cusec)		2			
Rotational Speed (RPM)		1460			
Head (ft.)		100			
Paint of Pumping Unit		Fair			
Number of Valves	Gate Valve	2

Non-Returning Valve	2			
Base Plate		Yes	No		
Electro-Mechanical Equipment Details					
Transformer Capacity (kVA)		100			
Sanctioned Load (Kwh)		30			
Motor Power (HP)		40			
Motor Make		Siemens			
MCU		Yes	No		
Earthing of Motor		Yes	No		
Power Wiring		Yes	No		
Service Cable		Yes	No		
Earthing of MCU		Yes	No		
Energy Meter		Yes	No		
Water Meter		Yes	No		
PFI Equipment		Yes	No		
Generator		Yes	No		
Change Over		Yes	No		
Overall Rating					
Average Score	1	2	3	4	5

Integrated Development and Asset Management Plan (IDAMP)					
Municipal Committee Okara					
Form: IDAMP-A1	Intermediate Pumping Station Asset Condition Assessment			Asset Code: _____ Date: 05-05-2023	
Asset Condition	Excellent	Good	Fair	Poor	Failing
Category	A	B	C	D	E
Remarks / Requirements					
<ul style="list-style-type: none"> No remarks 					
<i>Data Collected By: Mr. Haroon</i>		<i>Designation: Team Member</i>

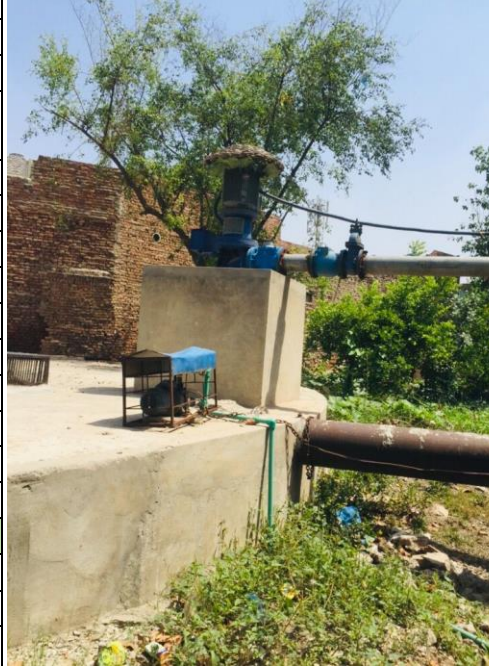
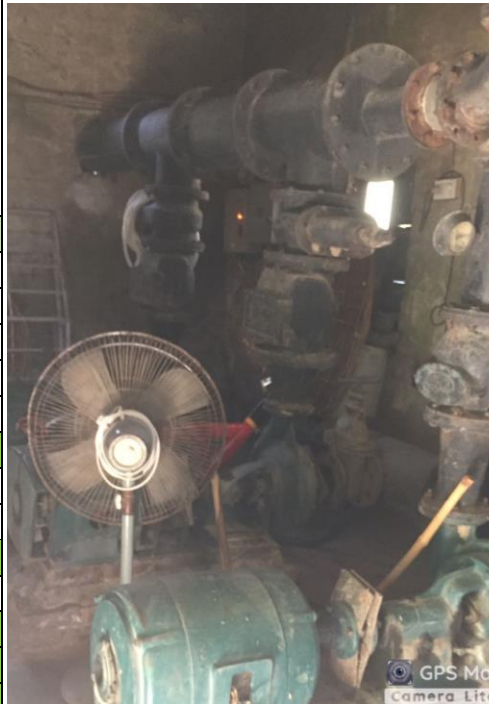
Integrated Development and Asset Management Plan (IDAMP)					
Municipal Committee Okara					
Form: IDAMP-A1		Intermediate Pumping Station Asset Condition Assessment		Asset Code: _____ Date: 05-05-2023	
Asset Detail			Pictures		
Name		Akbar Road Water Works			
Location	Latitude	30.8117			
	Longitude	73.4376			
Address					
Area (Acres)		0.6			
Working Status		Functional	Non-Functional		
Installation Year of Tube Well		2021			
Installation Year of Pump		2021			
Capital Cost of Machinery					
Operational Hours		7			
Delivery Pipe	Dia	6			
	Material	MS			
Apron Around Pump House		Yes	No		
Hoisting Girder		Yes	No		
Civil Structure Condition		Good	Fair	Poor	
Approach to Pump House		Good	Fair	Poor	
Pump Details					
Pump Type		Turbine	Centrifugal		
Nos. of Pumps		1	3		
Pump Make		KSB			
Discharge Capacity (Cusec)		2			
Rotational Speed (RPM)		1470			
Head (ft.)		100			
Paint of Pumping Unit		Poor			
Number of Valves	Gate Valve	2

Non-Returning Valve	2			
Base Plate		Yes	No		
Electro-Mechanical Equipment Details					
Transformer Capacity (kVA)		100			
Sanctioned Load (Kwh)		30			
Motor Power (HP)		40			
Motor Make		Siemens			
MCU		Yes	No		
Earthing of Motor		Yes	No		
Power Wiring		Yes	No		
Service Cable		Yes	No		
Earthing of MCU		Yes	No		
Energy Meter		Yes	No		
Water Meter		Yes	No		
PFI Equipment		Yes	No		
Generator		Yes	No		
Change Over		Yes	No		
Overall Rating					
Average Score	1	2	3	4	5

Integrated Development and Asset Management Plan (IDAMP)					
Municipal Committee Okara					
Form: IDAMP-A1		Intermediate Pumping Station Asset Condition Assessment			Asset Code: _____
					Date: 05-05-2023
Asset Condition	Excellent	Good	Fair	Poor	Failing
Category	A	B	C	D	E
Remarks / Requirements					
<ul style="list-style-type: none"> No remarks 					
Data Collected By: Mr. Haroon		Designation: Team Member

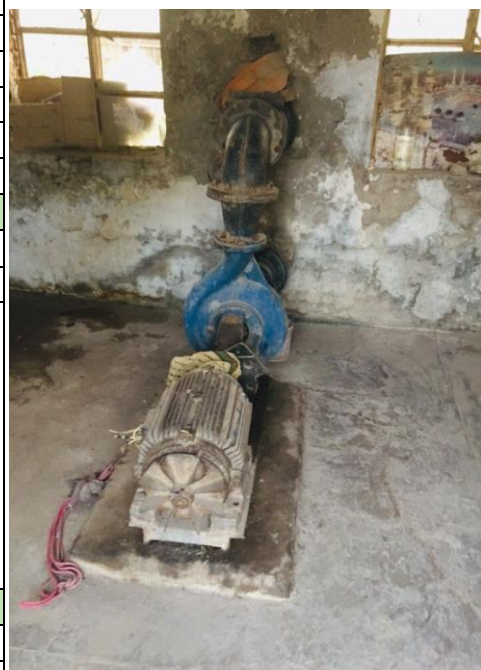
Integrated Development and Asset Management Plan (IDAMP)								
Municipal Committee Okara								
Form: IDAMP-A1	Intermediate Pumping Station Asset Condition Assessment			Asset Code: _____ Date: 05-05-2023				
Asset Detail			Pictures					
Name	Chamra Mandi							
Location	Latitude	30.8012						
	Longitude	73.4434						
Address								
Area (Acres)	0.53							
Working Status	Functional	Non-Functional						
Installation Year of Tube Well	1983							
Installation Year of Pump	1983							
Capital Cost of Machinery								
Operational Hours	0							
Delivery Pipe	Dia	6						
	Material	MS						
Apron Around Pump House	Yes	No						
Hoisting Girder	Yes	No						
Civil Structure Condition	Good	Fair	Poor					
Approach to Pump House	Good	Fair	Poor					
Pump Details								
Pump Type	Centrifugal							
Nos. of Pumps	1							
Pump Make	Abandoned							
Discharge Capacity (Cusec)								
Rotational Speed (RPM)								
Head (ft.)

Paint of Pumping Unit								
Number of Valves					Gate Valve			
					Non-Returning Valve			
Base Plate								
Electro-Mechanical Equipment Details								
Transformer Capacity (kVA)								
Sanctioned Load (Kwh)								
Motor Power (HP)	40							
Motor Make	Siemens							
MCU	Yes	No						
Earthing of Motor	Yes	No						
Power Wiring	Yes	No						
Service Cable	Yes	No						
Earthing of MCU	Yes	No						
Energy Meter	Yes	No						
Water Meter	Yes	No						
PFI Equipment	Yes	No						
Generator	Yes	No						
Change Over	Yes	No						
Overall Rating								
Average Score	1	2	3	4	5

Integrated Development and Asset Management Plan (IDAMP)						
Municipal Committee Okara						
Form: IDAMP-A1	Intermediate Pumping Station Asset Condition Assessment				Asset Code: _____	Date: 05-05-2023
Asset Condition	Excellent	Good	Fair	Poor	Failing	
Category	A	B	C	D	E	
Remarks / Requirements						
<ul style="list-style-type: none"> No remarks 						
Data Collected By: Mr. Haroon		Designation: Team Member

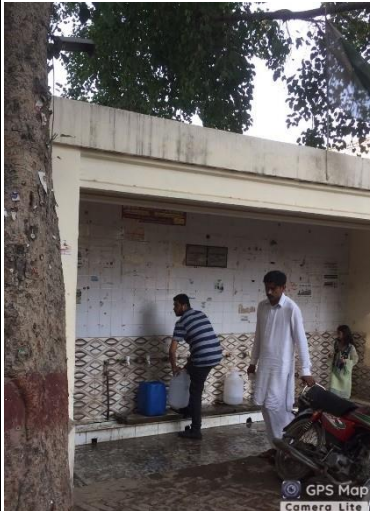
Integrated Development And Asset Management Plan (IDAMP)					
Municipal Committee Okara					
Form: IDAMP-A4	Water Filtration Plant Asset Condition Assessment			Asset Code: _____ Date: 05-05-2023	
Name		Old Water Works Tehsil Road		Pictures	
Location	Latitude	30.8111

Longitude	73.4445			
Address					
Installation Year		2001			
Installing Agency					
O&M Agency		MC			
Filtration Capacity (Liter/Hour)		2000			
Operational Hours		6			
No. of Taps		10			
Effluent Test (If Available)					
Latest water quality analysis carried out?					
If yes, which lab and parameters?					
Findings of water quality analysis?					
In case of any parameter above the permissible limit, which steps are taken to provide safe water?					
Plant Type		RO	UF		
Source of Water		Local Tube Well	Public Water Supply		
Working Status		Functional		Non-Functional	
Pumping Unit		Yes		No	
Control Panel		Yes		No	
Service Cable		Yes		No	
Ultraviolet Lamp		Yes		No

Takeaway Hall Condition		Good	Fair	Poor	
Building Structure Condition		Good	Fair	Poor	
Approach to Pump House		Good	Fair	Poor	
Overall Rating					
Average Score	1	2	3	4	5
Asset Condition	Excellent	Good	Fair	Poor	Failing
Category	A	B	C	D	E
Remarks / Requirements					
<ul style="list-style-type: none"> No remarks 					
Data Collected By: Mr. Haroon		Designation: Team Member

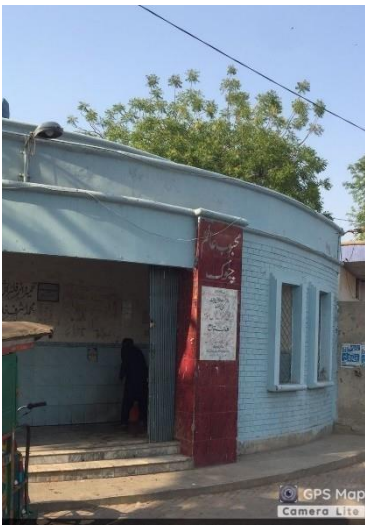
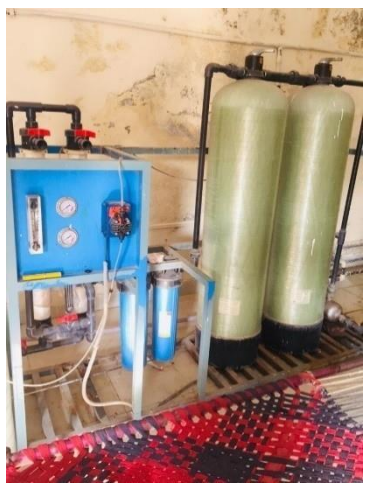
Integrated Development And Asset Management Plan (IDAMP)					
Municipal Committee Okara					
Form: IDAMP-A4		Water Filtration Plant Asset Condition Assessment			Asset Code: _____
					Date: 05-05-2023
Name		Govt Girls model H.s at tehsil road Mehboob alam chowk			Pictures
Location	Latitude	30.8092

Longitude	73.4409+			
Address					
Installation Year		2008			
Installing Agency					
O&M Agency		MC			
Filtration Capacity (Liter/Hour)		2000			
Operational Hours		6			
No. of Taps		10			
Effluent Test (If Available)					
Latest water quality analysis carried out?					
If yes, which lab and parameters?					
Findings of water quality analysis?					
In case of any parameter above the permissible limit, which steps are taken to provide safe water?					
Plant Type		RO	UF		
Source of Water		Local Tube Well	Public Water Supply		
Working Status		Functional	Non-Functional		
Pumping Unit		Yes	No		
Control Panel		Yes	No

Service Cable		Yes	No		
Ultraviolet Lamp		Yes	No		
Takeaway Hall Condition		Good	Fair	Poor	
Building Structure Condition		Good	Fair	Poor	
Approach to Pump House		Good	Fair	Poor	
Overall Rating					
Average Score	1	2	3	4	5
Asset Condition	Excellent	Good	Fair	Poor	Failing
Category	A	B	C	D	E
Remarks / Requirements					
<ul style="list-style-type: none"> No remarks 					
Data Collected By: Mr. Haroon		Designation: Team Member

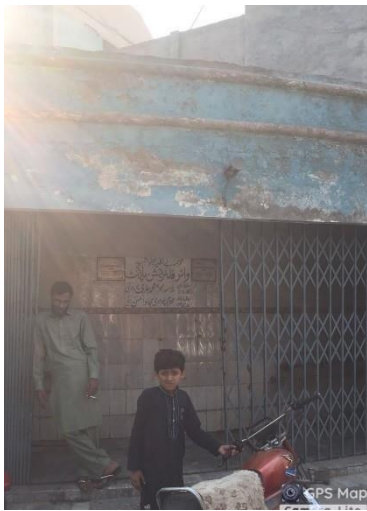
Integrated Development And Asset Management Plan (IDAMP)					
Municipal Committee Okara					
Form: IDAMP-A4	Water Filtration Plant Asset Condition Assessment			Asset Code: _____ Date: 05-05-2023	
Name		Benazir Bhutto Shaheed, Qadir Colony			Pictures
Location	Latitude	30.8076

Longitude	73.4361			
Address					
Installation Year		2010			
Installing Agency					
O&M Agency		MC			
Filtration Capacity (Liter/Hour)		1000			
Operational Hours		6			
No. of Taps		8			
Effluent Test (If Available)					
Latest water quality analysis carried out?					
If yes, which lab and parameters?					
Findings of water quality analysis?					
In case of any parameter above the permissible limit, which steps are taken to provide safe water?					
Plant Type		RO	UF		
Source of Water		Local Tube Well	Public Water Supply		
Working Status		Functional	Non-Functional		
Pumping Unit		Yes	No		
Control Panel		Yes	No		
Service Cable		Yes	No

Ultraviolet Lamp		Yes	No		
Takeaway Hall Condition		Good	Fair	Poor	
Building Structure Condition		Good	Fair	Poor	
Approach to Pump House		Good	Fair	Poor	
Overall Rating					
Average Score	1	2	3	4	5
Asset Condition	Excellent	Good	Fair	Poor	Failing
Category	A	B	C	D	E
Remarks / Requirements					
<ul style="list-style-type: none"> No remarks 					
Data Collected By: Mr. Haroon		Designation: Team Member

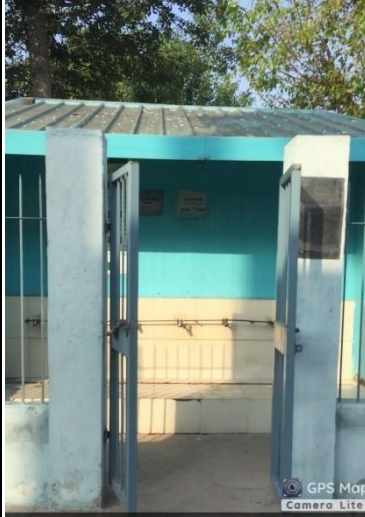
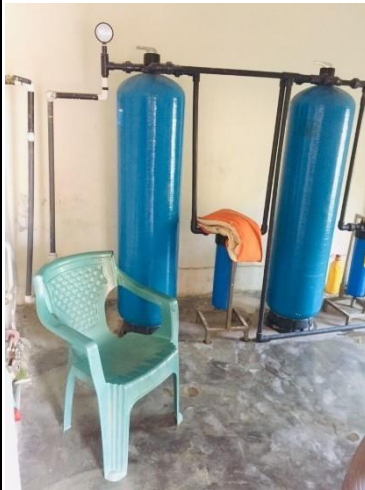
Integrated Development And Asset Management Plan (IDAMP)						
Municipal Committee Okara						
Form: IDAMP-A4	Water Filtration Plant Asset Condition Assessment			Asset Code: _____	Date: 05-05-2023	
Name		DHQ Hospital, Tehsil Road		Pictures		
Location	Latitude	30.8108

Longitude	73.4429				
Address						
Installation Year		2019				
Installing Agency						
O&M Agency		MC				
Filtration Capacity (Liter/Hour)		1000				
Operational Hours		6				
No. of Taps		7				
Effluent Test (If Available)						
Latest water quality analysis carried out?						
If yes, which lab and parameters?						
Findings of water quality analysis?						
In case of any parameter above the permissible limit, which steps are taken to provide safe water?						
Plant Type		RO	UF

Source of Water		Local Tube Well	Public Water Supply			
Working Status		Functional	Non-Functional			
Pumping Unit		Yes	No			
Control Panel		Yes	No			
Service Cable		Yes	No

Ultraviolet Lamp		Yes	No			
Takeaway Hall Condition		Good	Fair			Poor
Building Structure Condition		Good	Fair			Poor
Approach to Pump House		Good	Fair			Poor
Overall Rating						
Average Score	1	2	3	4	5	
Asset Condition	Excellent	Good	Fair	Poor	Failing	
Category	A	B	C	D	E	
Remarks / Requirements						
<ul style="list-style-type: none"> No remarks 						
Data Collected By: Mr. Haroon		Designation: Team Member

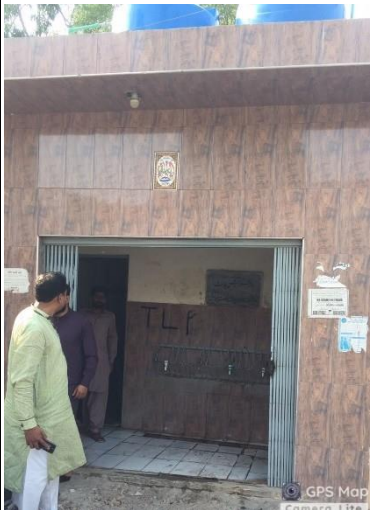
Integrated Development And Asset Management Plan (IDAMP)					
Municipal Committee Okara					
Form: IDAMP-A4	Water Filtration Plant Asset Condition Assessment			Asset Code: _____ Date: 05-05-2023	
Name		Stadium Road		Pictures	
Location	Latitude	30.8137

Longitude	73.4432			
Address					
Installation Year		2019			
Installing Agency					
O&M Agency		MC			
Filtration Capacity (Liter/Hour)		2000			
Operational Hours		6			
No. of Taps		6			
Effluent Test (If Available)					
Latest water quality analysis carried out?					
If yes, which lab and parameters?					
Findings of water quality analysis?					
In case of any parameter above the permissible limit, which steps are taken to provide safe water?					
Plant Type		RO	UF		
Source of Water		Local Tube Well	Public Water Supply		
Working Status		Functional		Non-Functional	
Pumping Unit		Yes		No	
Control Panel		Yes		No	
Service Cable		Yes		No	
Ultraviolet Lamp		Yes		No

Takeaway Hall Condition		Good	Fair	Poor	
Building Structure Condition		Good	Fair	Poor	
Approach to Pump House		Good	Fair	Poor	
Overall Rating					
Average Score	1	2	3	4	5
Asset Condition	Excellent	Good	Fair	Poor	Failing
Category	A	B	C	D	E
Remarks / Requirements					
<ul style="list-style-type: none"> No remarks 					
Data Collected By: Mr. Haroon		Designation: Team Member

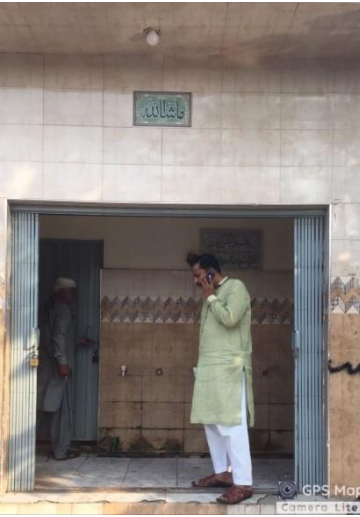
Integrated Development And Asset Management Plan (IDAMP)					
Municipal Committee Okara					
Form: IDAMP-A4	Water Filtration Plant Asset Condition Assessment			Asset Code: _____ Date: 05-05-2023	
Name		Near Junior Girls School		Pictures	
Location	Latitude	30.8150

Longitude	73.4500			
Address					
Installation Year		2020			
Installing Agency					
O&M Agency		MC			
Filtration Capacity (Liter/Hour)		2000			
Operational Hours		6			
No. of Taps		7			
Effluent Test (If Available)					
Latest water quality analysis carried out?					
If yes, which lab and parameters?					
Findings of water quality analysis?					
In case of any parameter above the permissible limit, which steps are taken to provide safe water?					
Plant Type		RO	UF		
Source of Water		Local Tube Well	Public Water Supply		
Working Status		Functional		Non-Functional	
Pumping Unit		Yes		No	
Control Panel		Yes		No	
Service Cable		Yes		No	
Ultraviolet Lamp		Yes		No

Takeaway Hall Condition		Good	Fair	Poor	
Building Structure Condition		Good	Fair	Poor	
Approach to Pump House		Good	Fair	Poor	
Overall Rating					
Average Score	1	2	3	4	5
Asset Condition	Excellent	Good	Fair	Poor	Failing
Category	A	B	C	D	E
Remarks / Requirements					
<ul style="list-style-type: none"> No remarks 					
Data Collected By: Mr. Haroon		Designation: Team Member

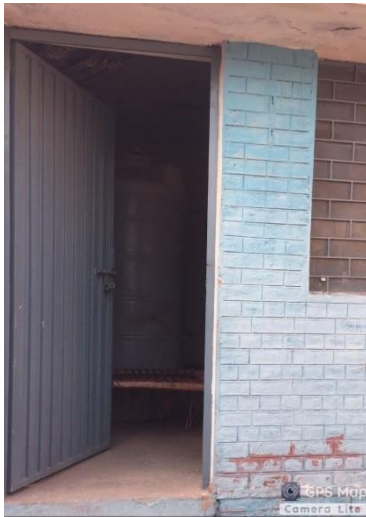
Integrated Development And Asset Management Plan (IDAMP)					
Municipal Committee Okara					
Form: IDAMP-A4	Water Filtration Plant Asset Condition Assessment			Asset Code: _____ Date: 05-05-2023	
Name		Govt. Islamia High School New Campus			Pictures
Location	Latitude	30.8171

Longitude	73.4517			
Address					
Installation Year		2010			
Installing Agency					
O&M Agency		MC			
Filtration Capacity (Liter/Hour)		1000			
Operational Hours		6			
No. of Taps		6			
Effluent Test (If Available)					
Latest water quality analysis carried out?					
If yes, which lab and parameters?					
Findings of water quality analysis?					
In case of any parameter above the permissible limit, which steps are taken to provide safe water?					
Plant Type		RO	UF		
Source of Water		Local Tube Well	Public Water Supply		
Working Status		Functional	Non-Functional		
Pumping Unit		Yes	No		
Control Panel		Yes	No		
Service Cable		Yes	No

Ultraviolet Lamp		Yes	No		
Takeaway Hall Condition		Good	Fair	Poor	
Building Structure Condition		Good	Fair	Poor	
Approach to Pump House		Good	Fair	Poor	
Overall Rating					
Average Score	1	2	3	4	5
Asset Condition	Excellent	Good	Fair	Poor	Failing
Category	A	B	C	D	E
Remarks / Requirements					
<ul style="list-style-type: none"> No remarks 					
Data Collected By: Mr. Haroon		Designation: Team Member

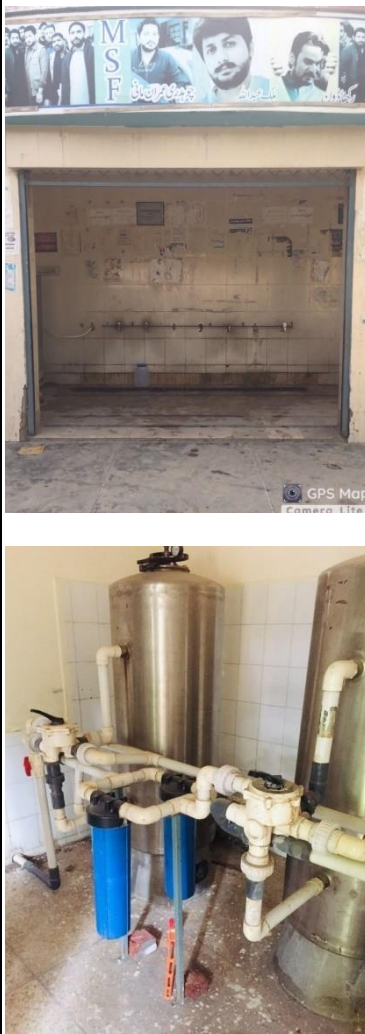
Integrated Development And Asset Management Plan (IDAMP)					
Municipal Committee Okara					
Form: IDAMP-A4	Water Filtration Plant Asset Condition Assessment			Asset Code: _____ Date: 05-05-2023	
Name		Ali Trust Hospital		Pictures	
Location	Latitude	30.8235

Longitude	73.4548			
Address					
Installation Year		2011			
Installing Agency					
O&M Agency		MC			
Filtration Capacity (Liter/Hour)		2000			
Operational Hours		6			
No. of Taps		7			
Effluent Test (If Available)					
Latest water quality analysis carried out?					
If yes, which lab and parameters?					
Findings of water quality analysis?					
In case of any parameter above the permissible limit, which steps are taken to provide safe water?					
Plant Type		RO	UF		
Source of Water		Local Tube Well	Public Water Supply		
Working Status		Functional		Non-Functional	
Pumping Unit		Yes		No	
Control Panel		Yes		No	
Service Cable		Yes		No	
Ultraviolet Lamp		Yes		No

Takeaway Hall Condition		Good	Fair	Poor	
Building Structure Condition		Good	Fair	Poor	
Approach to Pump House		Good	Fair	Poor	
Overall Rating					
Average Score	1	2	3	4	5
Asset Condition	Excellent	Good	Fair	Poor	Failing
Category	A	B	C	D	E
Remarks / Requirements					
<ul style="list-style-type: none"> No remarks 					
Data Collected By: Mr. Haroon		Designation: Team Member

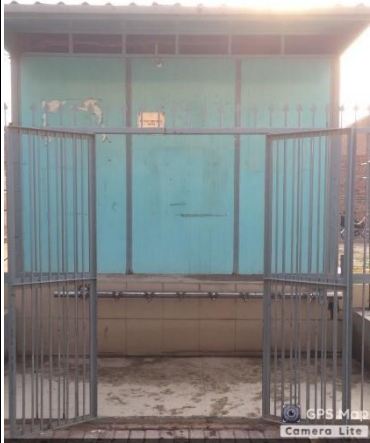
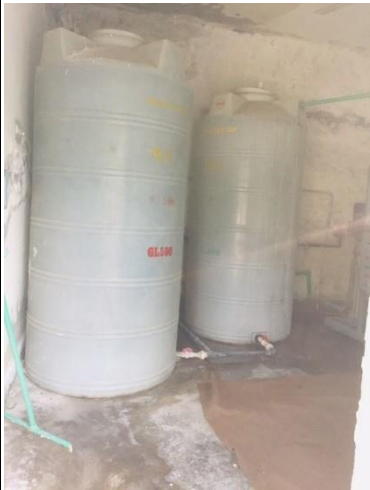
Integrated Development And Asset Management Plan (IDAMP)						
Municipal Committee Okara						
Form: IDAMP-A4	Water Filtration Plant Asset Condition Assessment			Asset Code: _____ Date: 05-05-2023		
Name		Sabri Colony, street No. 13		Pictures		
Location	Latitude	30.8164

Longitude	73.4361				
Address						
Installation Year		2018				
Installing Agency						
O&M Agency		MC				
Filtration Capacity (Liter/Hour)		1000				
Operational Hours		6				
No. of Taps		8				
Effluent Test (If Available)						
Latest water quality analysis carried out?						
If yes, which lab and parameters?						
Findings of water quality analysis?						
In case of any parameter above the permissible limit, which steps are taken to provide safe water?						
Plant Type		RO	UF

Source of Water		Local Tube Well	Public Water Supply			
Working Status		Functional	Non-Functional			
Pumping Unit		Yes	No			
Control Panel		Yes	No			
Service Cable		Yes	No

Ultraviolet Lamp		Yes	No			
Takeaway Hall Condition		Good	Fair			Poor
Building Structure Condition		Good	Fair			Poor
Approach to Pump House		Good	Fair			Poor
Overall Rating						
Average Score	1	2	3	4	5	
Asset Condition	Excellent	Good	Fair	Poor	Failing	
Category	A	B	C	D	E	
Remarks / Requirements						
<ul style="list-style-type: none"> No remarks 						
Data Collected By: Mr. Haroon		Designation: Team Member

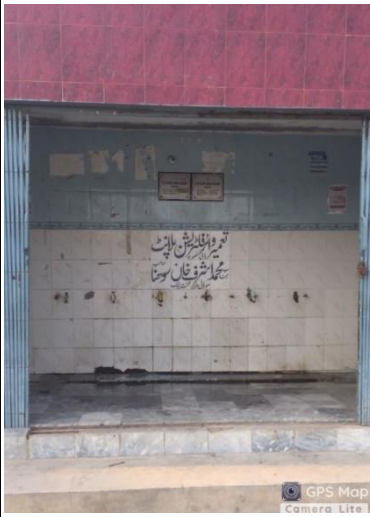
Integrated Development And Asset Management Plan (IDAMP)					
Municipal Committee Okara					
Form: IDAMP-A4	Water Filtration Plant Asset Condition Assessment			Asset Code: _____ Date: 05-05-2023	
Name		Govt School Sabri Colony			Pictures
Location	Latitude	30.8136

Longitude	73.4322			
Address					
Installation Year		2010			
Installing Agency					
O&M Agency		MC			
Filtration Capacity (Liter/Hour)		2000			
Operational Hours		6			
No. of Taps		6			
Effluent Test (If Available)					
Latest water quality analysis carried out?					
If yes, which lab and parameters?					
Findings of water quality analysis?					
In case of any parameter above the permissible limit, which steps are taken to provide safe water?					
Plant Type		RO	Simple Treatment		
Source of Water		Local Tube Well	Public Water Supply		
Working Status		Functional		Non-Functional	
Pumping Unit		Yes		No	
Control Panel		Yes		No	
Service Cable		Yes		No

Ultraviolet Lamp		Yes		No	
Takeaway Hall Condition		Good	Fair	Poor	
Building Structure Condition		Good	Fair	Poor	
Approach to Pump House		Good	Fair	Poor	
Overall Rating					
Average Score	1	2	3	4	5
Asset Condition	Excellent	Good	Fair	Poor	Failing
Category	A	B	C	D	E
Remarks / Requirements					
<ul style="list-style-type: none"> No remarks 					
Data Collected By: Mr. Haroon		Designation: Team Member

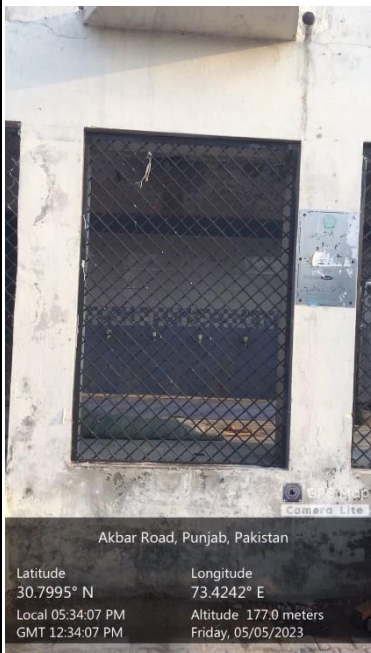
Integrated Development And Asset Management Plan (IDAMP)					
Municipal Committee Okara					
Form: IDAMP-A4		Water Filtration Plant Asset Condition Assessment			Asset Code: _____
					Date: 05-05-2023
Name		District Complex			Pictures
Location	Latitude	30.7995

Longitude	73.4242			
Address					
Installation Year		2020			
Installing Agency					
O&M Agency		MC			
Filtration Capacity (Liter/Hour)		2000			
Operational Hours		8			
No. of Taps		6			
Effluent Test (If Available)					
Latest water quality analysis carried out?					
If yes, which lab and parameters?					
Findings of water quality analysis?					
In case of any parameter above the permissible limit, which steps are taken to provide safe water?					
Plant Type		RO	Simple Treatment		
Source of Water		Local Tube Well	Public Water Supply		
Working Status		Functional		Non-Functional	
Pumping Unit		Yes		No	
Control Panel		Yes		No	
Service Cable		Yes		No

Ultraviolet Lamp		Yes		No	
Takeaway Hall Condition		Good	Fair	Poor	
Building Structure Condition		Good	Fair	Poor	
Approach to Pump House		Good	Fair	Poor	
Overall Rating					
Average Score	1	2	3	4	5
Asset Condition	Excellent	Good	Fair	Poor	Failing
Category	A	B	C	D	E
Remarks / Requirements					
<ul style="list-style-type: none"> No remarks 					
Data Collected By: Mr. Haroon		Designation: Team Member

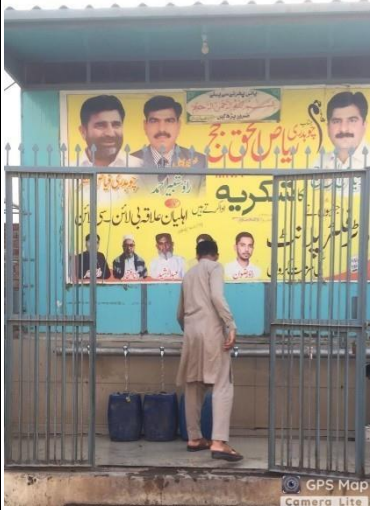
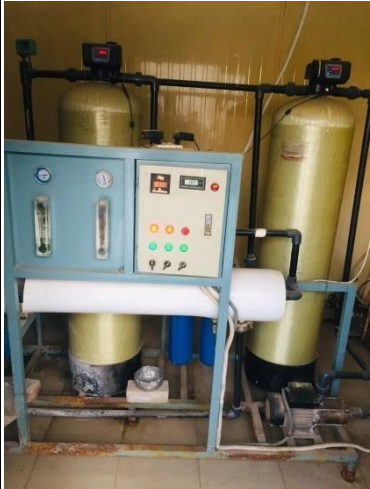
Integrated Development And Asset Management Plan (IDAMP)						
Municipal Committee Okara						
Form: IDAMP-A4	Water Filtration Plant Asset Condition Assessment			Asset Code: _____	Date: 05-05-2023	
Name		Filter Plant C line near Masjid		Pictures		
Location	Latitude	30.7954

Longitude	73.4395				
Address						
Installation Year		2018				
Installing Agency						
O&M Agency		MC				
Filtration Capacity (Liter/Hour)		1000				
Operational Hours		6				
No. of Taps		8				
Effluent Test (If Available)						
Latest water quality analysis carried out?						
If yes, which lab and parameters?						
Findings of water quality analysis?						
In case of any parameter above the permissible limit, which steps are taken to provide safe water?						
Plant Type		RO	UF

Source of Water		Local Tube Well	Public Water Supply			
Working Status		Functional	Non-Functional			
Pumping Unit		Yes	No			
Control Panel		Yes	No

Service Cable		Yes	No			
Ultraviolet Lamp		Yes	No			
Takeaway Hall Condition		Good	Fair			Poor
Building Structure Condition		Good	Fair			Poor
Approach to Pump House		Good	Fair			Poor
Overall Rating						
Average Score	1	2	3	4	5	
Asset Condition	Excellent	Good	Fair	Poor	Failing	
Category	A	B	C	D	E	
Remarks / Requirements						
<ul style="list-style-type: none"> No remarks 						
Data Collected By: Mr. Haroon		Designation: Team Member

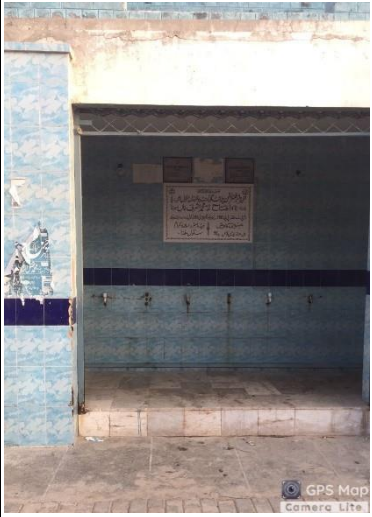
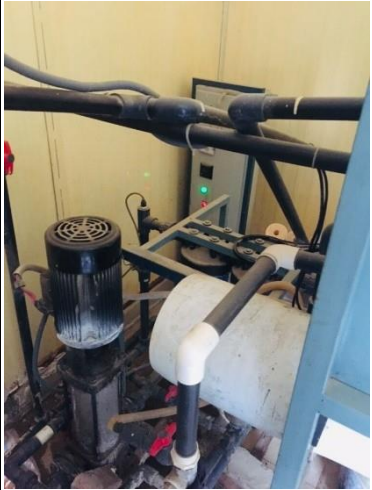
Integrated Development And Asset Management Plan (IDAMP)						
Municipal Committee Okara						
Form: IDAMP-A4	Water Filtration Plant Asset Condition Assessment			Asset Code: _____ Date: 05-05-2023		
Name		Govt Boys Elementary School 5/4.L		Pictures		
Location	Latitude	30.7916

Longitude	73.4407				
Address						
Installation Year		2008				
Installing Agency						
O&M Agency		MC				
Filtration Capacity (Liter/Hour)		1000				
Operational Hours		6				
No. of Taps		6				
Effluent Test (If Available)						
Latest water quality analysis carried out?						
If yes, which lab and parameters?						
Findings of water quality analysis?						
In case of any parameter above the permissible limit, which steps are taken to provide safe water?						
Plant Type		RO	UF

Source of Water		Local Tube Well	Public Water Supply			
Working Status		Functional	Non-Functional			
Pumping Unit		Yes	No			
Control Panel		Yes	No

Service Cable		Yes	No			
Ultraviolet Lamp		Yes	No			
Takeaway Hall Condition		Good	Fair			Poor
Building Structure Condition		Good	Fair			Poor
Approach to Pump House		Good	Fair			Poor
Overall Rating						
Average Score	1	2	3	4	5	
Asset Condition	Excellent	Good	Fair	Poor	Failing	
Category	A	B	C	D	E	
Remarks / Requirements						
<ul style="list-style-type: none"> • No remarks 						
Data Collected By: Mr. Haroon		Designation: Team Member

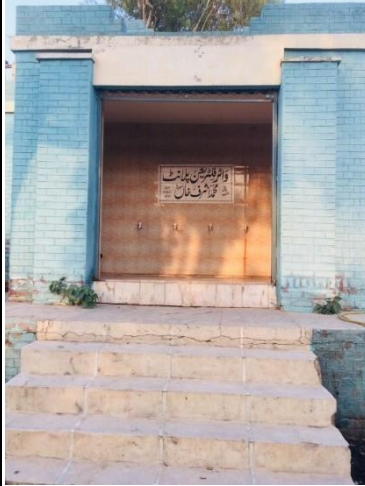
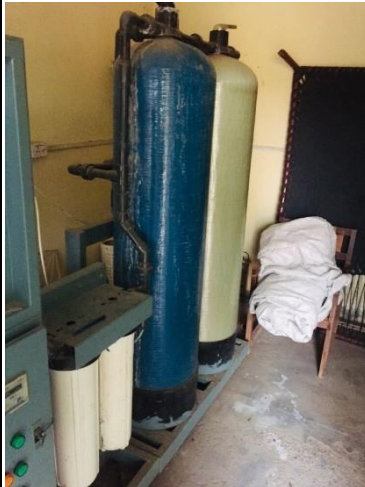
Integrated Development And Asset Management Plan (IDAMP)					
Municipal Committee Okara					
Form: IDAMP-A4		Water Filtration Plant Asset Condition Assessment		Asset Code: _____ Date: 05-05-2023	
Name			Chamra Mandi Water Works

Location	Latitude	30.8012			
	Longitude	73.4436			
Address					
Installation Year			2002		
Installing Agency					
O&M Agency			MC		
Filtration Capacity (Liter/Hour)			2000		
Operational Hours			6		
No. of Taps			8		
Effluent Test (If Available)					
Latest water quality analysis carried out?					
If yes, which lab and parameters?					
Findings of water quality analysis?					
In case of any parameter above the permissible limit, which steps are taken to provide safe water?					
Plant Type		RO	UF		
Source of Water		Local Tube Well	Public Water Supply		
Working Status		Functional	Non-Functional		
Pumping Unit		Yes	No		
Control Panel		Yes	No		
Service Cable		Yes	No		
Ultraviolet Lamp		Yes	No

Takeaway Hall Condition		Good	Fair	Poor	
Building Structure Condition		Good	Fair	Poor	
Approach to Pump House		Good	Fair	Poor	
Overall Rating					
Average Score	1	2	3	4	5
Asset Condition	Excellent	Good	Fair	Poor	Failing
Category	A	B	C	D	E
Remarks / Requirements					
<ul style="list-style-type: none"> No remarks 					
Data Collected By: Mr. Haroon		Designation: Team Member

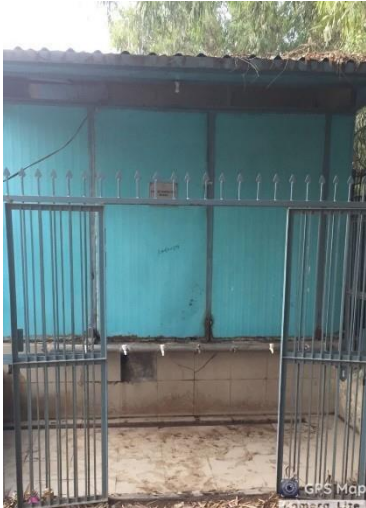
Integrated Development And Asset Management Plan (IDAMP)					
Municipal Committee Okara					
Form: IDAMP-A4	Water Filtration Plant Asset Condition Assessment			Asset Code: _____ Date: 05-05-2023	
Name		Govt. Girl College No. 2 (Madinah Town)			Pictures
Location	Latitude	30.7951

Longitude	73.4516			
Address					
Installation Year		2018			
Installing Agency					
O&M Agency		MC			
Filtration Capacity (Liter/Hour)		1000			
Operational Hours		6			
No. of Taps		6			
Effluent Test (If Available)					
Latest water quality analysis carried out?					
If yes, which lab and parameters?					
Findings of water quality analysis?					
In case of any parameter above the permissible limit, which steps are taken to provide safe water?					
Plant Type		RO	UF		
Source of Water		Local Tube Well	Public Water Supply		
Working Status		Functional	Non-Functional		
Pumping Unit		Yes	No		
Control Panel		Yes	No		
Service Cable		Yes	No

Ultraviolet Lamp		Yes	No		
Takeaway Hall Condition		Good	Fair	Poor	
Building Structure Condition		Good	Fair	Poor	
Approach to Pump House		Good	Fair	Poor	
Overall Rating					
Average Score	1	2	3	4	5
Asset Condition	Excellent	Good	Fair	Poor	Failing
Category	A	B	C	D	E
Remarks / Requirements					
<ul style="list-style-type: none"> No remarks 					
<i>Data Collected By: Mr. Haroon</i>		<i>Designation: Team Member</i>

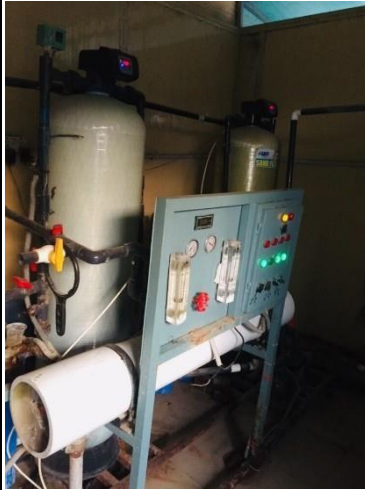
Integrated Development And Asset Management Plan (IDAMP)						
Municipal Committee Okara						
Form: IDAMP-A4		Water Filtration Plant Asset Condition Assessment		Asset Code: _____ Date: 05-05-2023		
Name		People Colony, Street No. 4		Pictures		
Location	Latitude	30.8002

Longitude	73.4530				
Address						
Installation Year		2018				
Installing Agency						
O&M Agency		MC				
Filtration Capacity (Liter/Hour)		1000				
Operational Hours		6				
No. of Taps		8				
Effluent Test (If Available)						
Latest water quality analysis carried out?						
If yes, which lab and parameters?						
Findings of water quality analysis?						
In case of any parameter above the permissible limit, which steps are taken to provide safe water?

Plant Type		RO	UF			
Source of Water		Local Tube Well	Public Water Supply			
Working Status		Functional	Non-Functional			
Pumping Unit		Yes	No			
Control Panel		Yes	No			
Service Cable		Yes	No

Ultraviolet Lamp		Yes	No			
Takeaway Hall Condition		Good	Fair			Poor
Building Structure Condition		Good	Fair			Poor
Approach to Pump House		Good	Fair	Poor		
Overall Rating						
Average Score	1	2	3	4	5	
Asset Condition	Excellent	Good	Fair	Poor	Failing	
Category	A	B	C	D	E	
Remarks / Requirements						
<ul style="list-style-type: none"> No remarks 						
Data Collected By: Mr. Haroon		Designation: Team Member

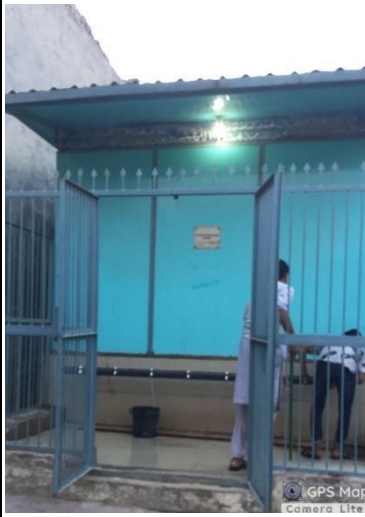
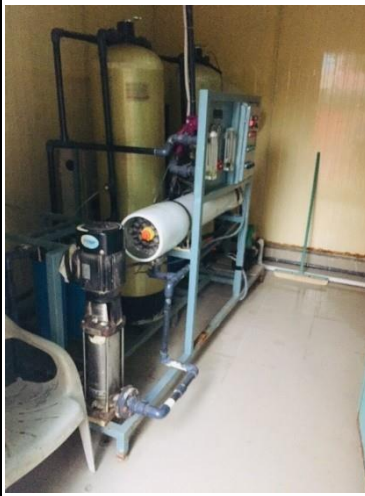
Integrated Development And Asset Management Plan (IDAMP)						
Municipal Committee Okara						
Form: IDAMP-A4	Water Filtration Plant Asset Condition Assessment			Asset Code: _____ Date: 05-05-2023		
Name		Sadiq Nagar Street No. 4		Pictures		
Location	Latitude	30.7979

Longitude	73.4528				
Address						
Installation Year		2018				
Installing Agency						
O&M Agency		MC				
Filtration Capacity (Liter/Hour)		1000				
Operational Hours		6				
No. of Taps		7				
Effluent Test (If Available)						
Latest water quality analysis carried out?						
If yes, which lab and parameters?						
Findings of water quality analysis?						
In case of any parameter above the permissible limit, which steps are taken to provide safe water?						
Plant Type		RO	UF

Source of Water		Local Tube Well	Public Water Supply			
Working Status		Functional	Non-Functional			
Pumping Unit		Yes	No			
Control Panel		Yes	No			
Service Cable		Yes	No

Ultraviolet Lamp		Yes	No			
Takeaway Hall Condition		Good	Fair			Poor
Building Structure Condition		Good	Fair			Poor
Approach to Pump House		Good	Fair			Poor
Overall Rating						
Average Score	1	2	3	4	5	
Asset Condition	Excellent	Good	Fair	Poor	Failing	
Category	A	B	C	D	E	
Remarks / Requirements						
<ul style="list-style-type: none"> No remarks 						
Data Collected By: Mr. Haroon		Designation: Team Member

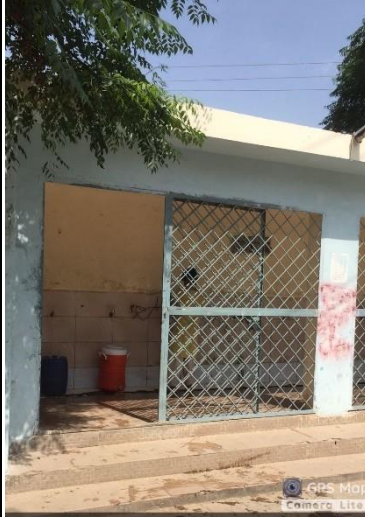
Integrated Development And Asset Management Plan (IDAMP)					
Municipal Committee Okara					
Form: IDAMP-A4	Water Filtration Plant Asset Condition Assessment			Asset Code: _____	Date: 06-05-2023
Name		Samadpura Railway Road		Pictures	
Location	Latitude	30.8076

Longitude	73.4494			
Address					
Installation Year		2005			
Installing Agency					
O&M Agency		MC			
Filtration Capacity (Liter/Hour)		2000			
Operational Hours		6			
No. of Taps		8			
Effluent Test (If Available)					
Latest water quality analysis carried out?					
If yes, which lab and parameters?					
Findings of water quality analysis?					
In case of any parameter above the permissible limit, which steps are taken to provide safe water?					
Plant Type		RO	UF		
Source of Water		Local Tube Well	Public Water Supply		
Working Status		Functional		Non-Functional	
Pumping Unit		Yes		No	
Control Panel		Yes		No	
Service Cable		Yes		No	
Ultraviolet Lamp		Yes		No

Takeaway Hall Condition		Good	Fair	Poor	
Building Structure Condition		Good	Fair	Poor	
Approach to Pump House		Good	Fair	Poor	
Overall Rating					
Average Score	1	2	3	4	5
Asset Condition	Excellent	Good	Fair	Poor	Failing
Category	A	B	C	D	E
Remarks / Requirements					
<ul style="list-style-type: none"> • No remarks 					
Data Collected By: Mr. Haroon		Designation: Team Member

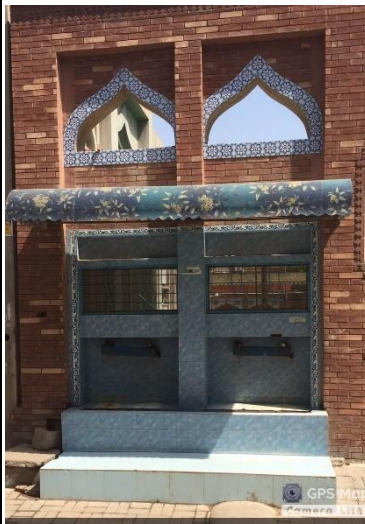
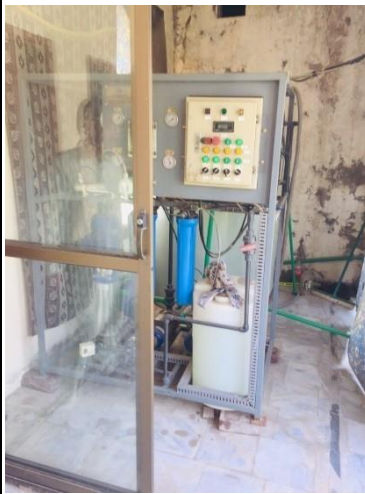
Integrated Development And Asset Management Plan (IDAMP)						
Municipal Committee Okara						
Form: IDAMP-A4	Water Filtration Plant Asset Condition Assessment			Asset Code: _____	Date: 06-05-2023	
Name		Astaana Alia Darbar, Ghaziabad		Pictures		
Location	Latitude	30.8043

Longitude	73.4566				
Address						
Installation Year		2018				
Installing Agency		Astaana Alia Darbar				
O&M Agency		MC				
Filtration Capacity (Liter/Hour)		1000				
Operational Hours		6				
No. of Taps		4				
Effluent Test (If Available)						
Latest water quality analysis carried out?						
If yes, which lab and parameters?						
Findings of water quality analysis?						
In case of any parameter above the permissible limit, which steps are taken to provide safe water?						
Plant Type		RO	UF

Source of Water		Local Tube Well	Public Water Supply			
Working Status		Functional	Non-Functional			
Pumping Unit		Yes	No			
Control Panel		Yes	No

Service Cable		Yes	No			
Ultraviolet Lamp		Yes	No			
Takeaway Hall Condition		Good	Fair			Poor
Building Structure Condition		Good	Fair			Poor
Approach to Pump House		Good	Fair			Poor
Overall Rating						
Average Score	1	2	3	4	5	
Asset Condition	Excellent	Good	Fair	Poor	Failing	
Category	A	B	C	D	E	
Remarks / Requirements						
<ul style="list-style-type: none"> No remarks 						
Data Collected By: Mr. Haroon		Designation: Team Member

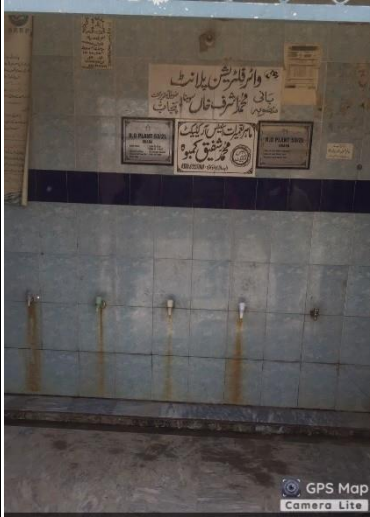
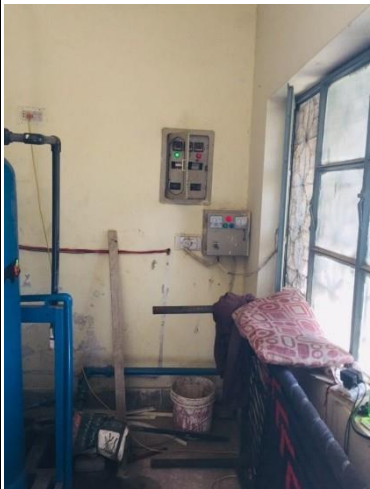
Integrated Development And Asset Management Plan (IDAMP)						
Municipal Committee Okara						
Form: IDAMP-A4	Water Filtration Plant Asset Condition Assessment			Asset Code: _____	Date: 06-05-2023	
Name		Govt. School 53/2L		Pictures		
Location	Latitude	30.7935

Longitude	73.4648				
Address						
Installation Year		2010				
Installing Agency						
O&M Agency		MC				
Filtration Capacity (Liter/Hour)		1000				
Operational Hours		8				
No. of Taps		6				
Effluent Test (If Available)						
Latest water quality analysis carried out?						
If yes, which lab and parameters?						
Findings of water quality analysis?						
In case of any parameter above the permissible limit, which steps are taken to provide safe water?						
Plant Type		RO	UF

Source of Water		Local Tube Well	Public Water Supply			
Working Status		Functional	Non-Functional			
Pumping Unit		Yes	No			
Control Panel		Yes	No			
Service Cable		Yes	No

Ultraviolet Lamp		Yes	No			
Takeaway Hall Condition		Good	Fair			Poor
Building Structure Condition		Good	Fair			Poor
Approach to Pump House		Good	Fair			Poor
Overall Rating						
Average Score	1	2	3	4	5	
Asset Condition	Excellent	Good	Fair	Poor	Failing	
Category	A	B	C	D	E	
Remarks / Requirements						
<ul style="list-style-type: none"> No remarks 						
Data Collected By: Mr. Haroon		Designation: Team Member

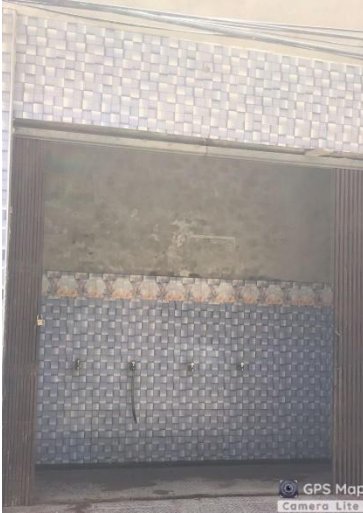
Integrated Development And Asset Management Plan (IDAMP)					
Municipal Committee Okara					
Form: IDAMP-A4		Water Filtration Plant Asset Condition Assessment			Asset Code: _____
					Date: 06-05-2023
Name		Makkah Madinah Town Phase 2 near Depalpur Road			Pictures
Location	Latitude	30.7999

Longitude	73.4680			
Address					
Installation Year		2021			
Installing Agency					
O&M Agency		MC			
Filtration Capacity (Liter/Hour)		1000			
Operational Hours		6			
No. of Taps		4			
Effluent Test (If Available)					
Latest water quality analysis carried out?					
If yes, which lab and parameters?					
Findings of water quality analysis?					
In case of any parameter above the permissible limit, which steps are taken to provide safe water?					
Plant Type		RO	UF		
Source of Water		Local Tube Well	Public Water Supply		
Working Status		Functional	Non-Functional		
Pumping Unit		Yes	No		
Control Panel		Yes	No		
Service Cable		Yes	No

Ultraviolet Lamp		Yes	No		
Takeaway Hall Condition		Good	Fair	Poor	
Building Structure Condition		Good	Fair	Poor	
Approach to Pump House		Good	Fair	Poor	
Overall Rating					
Average Score	1	2	3	4	5
Asset Condition	Excellent	Good	Fair	Poor	Failing
Category	A	B	C	D	E
Remarks / Requirements					
<ul style="list-style-type: none"> No remarks 					
Data Collected By: Mr. Haroon		Designation: Team Member

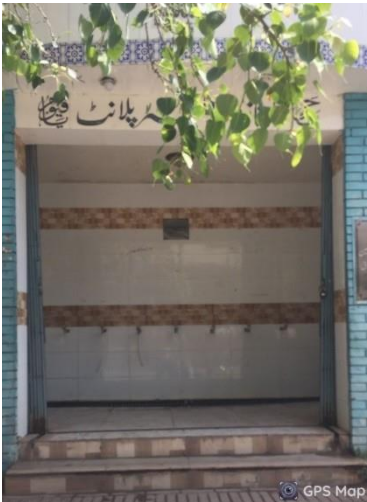
Integrated Development And Asset Management Plan (IDAMP)					
Municipal Committee Okara					
Form: IDAMP-A4		Water Filtration Plant Asset Condition Assessment			Asset Code: _____
					Date: 06-05-2023
Name		Filter Plant MC Okara			Pictures
Location	Latitude	30.8091

Longitude	73.4474			
Address					
Installation Year		2019			
Installing Agency					
O&M Agency		MC			
Filtration Capacity (Liter/Hour)		1000			
Operational Hours		6			
No. of Taps		6			
Effluent Test (If Available)					
Latest water quality analysis carried out?					
If yes, which lab and parameters?					
Findings of water quality analysis?					
In case of any parameter above the permissible limit, which steps are taken to provide safe water?					
Plant Type		RO	UF		
Source of Water		Local Tube Well	Public Water Supply		
Working Status		Functional	Non-Functional		
Pumping Unit		Yes	No		
Control Panel		Yes	No		
Service Cable		Yes	No		
Ultraviolet Lamp		Yes	No

Takeaway Hall Condition		Good	Fair	Poor	
Building Structure Condition		Good	Fair	Poor	
Approach to Pump House		Good	Fair	Poor	
Overall Rating					
Average Score	1	2	3	4	5
Asset Condition	Excellent	Good	Fair	Poor	Failing
Category	A	B	C	D	E
Remarks / Requirements					
<ul style="list-style-type: none"> No remarks 					
Data Collected By: Mr. Haroon		Designation: Team Member

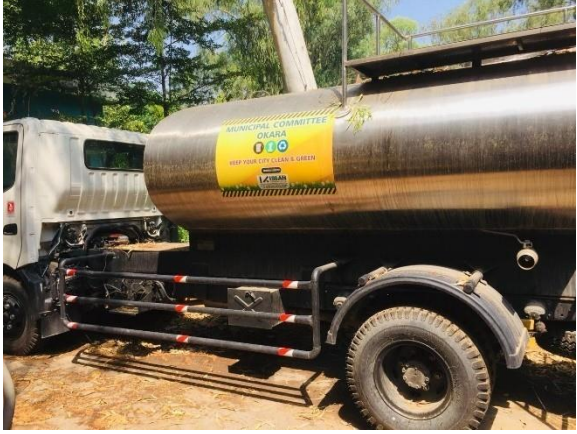
Integrated Development and Asset Management Plan (IDAMP)		
Municipal Committee Okara		
Form: IDAMP-A16	Moveable Asset Asset Condition Assessment	Asset Code: _____ Date: 05-05-2023
Type of Vehicle / Machinery	Pictures	
Water bowser

Water Bowser #01	Water Bowser #02
Capacity	500 Gallons	500 Gallons
Purpose	Water supply	Water supply
Year of Manufacturing	1982	2007
Model	Not available	MF 240
Capital Cost		
Fuel Consumption (Liters/Month)	490	331
Condition	Poor	Fair
Engine Capacity	4500cc	50hp
Maintenance Cost	Not available	Not available
Oiling /Fitness	Yes	Yes
Fitness Certificate	No	No
Registered	LE 997	Not available
Overall Rating	Poor	Fair
Remarks / Requirements		
<i>Data Collected By: Mr. Haroon</i>	<i>Designation: Team Member</i>

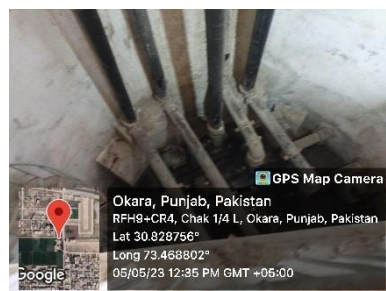
Integrated Development and Asset Management Plan (IDAMP)				
Municipal Committee Okara				
Form: IDAMP-A7	Sewerage Disposal Station Asset Condition Assessment			Asset Code: _____ Date: 05-05-2023
Asset Detail				Pictures
Name	1/4L Disposal Station			
Location	Latitude	30.828378°		
	Longitude	73.469006°		
Address	Chak 1/4L on Farooq Allowalia Road near Ali Orchard Housing Society			
Area (Acres)	0.5 acres			
Installation Year	2012-13			
Capital Cost of Machinery				
Outfall Drain Sewer	Dia	48"		
	Material	RCC		
Screening Chamber	No. of Screens	2		
	Screen Condition	Good	Fair	Poor
	Chamber Structure	Good		
Wet Wells	Number	2 Nos.		
	Shape	Rectangular	Circular	
	Size	25 ft		
	Structure	Masonry	RCC	
	Railing	Yes	No	
Force Main	No. of force mains	2		
	Dia	24"		
	Material	AC		
	Starting Point	Disposal station		
	Ending Point	Chamber at LBDC Canal		
Sullage Carrier	Length	950 ft		
	Size	5 ft inner		
	Shape	Katcha after crossing LBDC

Condition	Katcha and overflows on fields		
Delivery Pipe	Dia	12"		
	Material	CI		
Suction Pipe	Dia	12"		
	Material	CI		
Number of Valves	Sluice Valves	10		
	Non-Return Valves	5		
	Penstock Valves	2		
Ultimate Disposal	Rohi Nullah and fields			
Civil Structure Condition	Good	Fair	Poor	
Control Room Structure	Good	Fair	Poor	
Discharge Box Structure	Good	Fair	Poor	
Approach to Pump House	Good	Fair	Poor	
Hoisting Girder	Yes		No	
Boundary Wall & Gate	Yes		No	
Treatment of Sewage	Yes		No	
Wastewater daily discharge in m ³ /day? (based on available information at MC)	20500

Integrated Development and Asset Management Plan (IDAMP)			
Ultimate disposal of wastewater?	Rohi Nullah and fields		
Electro-Mechanical Equipment Details			
Number of WAPDA Feeders	1		
Transformer Capacity (kVA)	400 KVA		
Number of MCU	5		
Sanctioned Load (kWh)	187		
Power Factor Improvement Equipment	Yes	No	
Service Cable	Yes	No	
Power Wiring	Yes	No	
Earthing of Motor	Yes	No	
Earthing of MCU	Yes	No	
Generator Availability	Yes 200 KVA	No	
Light Wiring of Pump House	Yes	No	
Change Over	Yes	No	
Pump Detail			
	Pump A		Pump B
Pump Type	Centrifugal/ Non-Clogging		Centrifugal/ Non-Clogging
Pump Brand	KSB		KSB
Pump Paint	no		no
Motor Brand	Siemens		Siemens
Installation Year of Pump	2013		2013
Discharge Capacity (Cusecs)	5 cusecs		5 cusecs
Rotational Speed (RPM)	980		980
Head (ft.)	50		50
Motor Power (HP)	60 HP		60 HP
Pump Daily Running Time (Hours)	8 hrs		8 hrs
Base Plate	Yes	No	Yes
	Pump D		Pump E
Pump Type	Centrifugal/ Non-Clogging		Centrifugal/ Non-Clogging

Integrated Development and Asset Management Plan (IDAMP)					
Pump Paint	no	no			
Motor Brand	Siemens	Siemens			
Installation Year of Pump	2013	2013			
Discharge Capacity (Cusecs)	5 cusecs	5 cusecs			
Rotational Speed (RPM)	980	980			
Head (ft.)	50	50			
Motor Power (HP)	60 HP	60 HP			
Pump Daily Running Time (Hours)	During rain		During rain		
Base Plate	Yes	No	Yes	No	Yes No
Number of Valves	Sluice Valve	10			
	Non-Returning Valve	5			
Overall Rating					
Average Score	1	2	3	4	5
Asset Condition	Excellent	Good	Fair	Poor	Failing
Category	A	B	C	D	E
Remarks / Requirements					
<ul style="list-style-type: none"> • Staff Quarter maintenance required (floor damages, white washing, wiring issue, washroom maintenance) • Requirement of washroom for operators • Only chain pully seen, there is no girder in pump. • Barbed wire required for boundary wall as the wall is just 5 ft high 					
Data Collected By: Mr. Haroon	Designation: Team Member

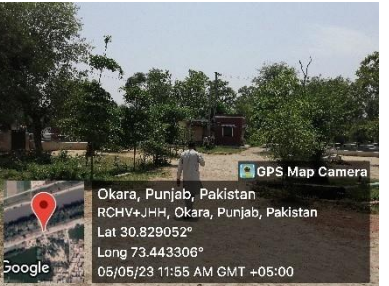
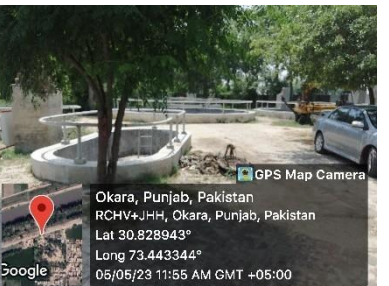
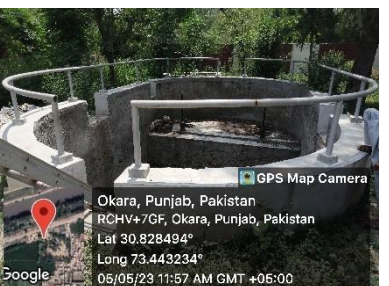
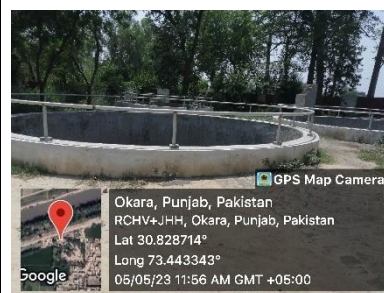
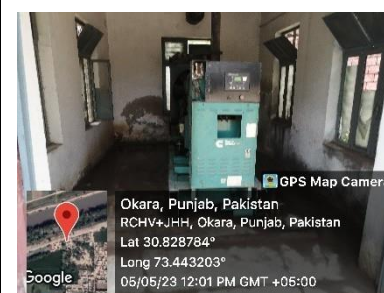
Integrated Development and Asset Management Plan (IDAMP)					
Municipal Committee Okara					
Form: IDAMP-A7	Sewerage Disposal Station Asset Condition Assessment			Asset Code: _____ Date: 05-05-2023	
Asset Detail				Pictures	
Name		2/4L Disposal Station

Location	Latitude	30.828652°			
	Longitude	73.443367°			
Address		On Faisalabad Link Road near LBD Canal and Darbar Qurban Ali Shah			
Area (Acres)		1.2 acres			
Installation Year		1978			
Capital Cost of Machinery					
Outfall Drain Sewer	Dia	54" and 27"			
	Material	RCC			
Screening Chamber	No. of Screens	2 Nos screening chambers having 3 screens (2 + 1)			
	Screen Condition	Good	Fair	Poor	
	Chamber Structure	Good			
Wet Wells	Number	3 Nos.			
	Shape	Rectangular	Circular		
	Size	30 ft			
	Structure	Masonry	RCC		
	Railing	Yes	No		
Force Main	No. of force mains	6			
	Dia	12"			
	Material	CI			
	Starting Point	Disposal station (DS)			
	Ending Point	Discharge box outside of DS

Length	250 Ft			
Sullage Carrier	Size	5 ft inner			
	Shape	Katcha after crossing LBDC			
	Length	-			
	Condition	Katcha and overflows on fields			
Delivery Pipe	Dia	6 Nos. – 18" (2 Nos.) and 12" (4 Nos.)			
	Material	CI			
Suction Pipe	Dia	18" - 5 Nos. (4 functional)			
	Material	CI			
Number of Valves	Sluice Valves	12			
	Non-Return Valves	6			
	Penstock Valves	3			
Ultimate Disposal		Rohi Nullah and fields			
Civil Structure Condition		Good	Fair	Poor	
Control Room Structure		Good	Fair	Poor	
Discharge Box Structure		Good	Fair	Poor	
Approach to Pump House		Good	Fair	Poor	
Hoisting Girder		Yes	No		
Boundary Wall & Gate		Yes	No		
Treatment of Sewage		Yes	No		
Wastewater daily discharge in m ³ /day? (based on available information at MC)		24300

Integrated Development and Asset Management Plan (IDAMP)						
Ultimate disposal of wastewater?		Rohi Nullah and fields				
Electro-Mechanical Equipment Details						
Number of WAPDA Feeders		1				
Transformer Capacity (kVA)		3 Nos. – 200 KVA each				
Number of MCU		7				
Sanctioned Load (kWh)		112				
Power Factor Improvement Equipment		Yes	No			
Service Cable		Yes	No			
Power Wiring		Yes	No			
Earthing of Motor		Yes	No			
Earthing of MCU		Yes	No			
Generator Availability		Yes (1 functional 350 KVA and 1 non-functional 350 KVA)			No	
Light Wiring of Pump House		Yes			No	
Change Over		Yes			No	
Pump Detail						
	Pump A		Pump B		Pump C	
Pump Type	Centrifugal/ Non-Clogging		Centrifugal/ Non-Clogging		Centrifugal/ Non-Clogging	
Pump Brand	KSB		KSB		KSB	
Pump Paint	no		no		no	
Motor Brand	Siemens		Siemens		Siemens	
Installation Year of Pump	Approx. 15 years ago		Approx. 15 years ago		Approx. 15 years ago	
Discharge Capacity (Cusecs)	7 cusecs		7 cusecs		7 cusecs

Rotational Speed (RPM)	980 each		980 each		980 each	
Head (ft.)	50		50		50	
Motor Power (HP)	100 HP		100 HP		100 HP	
Pump Daily Running Time (Hours)	8 hrs		8 hrs		8 hrs	
Base Plate	Yes	No	Yes	No	Yes	No
	Pump D		Pump E		Pump F	
Pump Type	Centrifugal/ Non-Clogging		Centrifugal/ Non-Clogging		Centrifugal/ Non-Clogging	
Pump Brand	KSB		KSB		KSB	
Pump Paint	no		no		no

Integrated Development and Asset Management Plan (IDAMP)					
Motor Brand		Siemens		Siemens	
Installation Year of Pump		Approx. 15 years ago		Approx. 15 years ago	
Discharge Capacity (Cusecs)		7 cusecs		5 cusecs	
Rotational Speed (RPM)		980 each		980 each	
Head (ft.)		50		50	
Motor Power (HP)		100 HP		60 HP	
Pump Daily Running Time (Hours)		8 hrs		During rain	
Base Plate		Yes	No	Yes	No
Number of Valves	Sluice Valve	12			
	Non-Returning Valve	6			
Overall Rating					
Average Score	1	2	3	4	5
Asset Condition	Excellent	Good	Fair	Poor	Failing
Category	A	B	C	D	E
Remarks / Requirements					
<ul style="list-style-type: none"> Needs repair of main gate due to rusting Requirement of washroom for operators Only chain pulley seen, there is no girder in both pump houses. Suction pipe rusting issue 1 delivery pipe leakage issue- needs repair 2 screens need to be replaced due to rusting 2 pumps have 1 delivery pipe. There should be 2 delivery pipes for separate pumps. Sullage carrier needs to be Pacca and stealing of raw wastewater by the farmers will be resolved Open wiring seen for MCU/ operator room

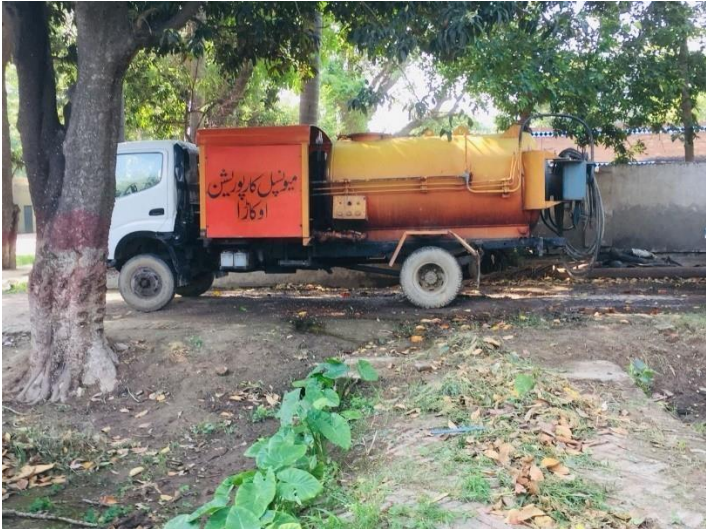
Jetting Machine#1	Jetting Machine#2	Sucker Machine# 1	Sucker + jetting (joint)
Capacity	4500Liters	4500Liters	4500Liters	4500Liters
Purpose	Jetting	Jetting	Sucker	Sucker & jetting
Year of Manufacturing	2007	2007	1996	2007
Model	Hino 300	Hino 300	PKB21	Hino 500
Capital Cost	Not available	Not available	Not available	Not available
Fuel Consumption (Liters/Month)	657	820	492	624
Condition	Fair	Fair	Poor	Fair
Engine Capacity	4009cc	4009cc	5460cc	4465cc
Maintenance Cost	Not available	Not available	Not available	Not available
Oiling /Fitness	Yes	Yes	Yes	Yes
Fitness Certificate	No	No	No	No
Registered	Not available	Not available	Not available	Not available
