Punjab Municipal Development Fund Company

Hiring of Consulting Services for Preparation of Integrated Development and Asset Management Plan (IDAMP) for 16 selected MCs In Punjab under Punjab Cities Program (PCP)

IDAMP – Municipal Committee Okara
May 2024

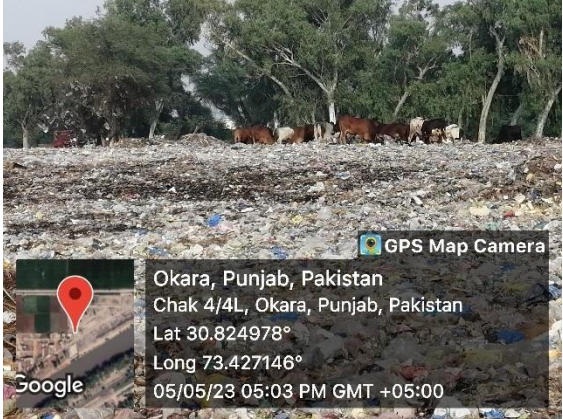
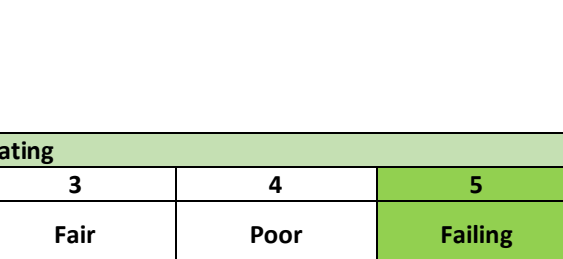
Integrated Development And Asset Management Plan (IDAMP)						
Municipal Committee Okara						
Form: IDAMP-A11	Solid Waste Dumping Site Asset Condition Assessment			Asset Code: _____	Date: 05-05-2023	
Name		Along Canal		Pictures		
Location	Latitude	30.810114

Longitude	73.442514				
Address				 		
Area (Acres)		2.75				
Distance from urban area		1-2 km

Year the site started for dumping service		2021				
Average waste dumped daily (based on information provided by MC)		98 Tons

EHS SOPs for waste handlers						
Availability of PPEs for waste collectors/handlers		Yes	No			
Expected Life (Years)		Filled				
Land Ownership		Private				
Site Accessibility		Poor				
Surface Type		Flat	Depressed			
Approach Road Condition		Good	Fair			
Parking Shed		Yes	No			
Boundary Wall		Yes	No			
Gate		Yes	No			
Ramps		Yes	No			
Any Building at Site		Yes	No			
Weigh Bridge		Yes	No			
Earth Cover Arrangements		Yes	No

Compaction Equipment		Yes	No			
Plantation Around Site		Yes	No			
Any illegal occupants or encroachments observed- if yes, type						
Overall Rating						
Average Score	1	2	3	4	5	
Asset Condition	Excellent	Good	Fair	Poor	Failing

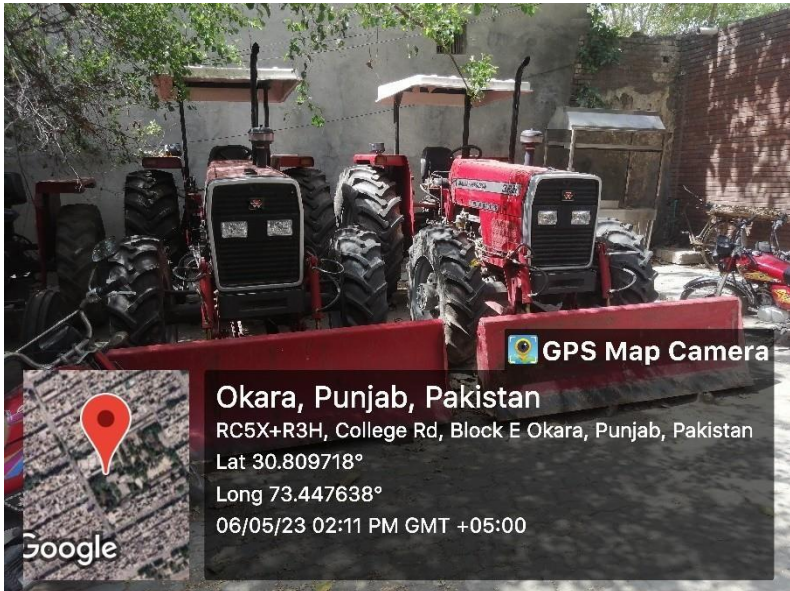
Tractor 1	Tractor 2	Tractor 3	Tractor 4	Tractor 5
Capacity	75 HP	75 HP	75 HP	75 HP	50 HP
Purpose	SWM	SWM	SWM	SWM	SWM
Year of Manufacturing	2015	2015	2015	1995	2000
Model	MF 375	MF 375	MF 375	MF 375	MF 240
Capital Cost	Not available	Not available	Not available	Not available	Not available
Fuel Consumption (Liters/Month)	902	833	836	633	426
Condition	Good	Good	Good	Fair	Fair
Engine Capacity	75 HP	75 HP	75 HP	75 HP	50 HP
Maintenance Cost	Not available	Not available	Not available	Not available	Not available
Oiling /Fitness	Yes	Yes	Yes	Yes	Yes
Fitness Certificate	No	No	No	No	No
Registered	OK 375 A	OK 375 B	OK 375 C	OK 566	OK 3591
Overall Rating	Good	Good	Good	Fair	Fair

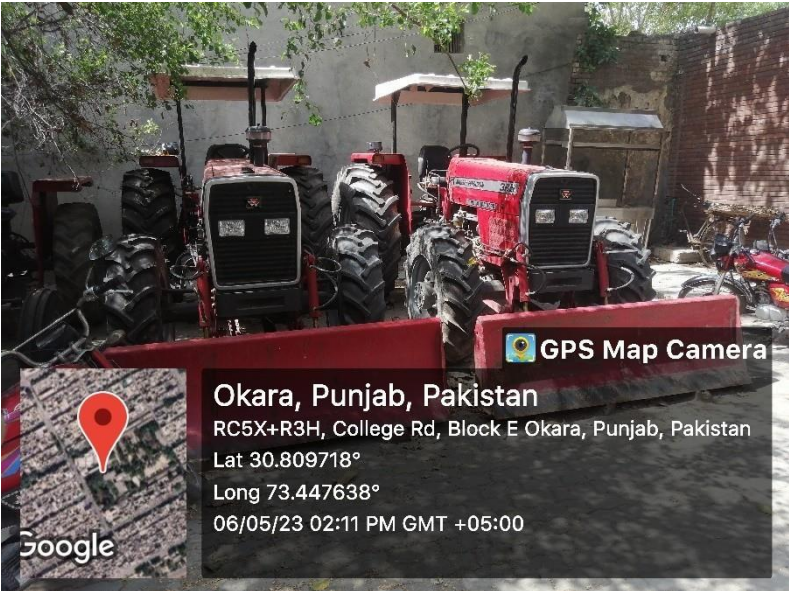
Tractor 6	Tractor 7	Tractor 8	Tractor 9	Tractor 10
Capacity	50 HP	50 HP	75 HP	85 HP	85 HP
Purpose	SWM	SWM	SWM	SWM	SWM
Year of Manufacturing	2000	1999	1995	2001	2001
Model	MF 240	MF 240	MF 375	MF 385	MF 385
Capital Cost	Not available	Not available	Not available	Not available	Not available
Fuel Consumption (Liters/Month)	276	614	893	775	898
Condition	Fair	Fair	Fair	Fair	Fair
Engine Capacity	50 HP	50 HP	75 HP	85 HP	85 HP
Maintenance Cost	Not available	Not available	Not available	Not available	Not available
Oiling /Fitness	Yes	Yes	Yes	Yes	Yes
Fitness Certificate	No	No	No	No	No
Registered	OKC 3592	OK 3593	OK 564	OK 7973	OK 7974
Overall Rating	Fair	Fair	Fair	Fair	Fair

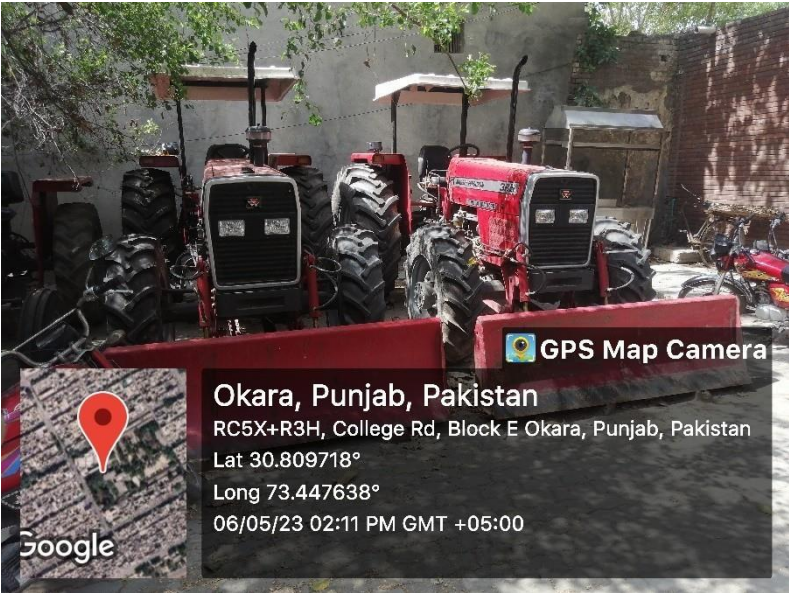
Tractor 11	Tractor 12	Tractor 13	Tractor 14	Tractor 15
Capacity	85 HP	50 HP	85 HP	50 HP	50 HP
Purpose	SWM	SWM	SWM	SWM	SWM
Year of Manufacturing	2007	2007	2007	2008	2007
Model	MF 385	MF 240	MF 385	MF 240	MF 240
Capital Cost	Not available	Not available	Not available	Not available	Not available
Fuel Consumption (Liters/Month)	1,076	447	733	Not in Use	448
Condition	Fair	Fair	Fair	Fair	Fair
Engine Capacity	85 HP	50 HP	85 HP	50 HP	50 HP
Maintenance Cost	Not available	Not available	Not available	Not available	Not available
Oiling /Fitness	Yes	Yes	Yes	Yes	Yes
Fitness Certificate	No	No	No	No	No
Registered	OK 2015	OKG 3330	OK 1005	OK 381	OK 481
Overall Rating	Fair	Fair	Fair	Fair	Fair

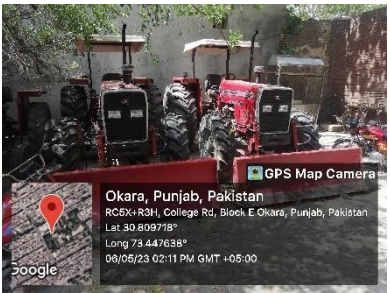
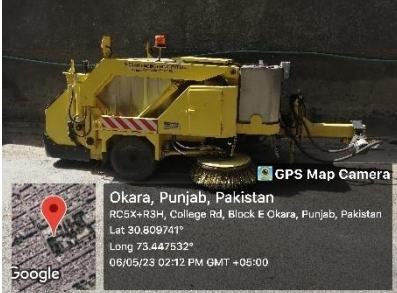
Integrated Development and Asset Management Plan (IDAMP)			
Municipal Committee Okara			
Form: IDAMP-A16	Moveable Asset Asset Condition Assessment	Asset Code: _____ Date: 05-05-2023	
Type of Vehicle / Machinery	Pictures		
Tractor	<div style="display: flex; justify-content: space-around;">

</div>		
	Tractor 16	Tractor 17	Mechanical Sweeper
Capacity	50 HP	50 HP	50 HP
Purpose	SWM	SWM	SWM
Year of Manufacturing	2000	2000	Not available
Model	MF 240	MF 240	Not available
Capital Cost	Not available	Not available	Not available
Fuel Consumption (Liters/Month)	132	56	Not available
Condition	Fair	Fair	Not available
Engine Capacity			Not available
Maintenance Cost	Not available	Not available	Not available
Oiling /Fitness	Yes	Yes	Not available
Fitness Certificate	No	No	Not available
Registered	OK 3331	OK 7972	Not available
Overall Rating	Fair	Fair	Not available
Remarks / Requirements			
<ul style="list-style-type: none"> No remarks

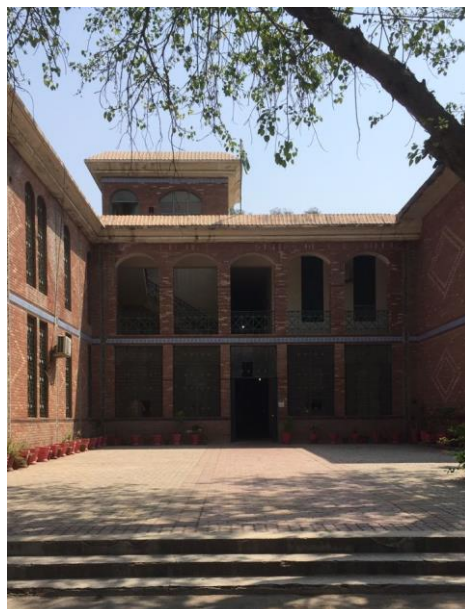
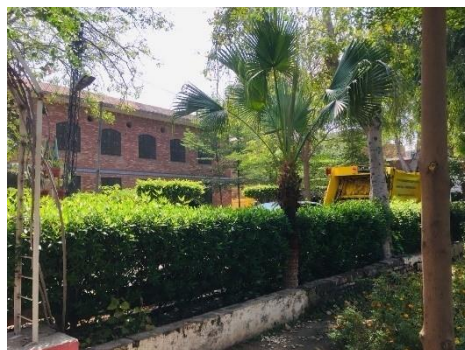
Integrated Development and Asset Management Plan (IDAMP)					
Municipal Committee Okara					
Form: IDAMP-A14	Building Asset Condition Assessment			Asset Code: _____ Date: 05-05-2023	
Name			MC Office		Pictures
Location	Latitude	30.8095			
	Longitude	73.4476			
Address					
Year of Construction			1965		
Land Area (Acres)			1.76		
No. of Stories			2		
Condition			Fair		
Purpose			Administration		
No. of Staff					
No. of Rooms					
Conference/Meeting Room			Yes	No	
Store Room			Yes	No	
Study Room/Book Shelf			Yes	No	
Boundary Wall			Yes	No	
Heating & Cooling Arrangement			Yes	No	
Parking Lots			Yes	No	
Drinking Water Facilities			Yes	No	
Availability and quality of water (based on available water quality test reports)			Yes	No	
Washrooms / Sewerage System			Yes	No	
Separate Washroom for Ladies			Yes	No	
Prayers Area/room			Yes	No	
Furniture			Yes	No	
Electric Appliances (Fans Etc.)			Yes	No	
Machinery & Equipment			Yes	No

Sports Club			Yes	No	
Staff Attendance System			Yes	No	
Emergency Alarm System			Yes	No	
Fire Fighting System / Equipment			Yes	No	
Ramps for wheel chairs at entry gate			Yes	No	
Security Guard			Yes	No	
Park/lawn outdoor/indoor plantation			Yes	No	
Overall Rating					
Average Score	1	2	3	4	5
Asset Condition	Excellent	Good	Fair	Poor	Failing
Category	A	B	C	D	E
Remarks / Requirements					
<ul style="list-style-type: none"> No remarks 					
<i>Data Collected By: Mr. Haroon</i>		<i>Designation: Team Member</i>		 	
<i>Sign & Date: 30-May-2023</i>

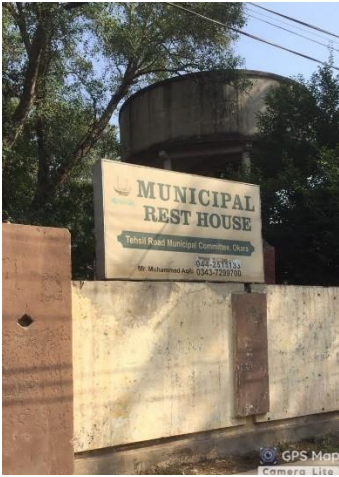
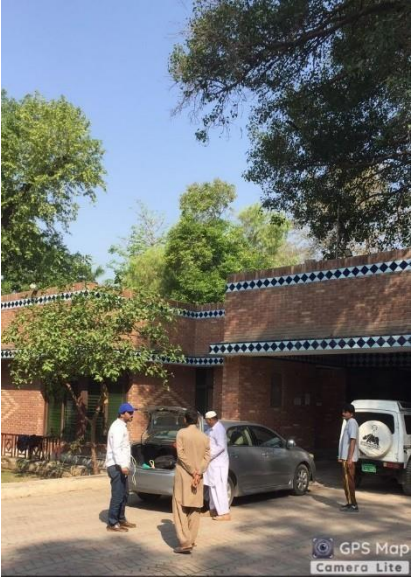
Integrated Development and Asset Management Plan (IDAMP)					
Municipal Committee Okara					
Form: IDAMP-A14		Building Asset Condition Assessment		Asset Code: _____ Date: 06-05-2023	
Name		Rest House		Pictures	
Location	Latitude	30.8108

Longitude	73.4444			
Address					
Year of Construction		1971			
Land Area (Acres)		0.5			
No. of Stories		1			
Condition		Fair			
Purpose		Rest House			
No. of Staff		1			
No. of Rooms		6			
Conference/Meeting Room		Yes	No		
Store Room		Yes	No		
Study Room/Book Shelf		Yes	No		
Boundary Wall		Yes	No		
Heating & Cooling Arrangement		Yes	No		
Parking Lots		Yes	No		
Drinking Water Facilities		Yes	No		
Availability and quality of water (based on available water quality test reports)		Yes	No		
Washrooms / Sewerage System		Yes	No		
Separate Washroom for Ladies		Yes	No		
Prayers Area/room		Yes	No		
Furniture		Yes	No		
Electric Appliances (Fans Etc.)		Yes	No		
Machinery & Equipment		Yes	No

Sports Club		Yes	No		
Staff Attendance System		Yes	No		
Emergency Alarm System		Yes	No		
Fire Fighting System / Equipment		Yes	No		
Ramps for wheel chairs at entry gate		Yes	No		
Security Guard		Yes	No		
Park/lawn outdoor/indoor plantation		Yes	No		
Overall Rating					
Average Score	1	2	3	4	5
Asset Condition	Excellent	Good	Fair	Poor	Failing
Category	A	B	C	D	E
Remarks / Requirements					
<ul style="list-style-type: none"> No remarks 					
Data Collected By: Mr. Haroon		Designation: Team Member

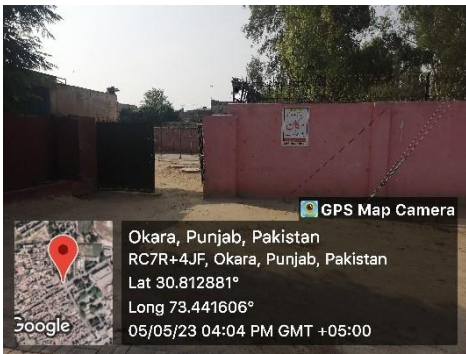
Integrated Development and Asset Management Plan (IDAMP)							
Municipal Committee Okara							
Form: IDAMP-A15		Slaughterhouse Asset Condition Assessment		Asset Code: _____ Date: 06-05-2023			
Name		Slaughter House		Pictures			
Location	Latitude	30.812881

Longitude	73.441606					
Address							
Year of Construction		1965					
Total Area (Acres)		0.15					
Ownership		MC					
Slaughter Capacity (Per Day)	Larger Animals	19-25					
	Smaller Animals	100					
Supervisor		Yes	No				
Doctor's Room		Yes	No				
Inhabitation Facility		Yes	No				
Slaughtering Hall		Yes	No				
Evisceration Hall		Yes	No				
Meat Cutting Room		Yes	No				
Blood Collection Arrangements		Yes	No				
Skin Storage Room		Yes	No				
Tools Disinfectant System		Yes	No				
Health and Hygiene SOPs		Yes	No				
Refrigeration / Storage System		Yes	No				
Separate Facility for Sick Animals		Yes	No				
Water Supply System		Yes	No				
Drainage & Disposal Facility		Yes	No

Solid Waste Collection Facility		Yes	No				
Boundary Wall & Gate		Yes	No				
Approach Road Condition		Good	Fair	Poor			
Civil Structure Condition		Good	Fair	Poor			
Overall Rating							
Average Score	1	2	3	4	5		
Asset Condition	Excellent	Good	Fair	Poor	Failing		
Category	A	B	C	D	E		
Remarks / Requirements							
<ul style="list-style-type: none"> No remarks 							
Data Collected By: Mr. Haroon		Designation: Team Member

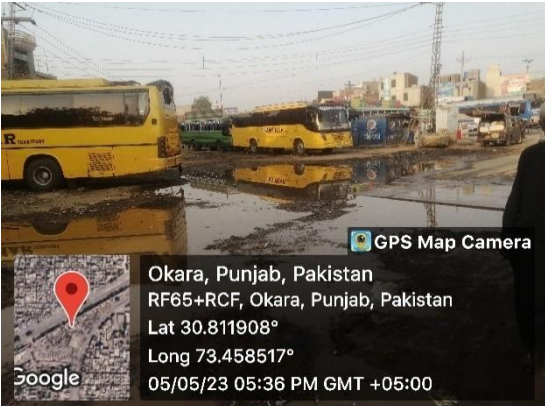
Integrated Development and Asset Management Plan (IDAMP)							
Municipal Committee Okara							
Form: IDAMP-A12	Bus Stand			Asset Code: _____			
Asset Condition Assessment			Date: 06-05-2023				
Name		Bus Stand		Pictures			
Location	Latitude	30.811908

Longitude	73.458517					
Address							
Year of Construction		1962					
Last Major Renovation		No					
Area (Acres)		2.17					
Ownership		MC					
Class		A	B			C	D
Designed Capacity of Vehicles	Buses						
	Coasters						
	Wagons						
Daily parking of vehicles (based on information provided by MC)	Buses	Not available					
	Coasters						
	Wagons						
	Rickshaws						
Distance from the urban area		Within city					
Security	At Entry	Yes	No				
	At Exit	Yes	No				
Gate	At Entry	Yes	No				
	At Exit	Yes	No				
Waiting Area	Men	Yes	No				
	Families	Yes	No				
Washroom	Male	Yes	No				
	Female	Yes	No				
Prayer Room	Male	Yes	No				
	Female	Yes	No				
Administration Office		Yes	No

Integrated Development and Asset Management Plan (IDAMP)					
Municipal Committee Okara					
Form: IDAMP-A12		Bus Stand Asset Condition Assessment			Asset Code: _____
					Date: 06-05-2023
Parking Stand	Rickshaw	Yes	No		
	Cars	Yes	No		
Fuel Outlets		Yes	No		
Reception Desk		Yes	No		
Ticketing System		Yes	No		
Tuck Shop		Yes	No		
Workshop		Yes	No		
Ablution Area		Yes	No		
Pedestrian		Yes	No		
Green Spaces		Yes	No		
Water Drinking Arrangement		Yes	No		
Water Disposal Arrangement		Yes	No		
Boarding Shed		Yes	No		
Workshops		Yes	No		
Lighting		Yes	No		
Boundary Wall		Yes	No		
Flooring & Pavement	Type				
	Condition	Good	Fair	Poor	
Overall Rating					
Average Score	1	2	3	4	5
Asset Condition	Excellent	Good	Fair	Poor	Failing
Category	A	B	C	D	E
Remarks / Requirements					
<ul style="list-style-type: none"> No remarks 					
Data Collected By: Mr. Haroon		Designation: Team Member

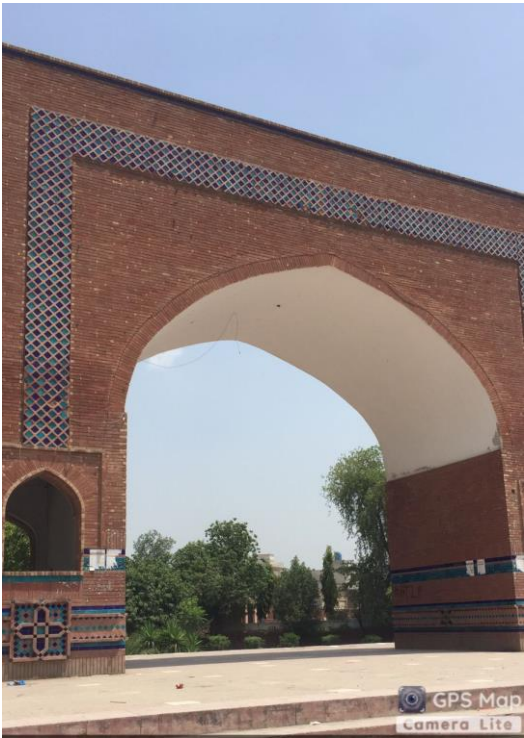
Location	Latitude	30.7997			
	Longitude	73.4313			
Area In Acres		5.75			
Ownership-Owned by MC or possession allocated to MC by any other department (documents available)					
Turfing Condition		Good	Fair		
Approach Road		Good	Fair		
Parking Lots		Yes	No		
Canteen Availability		Yes	No		
Average number of daily visitors (based on the assessment of MC staff)					
Any illegal occupants or encroachments observed-if yes, type					
Security system		Yes	No		
Watering & Irrigation					
Tube Well		Yes	No		
Water Supply from Municipal System		Yes	No		
Water Tank		Yes	No		
Pumping Unit		Yes	No		
Distribution Pipe Lines		Yes	No		
Valves		Yes	No		
Sprinkler System		Yes	No		
Ground water storage reservoirs/ponds		Yes	No		
Landscaping & Plantation

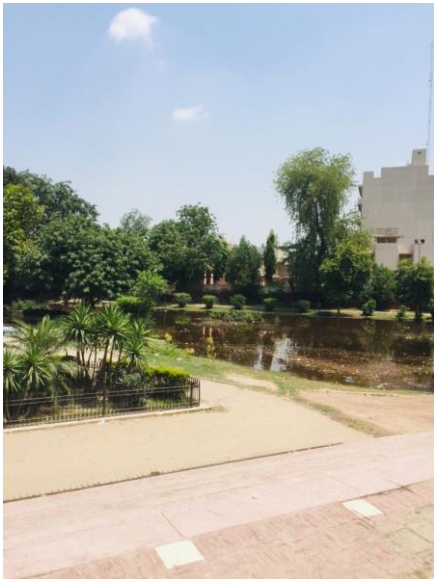
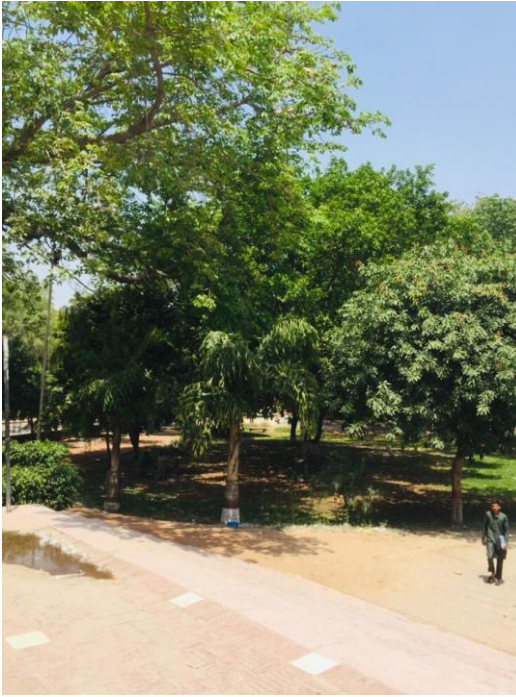
Integrated Development and Asset Management Plan (IDAMP)					
Municipal Committee Okara					
Form: IDAMP-A10		Park Asset Condition Assessment		Asset Code: _____ Date: 06-05-2023	
Name		Jinnah Park

Structures						
No. of Toilets	Gents	1				
	Ladies	1				
Condition of Toilets	Gents	Poor				
	Ladies	Poor				
Buildings	Yes	No				
Fountains & Water Fall Structure	Yes	No				
Walkways	Yes	No				
Jogging tracks	Yes	No				
Ramps at entry gates for wheel chairs	Yes	No				
Bridges & Culverts	Yes	No				
Play Area	Yes	No				
Gazebos	Yes	No				
Benches/ sitting arrangements	Yes	No				
Boundary Wall & Gate	Yes	No				
Toilets	Yes	No				
Lakes & Brooks	Yes	No				
Mechanical Equipment						
Pumping Units	Yes	No				
Swings	Yes	No				
Children Games	Yes	No				
Fixtures	Yes	No				
Benches	Yes	No				
Sanitation & Water Supply						
Litter Bins	Yes	No				
Condition of SWM	Poor					
Toilet Fixtures	Yes	No				
Sewerage System	Yes	No				
Vegetation Cuttings & Disposal	Yes	No				
Drinking water availability and quality (based on availability of water quality test reports)						
Water Pipes	Yes	No				
HR

Security Guards	Yes	No				
Landscape Experts	Yes	No				
Mali / Beldaar (Number)	Yes	No				
Overall Rating						
Average Score	1	2	3	4	5	
Asset Condition	Excellent	Good	Fair	Poor	Failing	
Category	A	B	C	D	E	
Remarks / Requirements

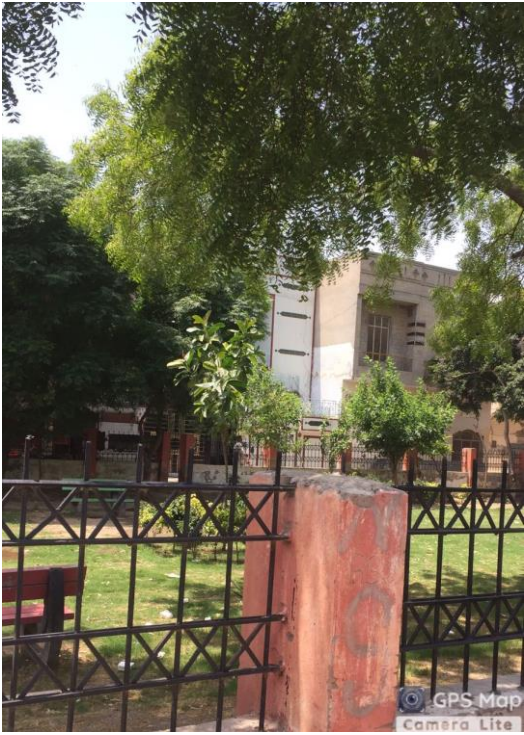
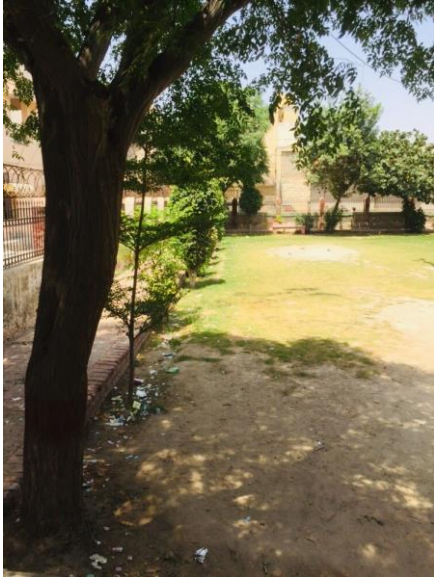
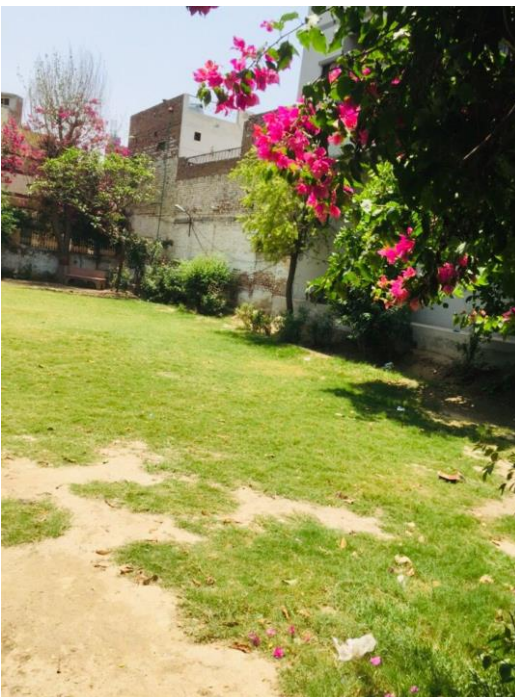
Integrated Development and Asset Management Plan (IDAMP)					
Municipal Committee Okara					
Form: IDAMP-A10		Park Asset Condition Assessment		Asset Code: _____ Date: 06-05-2023	
Name		Sher-e-Rubani Town Park

Location	Latitude	30.8081			
	Longitude	73.4540			
Area In Acres		0.25			
Ownership- Owned by MC or possession allocated to MC by any other department (documents available)					
Turfing Condition		Good	Fair		Poor
Approach Road		Good	Fair		Poor
Parking Lots		Yes	No		
Canteen Availability		Yes	No		
Average number of daily visitors (based on the assessment of MC staff)					
Any illegal occupants or encroachments observed-if yes, type					
Security system		Yes	No		
Watering & Irrigation					
Tube Well		Yes	No		
Water Supply from Municipal System		Yes	No		
Water Tank		Yes	No		
Pumping Unit		Yes	No		
Distribution Pipe Lines		Yes	No		
Valves		Yes	No		
Sprinkler System		Yes	No		
Ground water storage reservoirs/ponds		Yes	No

Landscaping & Plantation					
Grass Beds		Yes	No		
Flower Beds		Yes	No		
Hedges		Yes	No		
Plants		Yes	No		
Number of trees and species (based on readily available information at MC)					
Lights					
Total Number					
Poles		Yes	No		
Cables		Yes	No		
Brackets And Lights		Yes	No		
Bulbs And Tubes		Yes	No		
Control Units		Yes	No		
Structures					
No. of Toilets	Gents			0

Condition of Toilets	Gents				
	Ladies				
Buildings	Yes	No			
Fountains & Water Fall Structure	Yes	No			
Walkways	Yes	No			
Jogging tracks	Yes	No			
Ramps at entry gates for wheel chairs	Yes	No			
Bridges & Culverts	Yes	No			
Play Area	Yes	No			
Gazebos	Yes	No			
Benches/ sitting arrangements	Yes	No			
Boundary Wall & Gate	Yes	No			
Toilets	Yes	No			
Lakes & Brooks	Yes	No			
Mechanical Equipment					
Pumping Units	Yes	No			
Swings	Yes	No			
Children Games	Yes	No			
Fixtures	Yes	No			
Benches	Yes	No			
Sanitation & Water Supply					
Litter Bins	Yes	No			
Condition of SWM	Poor				
Toilet Fixtures	Yes	No			
Sewerage System	Yes	No			
Vegetation Cuttings & Disposal	Yes	No			
Drinking water availability and quality (based on availability of water quality test reports)					
Water Pipes	Yes	No			
HR					
Security Guards	Yes	No			
Landscape Experts	Yes	No			
Mali / Beldaar (Number)	Yes	No			
Overall Rating

Average Score	1	2	3	4	5
Asset Condition	Excellent	Good	Fair	Poor	Failing
Category	A	B	C	D	E
Remarks / Requirements					
•					
Data Collected By: Mr. Haroon		Designation: Team Member

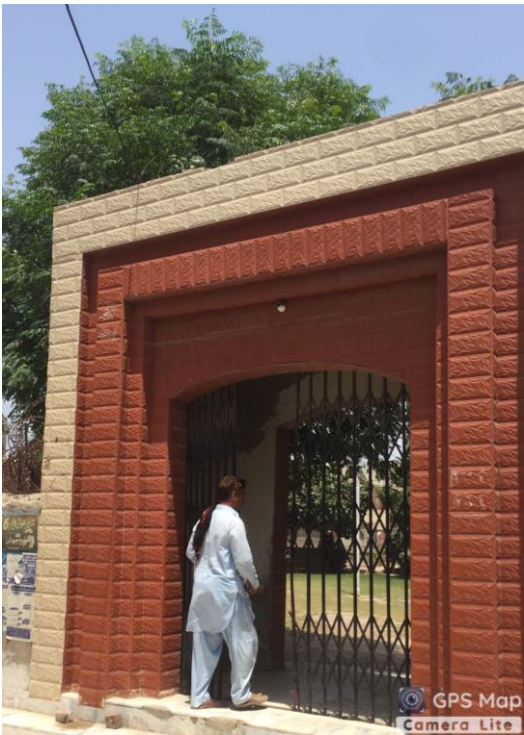
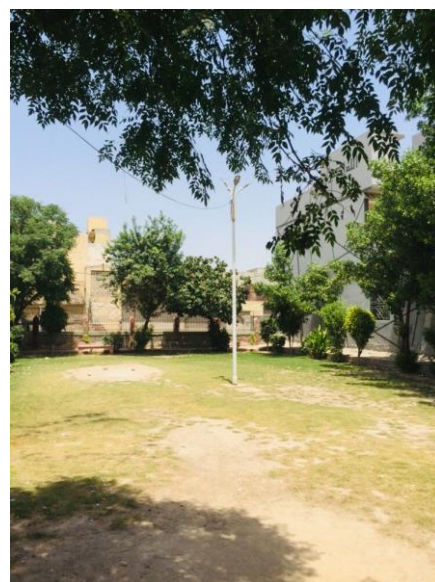
Form: IDAMP-A10		Park Asset Condition Assessment			Asset Code: _____ Date: 06-05-2023	
Name		Peoples Colony Park

Location	Latitude	30.7998				
	Longitude	73.4523				
Area In Acres		0.25				
Ownership- Owned by MC or possession allocated to MC by any other department (documents available)						
Turfing Condition		Good	Fair	Poor		
Approach Road		Good	Fair	Poor		
Parking Lots		Yes	No			
Canteen Availability		Yes	No			
Average number of daily visitors (based on the assessment of MC staff)						
Any illegal occupants or encroachments observed-if yes, type						
Security system		Yes	No			
Watering & Irrigation						
Tube Well		Yes	No			
Water Supply from Municipal System		Yes	No			
Water Tank		Yes	No			
Pumping Unit		Yes	No			
Distribution Pipe Lines		Yes	No			
Valves		Yes	No			
Sprinkler System		Yes	No			
Ground water storage reservoirs/ponds		Yes	No			
Landscaping & Plantation						
Grass Beds		Yes	No			
Flower Beds		Yes	No

Hedges		Yes	No			
Plants		Yes	No			
Number of trees and species (based on readily available information at MC)						
Lights						
Total Number						
Poles		Yes	No			
Cables		Yes	No			
Brackets And Lights		Yes	No			
Bulbs And Tubes		Yes	No			
Control Units		Yes	No			
Structures						
No. of Toilets	Gents	0				
	Ladies	0				
Condition of Toilets	Gents					
	Ladies					
Buildings		Yes	No

Fountains & Water Fall Structure	Yes	No			
Walkways	Yes	No			
Jogging tracks	Yes	No			
Ramps at entry gates for wheel chairs	Yes	No			
Bridges & Culverts	Yes	No			
Play Area	Yes	No			
Gazebos	Yes	No			
Benches/ sitting arrangements	Yes	No			
Boundary Wall & Gate	Yes	No			
Toilets	Yes	No			
Lakes & Brooks	Yes	No			
Mechanical Equipment					
Pumping Units	Yes	No			
Swings	Yes	No			
Children Games	Yes	No			
Fixtures	Yes	No			
Benches	Yes	No			
Sanitation & Water Supply					
Litter Bins	Yes	No			
Condition of SWM	Poor				
Toilet Fixtures	Yes	No			
Sewerage System	Yes	No			
Vegetation Cuttings & Disposal	Yes	No			
Drinking water availability and quality (based on availability of water quality test reports)					
Water Pipes	Yes	No			
HR					
Security Guards	Yes	No			
Landscape Experts	Yes	No			
Mali / Beldaar (Number)	Yes	No			
Overall Rating					
Average Score	1	2	3	4	5
Asset Condition	Excellent	Good	Fair	Poor	Failing
Category	A	B	C	D	E

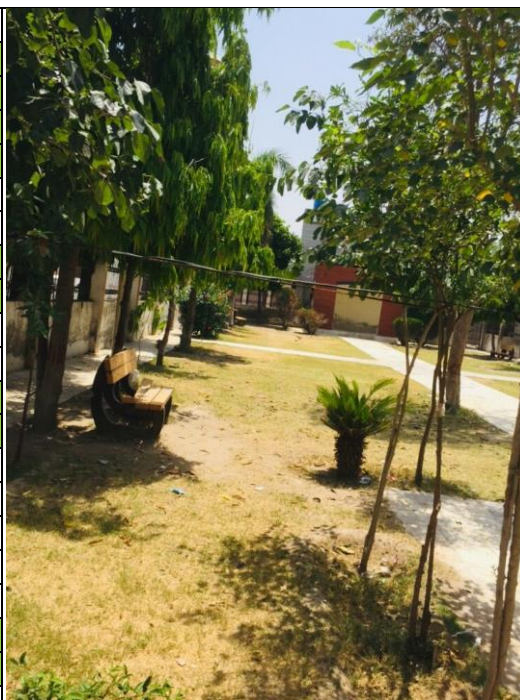
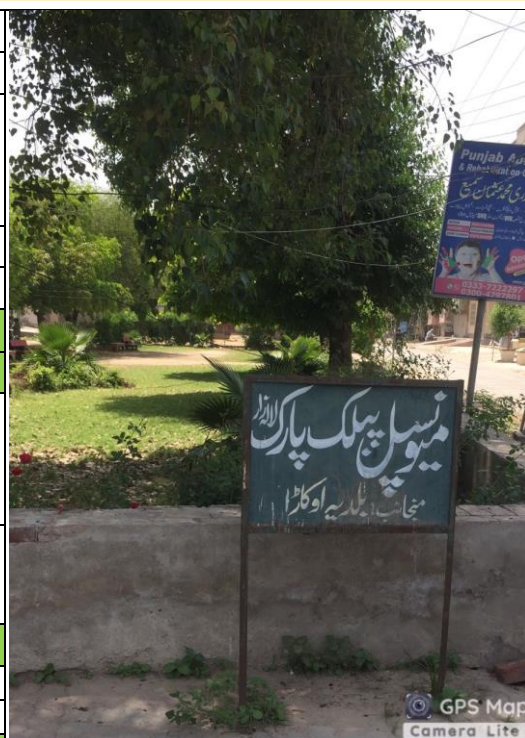
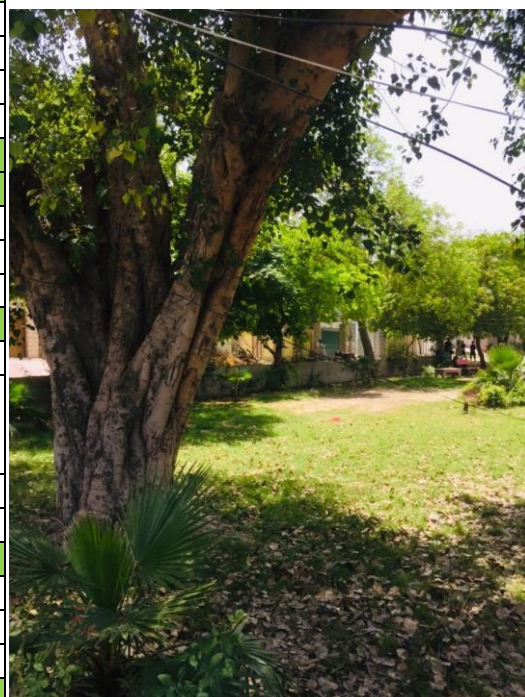
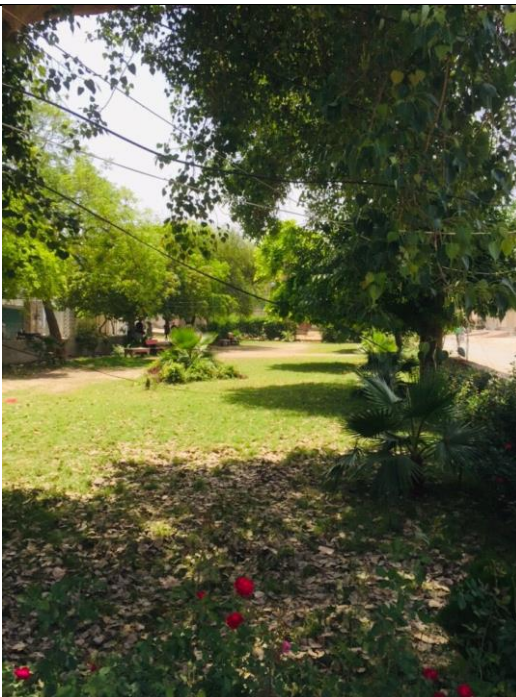
Municipal Committee Okara				
Form: IDAMP-A10	Park Asset Condition Assessment		Asset Code: _____ Date: 06-05-2023	
Name	Lalazar Colony Park		Pictures	
Location	Latitude	30.8117

Longitude	73.4512	
Area In Acres		0.25	
Ownership- Owned by MC or possession allocated to MC by any other department (documents available)			
Turfing Condition		Good	Fair
Approach Road		Good	Fair
Parking Lots		Yes	No
Canteen Availability		Yes	No
Average number of daily visitors (based on the assessment of MC staff)			
Any illegal occupants or encroachments observed-if yes, type			
Security system		Yes	No
Watering & Irrigation			
Tube Well		Yes	No
Water Supply from Municipal System		Yes	No
Water Tank		Yes	No
Pumping Unit		Yes	No
Distribution Pipe Lines		Yes	No
Valves		Yes	No
Sprinkler System		Yes	No
Ground water storage reservoirs/ponds		Yes	No
Landscaping & Plantation			
Grass Beds		Yes	No
Flower Beds		Yes	No
Hedges		Yes	No
Plants		Yes	No
Number of trees and species (based on readily available information at MC)			
Lights			
Total Number			
Poles		Yes	No
Cables		Yes	No
Brackets And Lights		Yes	No
Bulbs And Tubes		Yes	No

Control Units		Yes	No
Structures			
No. of Toilets	Gents	0	
	Ladies	0	
Condition of Toilets	Gents		
	Ladies		
Buildings		Yes	No
Fountains & Water Fall Structure		Yes	No
Walkways		Yes	No
Jogging tracks		Yes	No
Ramps at entry gates for wheel chairs		Yes	No
Bridges & Culverts		Yes	No

Gazebos	Yes	No			
Benches/ sitting arrangements	Yes	No			
Boundary Wall & Gate	Yes	No			
Toilets	Yes	No			
Lakes & Brooks	Yes	No			
Mechanical Equipment					
Pumping Units	Yes	No			
Swings	Yes	No			
Children Games	Yes	No			
Fixtures	Yes	No			
Benches	Yes	No			
Sanitation & Water Supply					
Litter Bins	Yes	No			
Condition of SWM	Poor				
Toilet Fixtures	Yes	No			
Sewerage System	Yes	No			
Vegetation Cuttings & Disposal	Yes	No			
Drinking water availability and quality (based on availability of water quality test reports)					
Water Pipes	Yes	No			
HR					
Security Guards	Yes	No			
Landscape Experts	Yes	No			
Mali / Beldaar (Number)	Yes	No			
Overall Rating					
Average Score	1	2	3	4	5
Asset Condition	Excellent	Good	Fair	Poor	Failing
Category	A	B	C	D	E
Remarks / Requirements

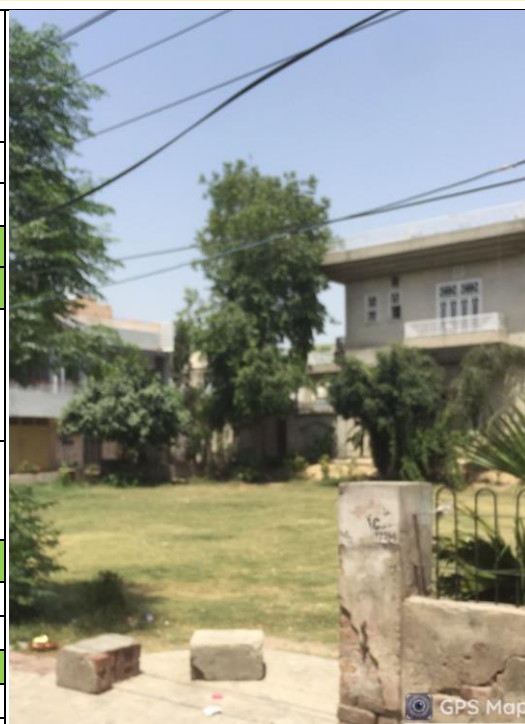
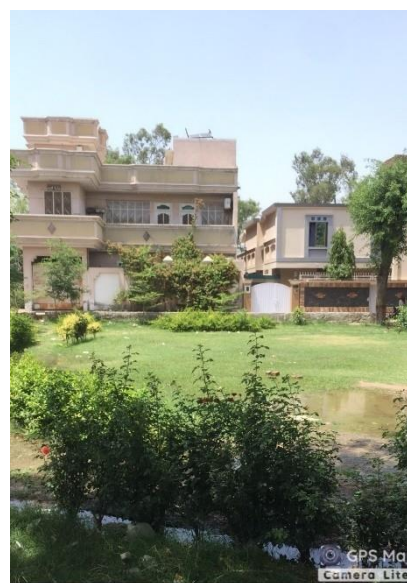
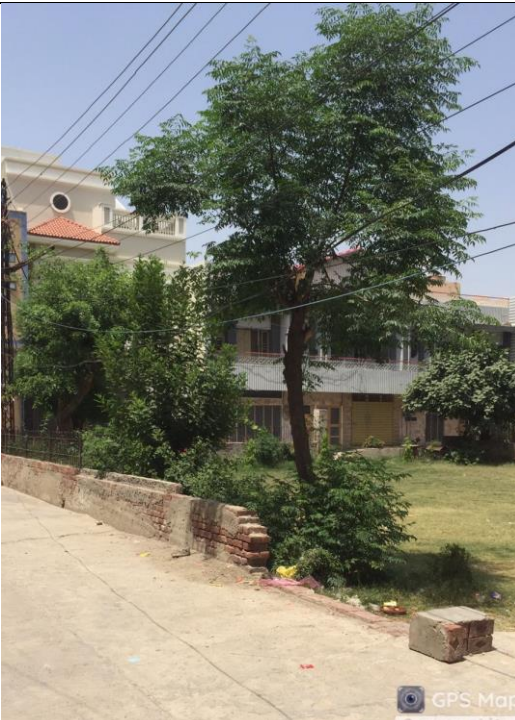
Municipal Committee Okara						
Form: IDAMP-A10		Park Asset Condition Assessment			Asset Code: _____ Date: 06-05-2023	
Name		Aamir Colony Park		Pictures		
Location	Latitude	30.8137				
	Longitude	73.4489				
Area In Acres		0.25

Ownership- Owned by MC or possession allocated to MC by any other department (documents available)			
Turfing Condition	Good	Fair	Poor
Approach Road	Good	Fair	Poor
Parking Lots	Yes	No	
Canteen Availability	Yes	No	
Average number of daily visitors (based on the assessment of MC staff)			
Any illegal occupants or encroachments observed-if yes, type			
Security system	Yes	No	
Watering & Irrigation			
Tube Well	Yes	No	
Water Supply from Municipal System	Yes	No	
Water Tank	Yes	No	
Pumping Unit	Yes	No	
Distribution Pipe Lines	Yes	No	
Valves	Yes	No	
Sprinkler System	Yes	No	
Ground water storage reservoirs/ponds	Yes	No	
Landscaping & Plantation			
Grass Beds	Yes	No	
Flower Beds	Yes	No	
Hedges	Yes	No	
Plants	Yes	No	
Number of trees and species (based on readily available information at MC)			
Lights			
Total Number			
Poles	Yes	No	
Cables	Yes	No	
Brackets And Lights	Yes	No	
Bulbs And Tubes	Yes	No	
Control Units	Yes	No	
Structures

No. of Toilets	Gents	0	
	Ladies	0	
Condition of Toilets	Gents		
	Ladies		
Buildings	Yes	No	
Fountains & Water Fall Structure	Yes	No	
Walkways	Yes	No	
Jogging tracks	Yes	No	
Ramps at entry gates for wheel chairs	Yes	No	
Bridges & Culverts	Yes	No	
Play Area	Yes	No	
Gazebos	Yes	No	
Benches/ sitting arrangements	Yes	No

Toilets	Yes	No			
Lakes & Brooks	Yes	No			
Mechanical Equipment					
Pumping Units	Yes	No			
Swings	Yes	No			
Children Games	Yes	No			
Fixtures	Yes	No			
Benches	Yes	No			
Sanitation & Water Supply					
Litter Bins	Yes	No			
Condition of SWM	Poor				
Toilet Fixtures	Yes	No			
Sewerage System	Yes	No			
Vegetation Cuttings & Disposal	Yes	No			
Drinking water availability and quality (based on availability of water quality test reports)					
Water Pipes	Yes	No			
HR					
Security Guards	Yes	No			
Landscape Experts	Yes	No			
Mali / Beldaar (Number)	Yes	No			
Overall Rating					
Average Score	1	2	3	4	5
Asset Condition	Excellent	Good	Fair	Poor	Failing
Category	A	B	C	D	E
Remarks / Requirements

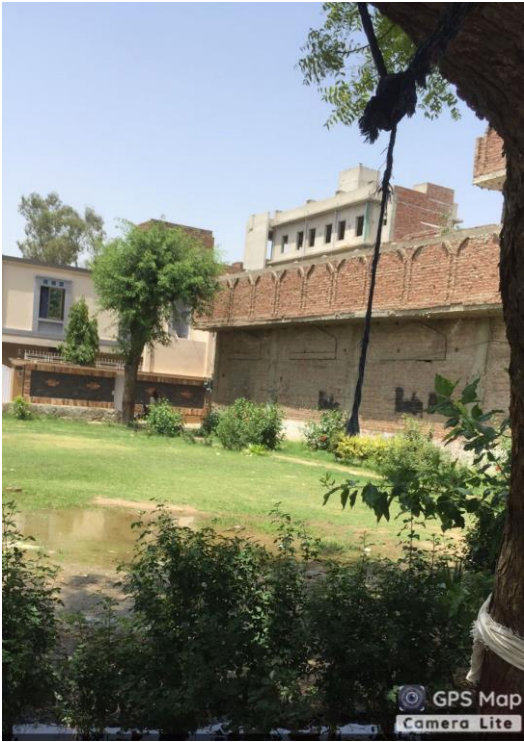
Municipal Committee Okara					
Form: IDAMP-A10		Park Asset Condition Assessment		Asset Code: _____ Date: 06-05-2023	
Name		Nawab Colony Park

Location	Latitude	30.8149			
	Longitude	73.4477			
Area In Acres		0.25			
Ownership-Owned by MC or possession allocated to MC by any other department (documents available)					
Turfing Condition		Good	Fair		Poor
Approach Road		Good	Fair		Poor
Parking Lots		Yes	No		
Canteen Availability		Yes	No		
Average number of daily visitors (based on the assessment of MC staff)					
Any illegal occupants or encroachments observed-if yes, type					
Security system		Yes	No		
Watering & Irrigation					
Tube Well		Yes	No		
Water Supply from Municipal System		Yes	No		
Water Tank		Yes	No		
Pumping Unit		Yes	No		
Distribution Pipe Lines		Yes	No		
Valves		Yes	No		
Sprinkler System		Yes	No		
Ground water storage reservoirs/ponds		Yes	No		
Landscaping & Plantation					
Grass Beds		Yes	No

Flower Beds		Yes	No		
Hedges		Yes	No		
Plants		Yes	No		
Number of trees and species (based on readily available information at MC)					
Lights					
Total Number					
Poles		Yes	No		
Cables		Yes	No		
Brackets And Lights		Yes	No		
Bulbs And Tubes		Yes	No		
Control Units		Yes	No		
Structures					
No. of Toilets	Gents	0			
	Ladies	0

Condition of Toilets	Gents				
	Ladies				
Buildings		Yes	No		
Fountains & Water Fall Structure		Yes	No		
Walkways		Yes	No		
Jogging tracks		Yes	No		
Ramps at entry gates for wheel chairs		Yes	No		
Bridges & Culverts		Yes	No		
Play Area		Yes	No		
Gazebos		Yes	No		
Benches/ sitting arrangements		Yes	No		
Boundary Wall & Gate		Yes	No		
Toilets		Yes	No		
Lakes & Brooks		Yes	No		
Mechanical Equipment					
Pumping Units		Yes	No		
Swings		Yes	No		
Children Games		Yes	No		
Fixtures		Yes	No		
Benches		Yes	No		
Sanitation & Water Supply					
Litter Bins		Yes	No		
Condition of SWM		Poor			
Toilet Fixtures		Yes	No		
Sewerage System		Yes	No		
Vegetation Cuttings & Disposal		Yes	No		
Drinking water availability and quality (based on availability of water quality test reports)					
Water Pipes		Yes	No		
HR					
Security Guards		Yes	No		
Landscape Experts		Yes	No		
Mali / Beldaar (Number)		Yes	No		
Overall Rating					
Average Score	1	2	3	4	5

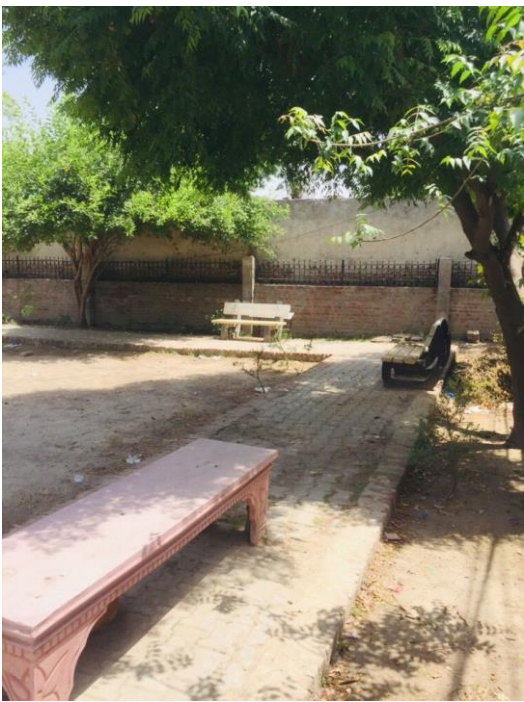
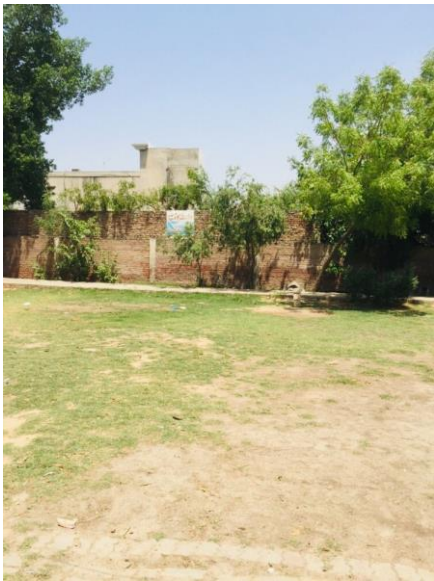
Municipal Committee Okara					
Form: IDAMP-A10		Park Asset Condition Assessment		Asset Code: _____ Date: 06-05-2023	
Name		Waris colony Park

Location	Latitude	30.813212			
	Longitude	73.44977			
Area In Acres		0.25			
Ownership- Owned by MC or possession allocated to MC by any other department (documents available)					
Turfing Condition		Good	Fair		Poor
Approach Road		Good	Fair		Poor
Parking Lots		Yes	No		
Canteen Availability		Yes	No		
Average number of daily visitors (based on the assessment of MC staff)					
Any illegal occupants or encroachments observed-if yes, type					
Security system		Yes	No		
Watering & Irrigation					
Tube Well		Yes	No		
Water Supply from Municipal System		Yes	No		
Water Tank		Yes	No		
Pumping Unit		Yes	No		
Distribution Pipe Lines		Yes	No		
Valves		Yes	No		
Sprinkler System		Yes	No		
Ground water storage reservoirs/ponds		Yes	No		
Landscaping & Plantation					
Grass Beds		Yes	No

Flower Beds		Yes	No		
Hedges		Yes	No		
Plants		Yes	No		
Number of trees and species (based on readily available information at MC)					
Lights					
Total Number					
Poles		Yes	No		
Cables		Yes	No		
Brackets And Lights		Yes	No		
Bulbs And Tubes		Yes	No		
Control Units		Yes	No		
Structures					
No. of Toilets	Gents	0			
	Ladies	0

Condition of Toilets	Gents				
	Ladies				
Buildings		Yes	No		
Fountains & Water Fall Structure		Yes	No		
Walkways		Yes	No		
Jogging tracks		Yes	No		
Ramps at entry gates for wheel chairs		Yes	No		
Bridges & Culverts		Yes	No		
Play Area		Yes	No		
Gazebos		Yes	No		
Benches/ sitting arrangements		Yes	No		
Boundary Wall & Gate		Yes	No		
Toilets		Yes	No		
Lakes & Brooks		Yes	No		
Mechanical Equipment					
Pumping Units		Yes	No		
Swings		Yes	No		
Children Games		Yes	No		
Fixtures		Yes	No		
Benches		Yes	No		
Sanitation & Water Supply					
Litter Bins		Yes	No		
Condition of SWM		Poor			
Toilet Fixtures		Yes	No		
Sewerage System		Yes	No		
Vegetation Cuttings & Disposal		Yes	No		
Drinking water availability and quality (based on availability of water quality test reports)					
Water Pipes		Yes	No		
HR					
Security Guards		Yes	No		
Landscape Experts		Yes	No		
Mali / Beldaar (Number)		Yes	No		
Overall Rating					
Average Score	1	2	3	4	5

Asset Condition	Excellent	Good	Fair	Poor	Failing
Category	A	B	C	D	E
Remarks / Requirements					
•					
Data Collected By: Mr. Haroon		Designation: Team Member		  Sign & Date: 30-May-2023	
Data Checked By: Mr. Muddasir Alvi		Designation: Team Lead		  Sign & Date: 30-May-2023

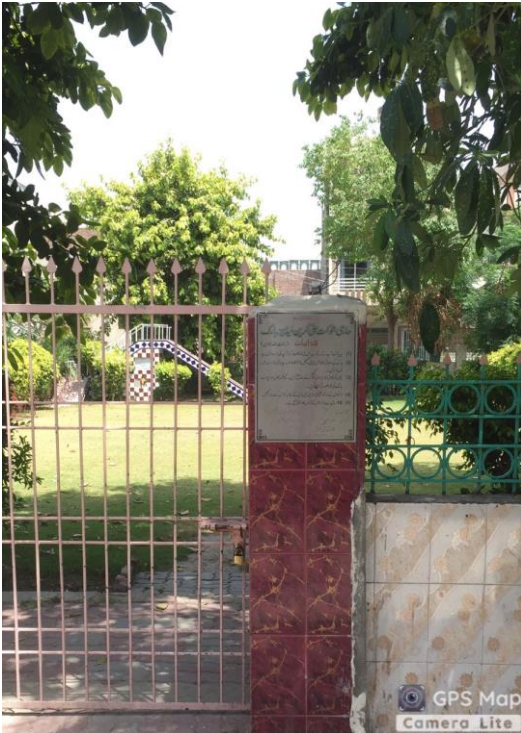
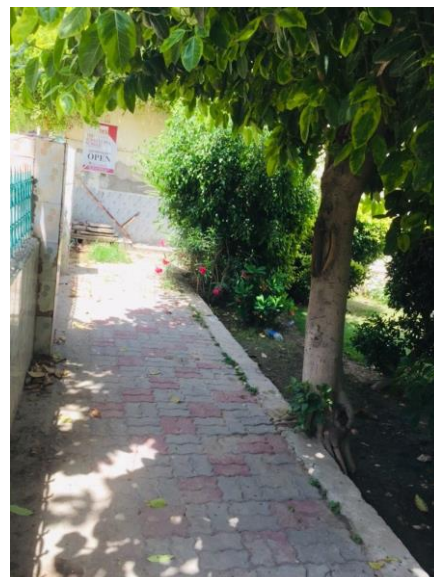
Form: IDAMP-A10		Park Asset Condition Assessment			Asset Code: _____ Date: 06-05-2023	
Name		Rehmat Ullah Town Park

Location	Latitude	30.8193				
	Longitude	73.4530				
Area In Acres		0.25				
Ownership- Owned by MC or possession allocated to MC by any other department (documents available)						
Turfing Condition		Good	Fair	Poor		
Approach Road		Good	Fair	Poor		
Parking Lots		Yes	No			
Canteen Availability		Yes	No			
Average number of daily visitors (based on the assessment of MC staff)						
Any illegal occupants or encroachments observed-if yes, type						
Security system		Yes	No			
Watering & Irrigation						
Tube Well		Yes	No			
Water Supply from Municipal System		Yes	No			
Water Tank		Yes	No			
Pumping Unit		Yes	No			
Distribution Pipe Lines		Yes	No			
Valves		Yes	No			
Sprinkler System		Yes	No			
Ground water storage reservoirs/ponds		Yes	No			
Landscaping & Plantation						
Grass Beds		Yes	No

Flower Beds		Yes	No			
Hedges		Yes	No			
Plants		Yes	No			
Number of trees and species (based on readily available information at MC)						
Lights						
Total Number						
Poles		Yes	No			
Cables		Yes	No			
Brackets And Lights		Yes	No			
Bulbs And Tubes		Yes	No			
Control Units		Yes	No			
Structures						
No. of Toilets	Gents	0				
	Ladies	0				
Condition of Toilets	Gents					
	Ladies					
Buildings		Yes	No

Fountains & Water Fall Structure	Yes	No			
Walkways	Yes	No			
Jogging tracks	Yes	No			
Ramps at entry gates for wheel chairs	Yes	No			
Bridges & Culverts	Yes	No			
Play Area	Yes	No			
Gazebos	Yes	No			
Benches/ sitting arrangements	Yes	No			
Boundary Wall & Gate	Yes	No			
Toilets	Yes	No			
Lakes & Brooks	Yes	No			
Mechanical Equipment					
Pumping Units	Yes	No			
Swings	Yes	No			
Children Games	Yes	No			
Fixtures	Yes	No			
Benches	Yes	No			
Sanitation & Water Supply					
Litter Bins	Yes	No			
Condition of SWM	Poor				
Toilet Fixtures	Yes	No			
Sewerage System	Yes	No			
Vegetation Cuttings & Disposal	Yes	No			
Drinking water availability and quality (based on availability of water quality test reports)					
Water Pipes	Yes	No			
HR					
Security Guards	Yes	No			
Landscape Experts	Yes	No			
Mali / Beldaar (Number)	Yes	No			
Overall Rating					
Average Score	1	2	3	4	5
Asset Condition	Excellent	Good	Fair	Poor	Failing
Category	A	B	C	D	E

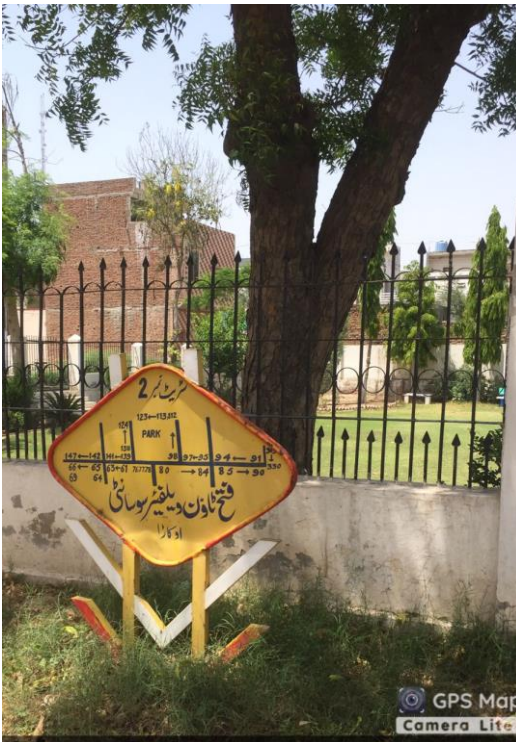
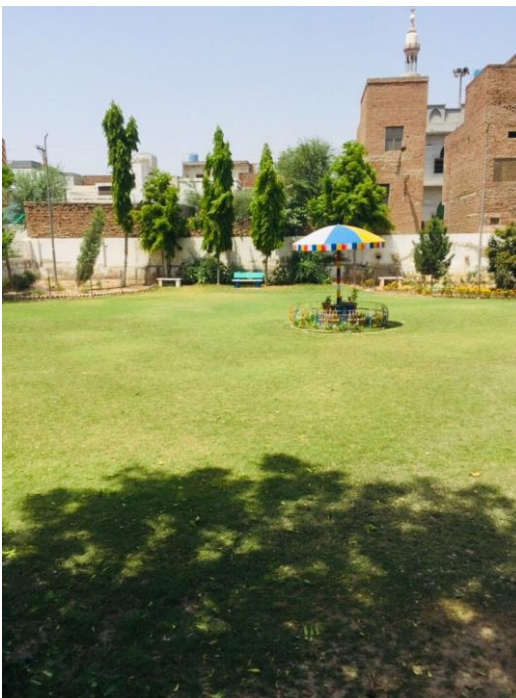
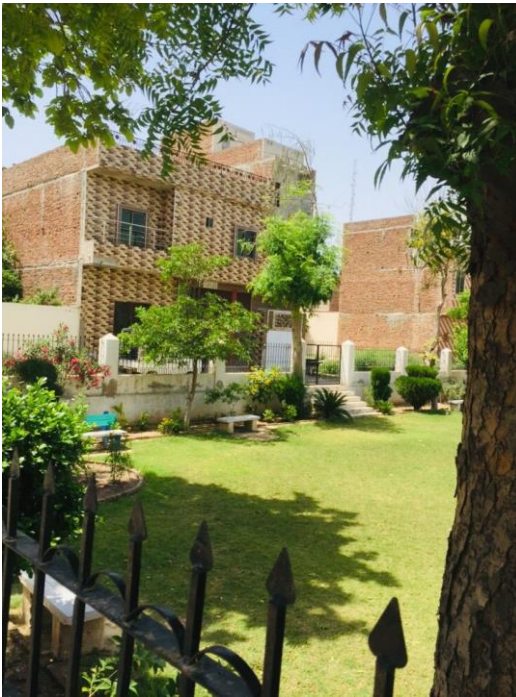
Name		Fateh Town Park - 1		Pictures		
Location	Latitude	30.8193

Longitude	73.4564				
Area In Acres		0.25				
Ownership-Owned by MC or possession allocated to MC by any other department (documents available)						
Turfing Condition		Good	Fair			Poor
Approach Road		Good	Fair			Poor
Parking Lots		Yes	No			
Canteen Availability		Yes	No			
Average number of daily visitors (based on the assessment of MC staff)						
Any illegal occupants or encroachments observed-if yes, type						
Security system		Yes	No			
Watering & Irrigation						
Tube Well		Yes	No			
Water Supply from Municipal System		Yes	No			
Water Tank		Yes	No			
Pumping Unit		Yes	No			
Distribution Pipe Lines		Yes	No			
Valves		Yes	No			
Sprinkler System		Yes	No			
Ground water storage reservoirs/ponds		Yes	No			
Landscaping & Plantation						
Grass Beds		Yes	No			
Flower Beds		Yes	No			
Hedges		Yes	No			
Plants		Yes	No			
Number of trees and species (based on readily available information at MC)

Lights						
Total Number						
Poles		Yes	No			
Cables		Yes	No			
Brackets And Lights		Yes	No			
Bulbs And Tubes		Yes	No			
Control Units		Yes	No			
Structures						
No. of Toilets	Gents	0				
	Ladies	0				
Condition of Toilets	Gents					
	Ladies					
Buildings		Yes	No			
Fountains & Water Fall Structure		Yes	No			
Walkways		Yes	No

Ramps at entry gates for wheel chairs	Yes	No			
Bridges & Culverts	Yes	No			
Play Area	Yes	No			
Gazebos	Yes	No			
Benches/ sitting arrangements	Yes	No			
Boundary Wall & Gate	Yes	No			
Toilets	Yes	No			
Lakes & Brooks	Yes	No			
Mechanical Equipment					
Pumping Units	Yes	No			
Swings	Yes	No			
Children Games	Yes	No			
Fixtures	Yes	No			
Benches	Yes	No			
Sanitation & Water Supply					
Litter Bins	Yes	No			
Condition of SWM	Poor				
Toilet Fixtures	Yes	No			
Sewerage System	Yes	No			
Vegetation Cuttings & Disposal	Yes	No			
Drinking water availability and quality (based on availability of water quality test reports)					
Water Pipes	Yes	No			
HR					
Security Guards	Yes	No			
Landscape Experts	Yes	No			
Mali / Beldaar (Number)	Yes	No			
Overall Rating					
Average Score	1	2	3	4	5
Asset Condition	Excellent	Good	Fair	Poor	Failing
Category	A	B	C	D	E
Remarks / Requirements

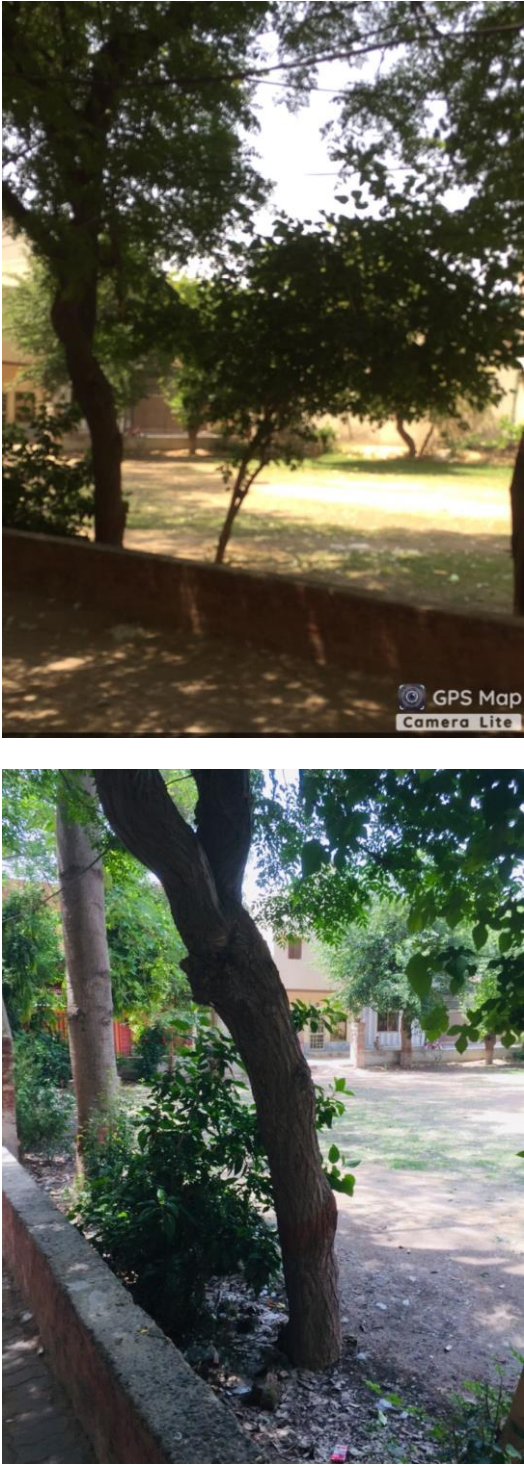
Municipal Committee Okara					
Form: IDAMP-A10		Park Asset Condition Assessment		Asset Code: _____ Date: 06-05-2023	
Name		Khan Colony		<div style="text-align: center;">Pictures</div>

Location	Latitude	30.8235			
	Longitude	73.4546			
Area In Acres		0.25			
Ownership- Owned by MC or possession allocated to MC by any other department (documents available)					
Turfing Condition		Good	Fair		Poor
Approach Road		Good	Fair		Poor
Parking Lots		Yes	No		
Canteen Availability		Yes	No		
Average number of daily visitors (based on the assessment of MC staff)					
Any illegal occupants or encroachments observed-if yes, type					
Security system		Yes	No		
Watering & Irrigation					
Tube Well		Yes	No		
Water Supply from Municipal System		Yes	No		
Water Tank		Yes	No		
Pumping Unit		Yes	No		
Distribution Pipe Lines		Yes	No		
Valves		Yes	No		
Sprinkler System		Yes	No		
Ground water storage reservoirs/ponds		Yes	No		
Landscaping & Plantation

Grass Beds		Yes	No		
Flower Beds		Yes	No		
Hedges		Yes	No		
Plants		Yes	No		
Number of trees and species (based on readily available information at MC)					
Lights					
Total Number					
Poles		Yes	No		
Cables		Yes	No		
Brackets And Lights		Yes	No		
Bulbs And Tubes		Yes	No		
Control Units		Yes	No		
Structures					
No. of Toilets	Gents	0			
	Ladies	0

Condition of Toilets	Gents				
	Ladies				
Buildings		Yes	No		
Fountains & Water Fall Structure		Yes	No		
Walkways		Yes	No		
Jogging tracks		Yes	No		
Ramps at entry gates for wheel chairs		Yes	No		
Bridges & Culverts		Yes	No		
Play Area		Yes	No		
Gazebos		Yes	No		
Benches/ sitting arrangements		Yes	No		
Boundary Wall & Gate		Yes	No		
Toilets		Yes	No		
Lakes & Brooks		Yes	No		
Mechanical Equipment					
Pumping Units		Yes	No		
Swings		Yes	No		
Children Games		Yes	No		
Fixtures		Yes	No		
Benches		Yes	No		
Sanitation & Water Supply					
Litter Bins		Yes	No		
Condition of SWM		Poor			
Toilet Fixtures		Yes	No		
Sewerage System		Yes	No		
Vegetation Cuttings & Disposal		Yes	No		
Drinking water availability and quality (based on availability of water quality test reports)					
Water Pipes		Yes	No		
HR					
Security Guards		Yes	No		
Landscape Experts		Yes	No		
Mali / Beldaar (Number)		Yes	No		
Overall Rating					
Average Score	1	2	3	4	5

Asset Condition	Excellent	Good	Fair	Poor	Failing
Category	A	B	C	D	E
Remarks / Requirements					
•					
Data Collected By: Mr. Haroon		Designation: Team Member

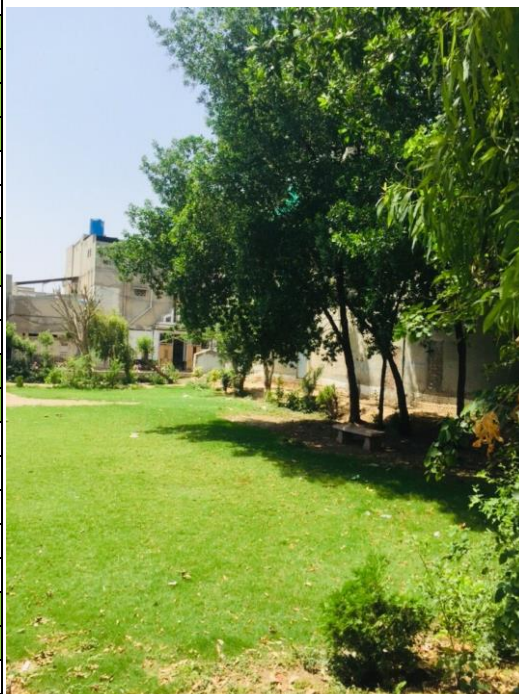
Lights						
Total Number						
Poles		Yes	No			
Cables		Yes	No			
Brackets And Lights		Yes	No			
Bulbs And Tubes		Yes	No			
Control Units		Yes	No			
Structures						
No. of Toilets	Gents	0				
	Ladies	0				
Condition of Toilets	Gents					
	Ladies					
Buildings		Yes	No			
Fountains & Water Fall Structure		Yes	No			
Walkways		Yes	No

Jogging tracks	Yes	No			
Ramps at entry gates for wheel chairs	Yes	No			
Bridges & Culverts	Yes	No			
Play Area	Yes	No			
Gazebos	Yes	No			
Benches/ sitting arrangements	Yes	No			
Boundary Wall & Gate	Yes	No			
Toilets	Yes	No			
Lakes & Brooks	Yes	No			
Mechanical Equipment					
Pumping Units	Yes	No			
Swings	Yes	No			
Children Games	Yes	No			
Fixtures	Yes	No			
Benches	Yes	No			
Sanitation & Water Supply					
Litter Bins	Yes	No			
Condition of SWM	Poor				
Toilet Fixtures	Yes	No			
Sewerage System	Yes	No			
Vegetation Cuttings & Disposal	Yes	No			
Drinking water availability and quality (based on availability of water quality test reports)					
Water Pipes	Yes	No			
HR					
Security Guards	Yes	No			
Landscape Experts	Yes	No			
Mali / Beldaar (Number)	Yes	No			
Overall Rating					
Average Score	1	2	3	4	5
Asset Condition	Excellent	Good	Fair	Poor	Failing
Category	A	B	C	D	E
Remarks / Requirements
