Punjab Municipal Development Fund Company

Hiring of Consulting Services for Preparation of Integrated Development and Asset Management Plan (IDAMP) for 16 selected MCs In Punjab under Punjab Cities Program (PCP)

IDAMP – Municipal Committee Okara
May 2024

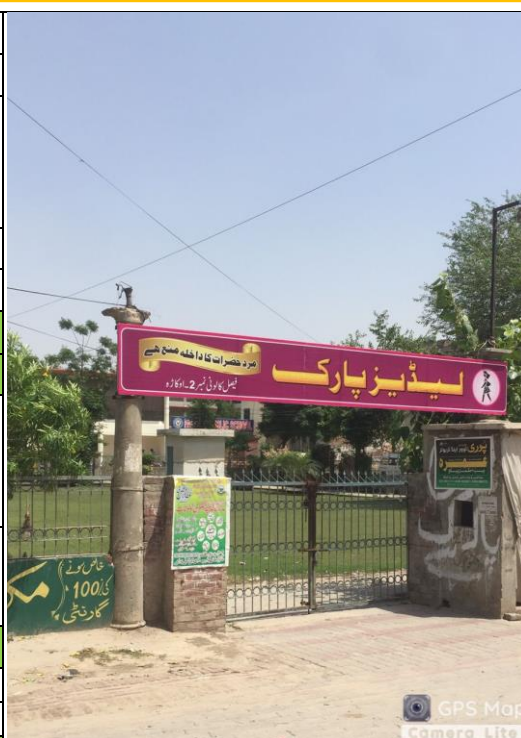
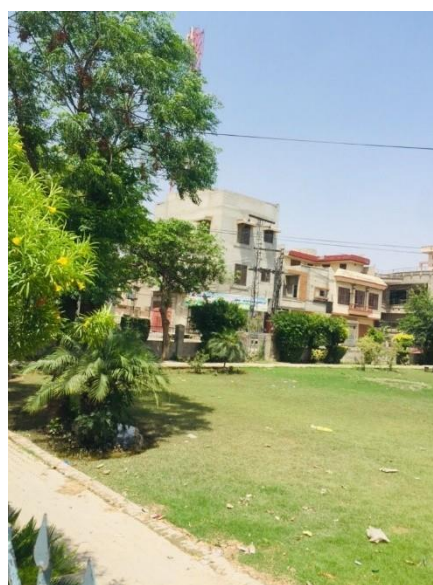
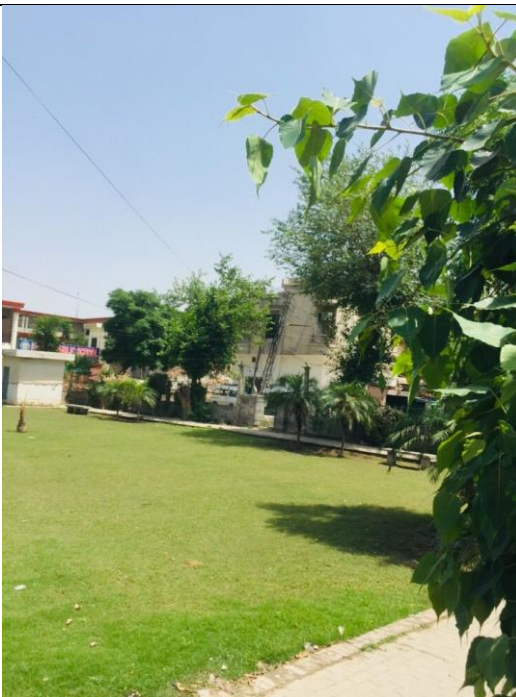
Municipal Committee Okara					
Form: IDAMP-A10		Park Asset Condition Assessment		Asset Code: _____ Date: 06-05-2023	
Name		Faisal Colony No. 2 Park		Pictures	
Location	Latitude	30.8221

Longitude	73.4563	
Area In Acres		0.25	
Ownership- Owned by MC or possession allocated to MC by any other department (documents available)			
Turfing Condition		Good	Fair
Approach Road		Good	Fair
Parking Lots		Yes	No
Canteen Availability		Yes	No
Average number of daily visitors (based on the assessment of MC staff)			
Any illegal occupants or encroachments observed-if yes, type			
Security system		Yes	No
Watering & Irrigation			
Tube Well		Yes	No
Water Supply from Municipal System		Yes	No
Water Tank		Yes	No
Pumping Unit		Yes	No
Distribution Pipe Lines		Yes	No
Valves		Yes	No
Sprinkler System		Yes	No
Ground water storage reservoirs/ponds		Yes	No
Landscaping & Plantation			
Grass Beds		Yes	No
Flower Beds		Yes	No
Hedges		Yes	No
Plants		Yes	No
Number of trees and species (based on readily available information at MC)			
Lights			
Total Number			
Poles		Yes	No
Cables		Yes	No
Brackets And Lights		Yes	No
Bulbs And Tubes		Yes	No

Control Units		Yes	No
Structures			
No. of Toilets	Gents	0	
	Ladies	0	
Condition of Toilets	Gents		
	Ladies		
Buildings		Yes	No
Fountains & Water Fall Structure		Yes	No
Walkways		Yes	No
Jogging tracks		Yes	No
Ramps at entry gates for wheel chairs		Yes	No
Bridges & Culverts		Yes	No

Gazebos	Yes	No			
Benches/ sitting arrangements	Yes	No			
Boundary Wall & Gate	Yes	No			
Toilets	Yes	No			
Lakes & Brooks	Yes	No			
Mechanical Equipment					
Pumping Units	Yes	No			
Swings	Yes	No			
Children Games	Yes	No			
Fixtures	Yes	No			
Benches	Yes	No			
Sanitation & Water Supply					
Litter Bins	Yes	No			
Condition of SWM	Poor				
Toilet Fixtures	Yes	No			
Sewerage System	Yes	No			
Vegetation Cuttings & Disposal	Yes	No			
Drinking water availability and quality (based on availability of water quality test reports)					
Water Pipes	Yes	No			
HR					
Security Guards	Yes	No			
Landscape Experts	Yes	No			
Mali / Beldaar (Number)	Yes	No			
Overall Rating					
Average Score	1	2	3	4	5
Asset Condition	Excellent	Good	Fair	Poor	Failing
Category	A	B	C	D	E
Remarks / Requirements

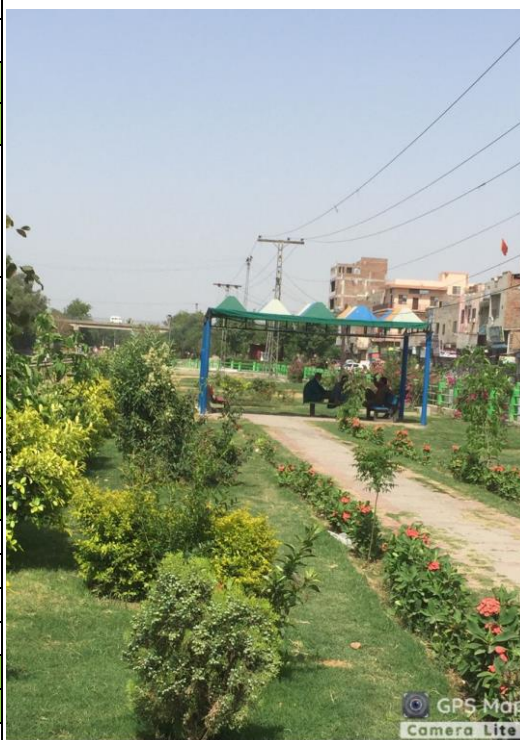
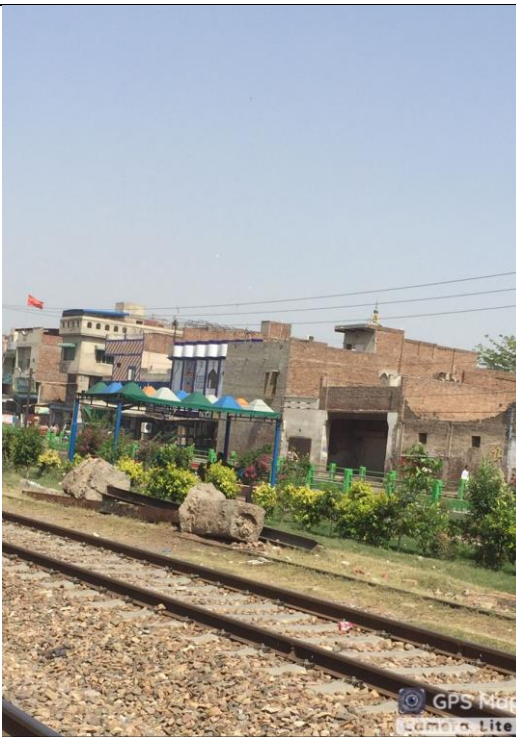
Municipal Committee Okara						
Form: IDAMP-A10		Park Asset Condition Assessment			Asset Code: _____ Date: 06-05-2023	
Name		Sikandar Chowk Park		Pictures		
Location	Latitude	30.8088				
	Longitude	73.4514				
Area In Acres		0.25

Ownership- Owned by MC or possession allocated to MC by any other department (documents available)			
Turfing Condition	Good	Fair	Poor
Approach Road	Good	Fair	Poor
Parking Lots	Yes	No	
Canteen Availability	Yes	No	
Average number of daily visitors (based on the assessment of MC staff)			
Any illegal occupants or encroachments observed-if yes, type			
Security system	Yes	No	
Watering & Irrigation			
Tube Well	Yes	No	
Water Supply from Municipal System	Yes	No	
Water Tank	Yes	No	
Pumping Unit	Yes	No	
Distribution Pipe Lines	Yes	No	
Valves	Yes	No	
Sprinkler System	Yes	No	
Ground water storage reservoirs/ponds	Yes	No	
Landscaping & Plantation			
Grass Beds	Yes	No	
Flower Beds	Yes	No	
Hedges	Yes	No	
Plants	Yes	No	
Number of trees and species (based on readily available information at MC)			
Lights			
Total Number			
Poles	Yes	No	
Cables	Yes	No	
Brackets And Lights	Yes	No	
Bulbs And Tubes	Yes	No	
Control Units	Yes	No	
Structures

No. of Toilets	Gents	0	
	Ladies	0	
Condition of Toilets	Gents		
	Ladies		
Buildings	Yes	No	
Fountains & Water Fall Structure	Yes	No	
Walkways	Yes	No	
Jogging tracks	Yes	No	
Ramps at entry gates for wheel chairs	Yes	No	
Bridges & Culverts	Yes	No	
Play Area	Yes	No	
Gazebos	Yes	No	
Benches/ sitting arrangements	Yes	No

Toilets	Yes	No			
Lakes & Brooks	Yes	No			
Mechanical Equipment					
Pumping Units	Yes	No			
Swings	Yes	No			
Children Games	Yes	No			
Fixtures	Yes	No			
Benches	Yes	No			
Sanitation & Water Supply					
Litter Bins	Yes	No			
Condition of SWM	Poor				
Toilet Fixtures	Yes	No			
Sewerage System	Yes	No			
Vegetation Cuttings & Disposal	Yes	No			
Drinking water availability and quality (based on availability of water quality test reports)					
Water Pipes	Yes	No			
HR					
Security Guards	Yes	No			
Landscape Experts	Yes	No			
Mali / Beldaar (Number)	Yes	No			
Overall Rating					
Average Score	1	2	3	4	5
Asset Condition	Excellent	Good	Fair	Poor	Failing
Category	A	B	C	D	E
Remarks / Requirements

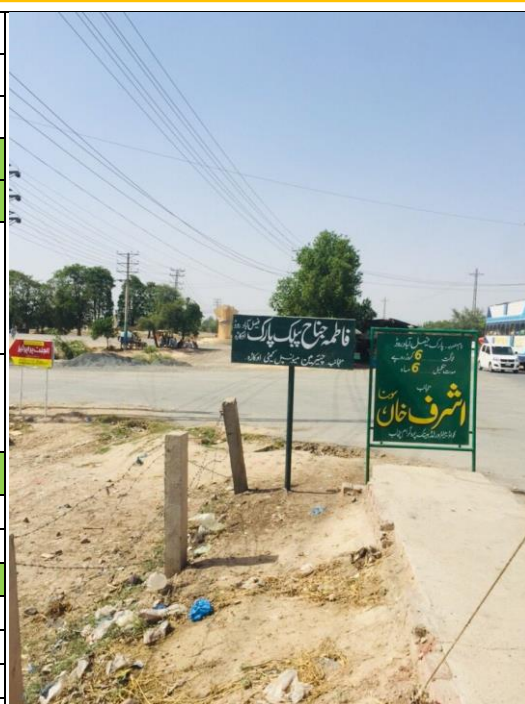
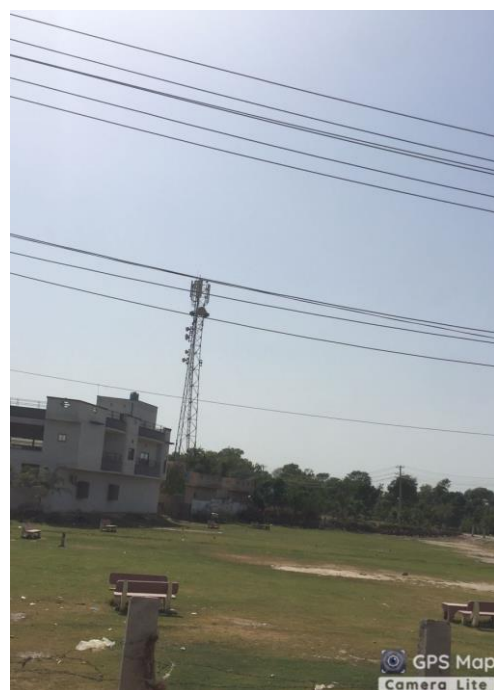
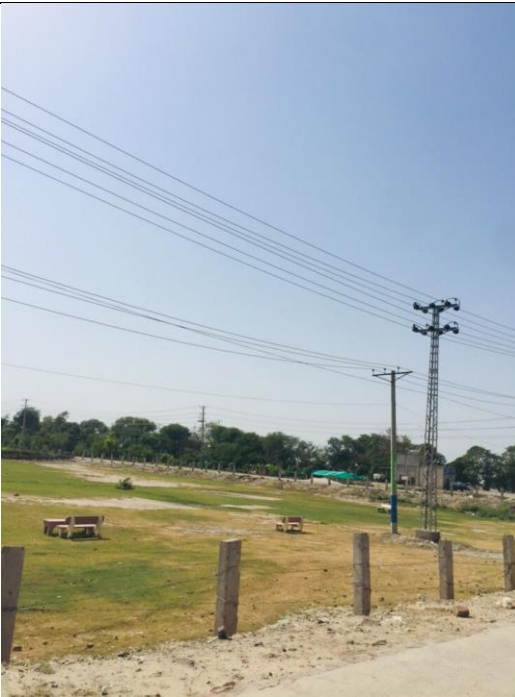
(documents available)			
Turfing Condition	Good	Fair	Poor
Approach Road	Good	Fair	Poor
Parking Lots	Yes	No	
Canteen Availability	Yes	No	
Average number of daily visitors (based on the assessment of MC staff)			
Any illegal occupants or encroachments observed-if yes, type			
Security system	Yes	No	
Watering & Irrigation			
Tube Well	Yes	No	
Water Supply from Municipal System	Yes	No	
Water Tank	Yes	No	
Pumping Unit	Yes	No	
Distribution Pipe Lines	Yes	No	
Valves	Yes	No	
Sprinkler System	Yes	No	
Ground water storage reservoirs/ponds	Yes	No	
Landscaping & Plantation			
Grass Beds	Yes	No	
Flower Beds	Yes	No	
Hedges	Yes	No	
Plants	Yes	No	
Number of trees and species (based on readily available information at MC)			
Lights			
Total Number			
Poles	Yes	No	
Cables	Yes	No	
Brackets And Lights	Yes	No	
Bulbs And Tubes	Yes	No	
Control Units	Yes	No	
Structures			
No. of Toilets	Gents	0	
	Ladies	0	
Condition of Toilets	Gents		
	Ladies		
Buildings	Yes	No

Fountains & Water Fall Structure	Yes	No	
Walkways	Yes	No	
Jogging tracks	Yes	No	
Ramps at entry gates for wheel chairs	Yes	No	
Bridges & Culverts	Yes	No	
Play Area	Yes	No	
Gazebos	Yes	No	
Benches/ sitting arrangements	Yes	No	
Boundary Wall & Gate	Yes	No	
Toilets	Yes	No

Mechanical Equipment					
Pumping Units	Yes	No			
Swings	Yes	No			
Children Games	Yes	No			
Fixtures	Yes	No			
Benches	Yes	No			
Sanitation & Water Supply					
Litter Bins	Yes	No			
Condition of SWM	Poor				
Toilet Fixtures	Yes	No			
Sewerage System	Yes	No			
Vegetation Cuttings & Disposal	Yes	No			
Drinking water availability and quality (based on availability of water quality test reports)					
Water Pipes	Yes	No			
HR					
Security Guards	Yes	No			
Landscape Experts	Yes	No			
Mali / Beldaar (Number)	Yes	No			
Overall Rating					
Average Score	1	2	3	4	5
Asset Condition	Excellent	Good	Fair	Poor	Failing
Category	A	B	C	D	E
Remarks / Requirements					
•					
Data Collected By: Mr. Haroon		Designation: Team Member

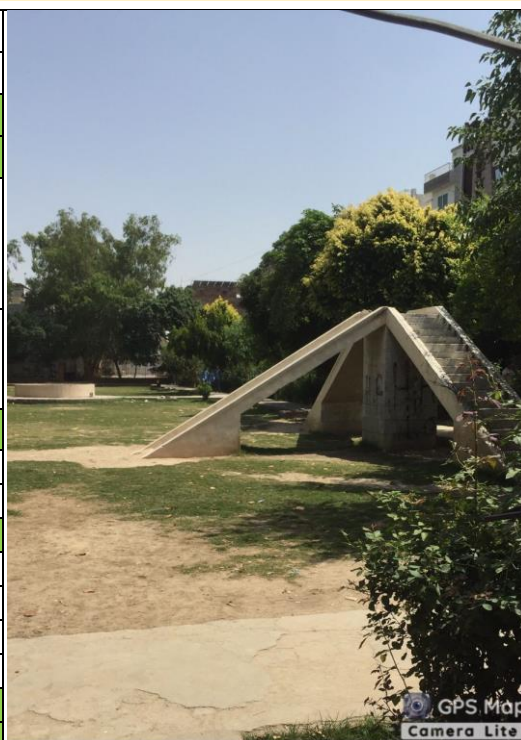
Turfing Condition	Good	Fair	Poor
Approach Road	Good	Fair	Poor
Parking Lots	Yes	No	
Canteen Availability	Yes	No	
Average number of daily visitors (based on the assessment of MC staff)			
Any illegal occupants or encroachments observed-if yes, type			
Security system	Yes	No	
Watering & Irrigation			
Tube Well		Yes	No
Water Supply from Municipal System		Yes	No
Water Tank		Yes	No
Pumping Unit		Yes	No
Distribution Pipe Lines		Yes	No
Valves		Yes	No
Sprinkler System		Yes	No
Ground water storage reservoirs/ponds		Yes	No
Landscaping & Plantation			
Grass Beds		Yes	No
Flower Beds		Yes	No
Hedges		Yes	No
Plants		Yes	No
Number of trees and species (based on readily available information at MC)			
Lights			
Total Number			
Poles		Yes	No
Cables		Yes	No
Brackets And Lights		Yes	No
Bulbs And Tubes		Yes	No
Control Units		Yes	No
Structures			
No. of Toilets	Gents	0	
	Ladies	0	
Condition of Toilets	Gents		
	Ladies		
Buildings		Yes	No
Fountains & Water Fall Structure		Yes	No

Walkways		Yes	No
Jogging tracks		Yes	No
Ramps at entry gates for wheel chairs		Yes	No
Bridges & Culverts		Yes	No
Play Area		Yes	No
Gazebos		Yes	No
Benches/ sitting arrangements		Yes	No
Boundary Wall & Gate		Yes	No
Toilets		Yes	No
Lakes & Brooks		Yes	No

Mechanical Equipment		
Pumping Units	Yes	No
Swings	Yes	No
Children Games	Yes	No
Fixtures	Yes	No
Benches	Yes	No
Sanitation & Water Supply		
Litter Bins	Yes	No
Condition of SWM	Poor	
Toilet Fixtures	Yes	No
Sewerage System	Yes	No
Vegetation Cuttings & Disposal	Yes	No
Drinking water availability and quality (based on availability of water quality test reports)		
Water Pipes	Yes	No
HR		
Security Guards	Yes	No
Landscape Experts	Yes	No
Mali / Beldaar (Number)	Yes	No

Overall Rating					
Average Score	1	2	3	4	5
Asset Condition	Excellent	Good	Fair	Poor	Failing
Category	A	B	C	D	E
Remarks / Requirements					
•					
Data Collected By: Mr. Haroon		Designation: Team Member

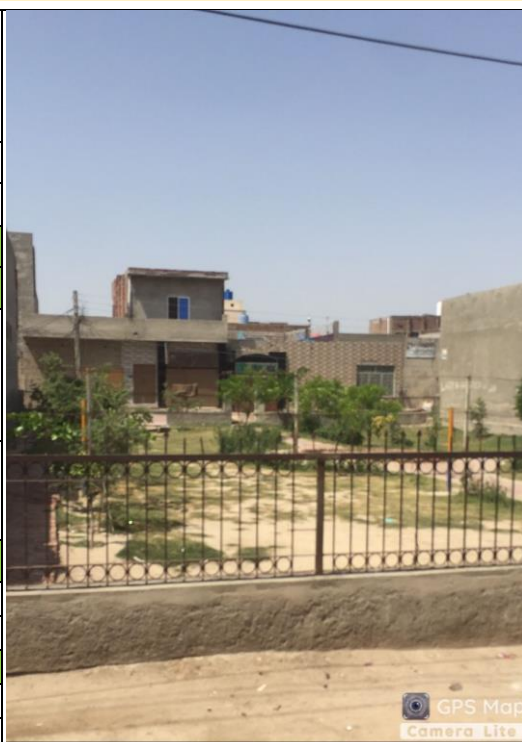
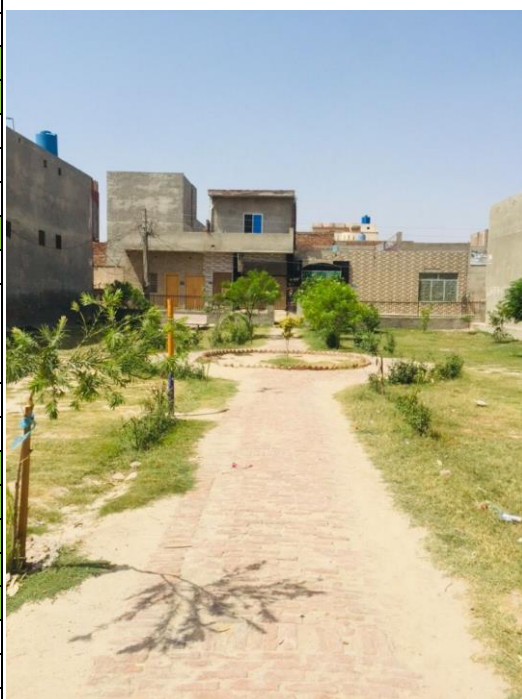
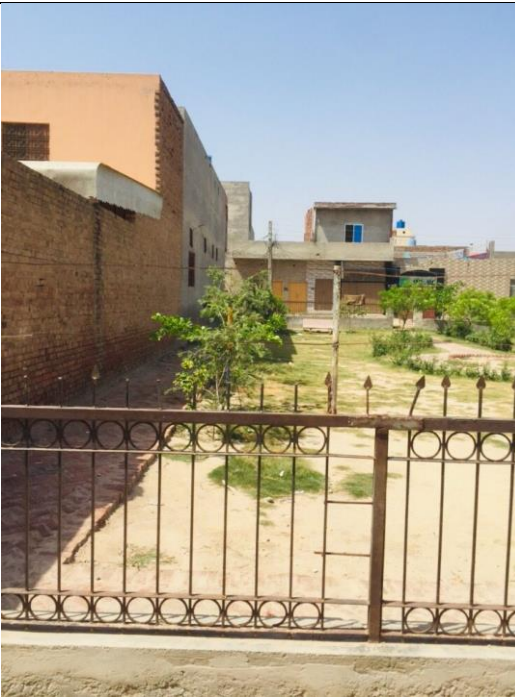
Municipal Committee Okara					
Form: IDAMP-A10		Park Asset Condition Assessment		Asset Code: _____ Date: 06-05-2023	
Name		Sabri Colony Park		Pictures	
Location	Latitude	30.8149			
	Longitude	73.4351			
Area In Acres		0.25

Ownership- Owned by MC or possession allocated to MC by any other department (documents available)			
Turfing Condition	Good	Fair	Poor
Approach Road	Good	Fair	Poor
Parking Lots	Yes	No	
Canteen Availability	Yes	No	
Average number of daily visitors (based on the assessment of MC staff)			
Any illegal occupants or encroachments observed-if yes, type			
Security system	Yes	No	
Watering & Irrigation			
Tube Well	Yes	No	
Water Supply from Municipal System	Yes	No	
Water Tank	Yes	No	
Pumping Unit	Yes	No	
Distribution Pipe Lines	Yes	No	
Valves	Yes	No	
Sprinkler System	Yes	No	
Ground water storage reservoirs/ponds	Yes	No	
Landscaping & Plantation			
Grass Beds	Yes	No	
Flower Beds	Yes	No	
Hedges	Yes	No	
Plants	Yes	No	
Number of trees and species (based on readily available information at MC)			
Lights			
Total Number			
Poles	Yes	No	
Cables	Yes	No	
Brackets And Lights	Yes	No	
Bulbs And Tubes	Yes	No	
Control Units	Yes	No	
Structures

No. of Toilets	Gents	0	
	Ladies	0	
Condition of Toilets	Gents		
	Ladies		
Buildings	Yes	No	
Fountains & Water Fall Structure	Yes	No	
Walkways	Yes	No	
Jogging tracks	Yes	No	
Ramps at entry gates for wheel chairs	Yes	No	
Bridges & Culverts	Yes	No	
Play Area	Yes	No	
Gazebos	Yes	No	
Benches/ sitting arrangements	Yes	No

Toilets	Yes	No			
Lakes & Brooks	Yes	No			
Mechanical Equipment					
Pumping Units	Yes	No			
Swings	Yes	No			
Children Games	Yes	No			
Fixtures	Yes	No			
Benches	Yes	No			
Sanitation & Water Supply					
Litter Bins	Yes	No			
Condition of SWM	Poor				
Toilet Fixtures	Yes	No			
Sewerage System	Yes	No			
Vegetation Cuttings & Disposal	Yes	No			
Drinking water availability and quality (based on availability of water quality test reports)					
Water Pipes	Yes	No			
HR					
Security Guards	Yes	No			
Landscape Experts	Yes	No			
Mali / Beldaar (Number)	Yes	No			
Overall Rating					
Average Score	1	2	3	4	5
Asset Condition	Excellent	Good	Fair	Poor	Failing
Category	A	B	C	D	E
Remarks / Requirements

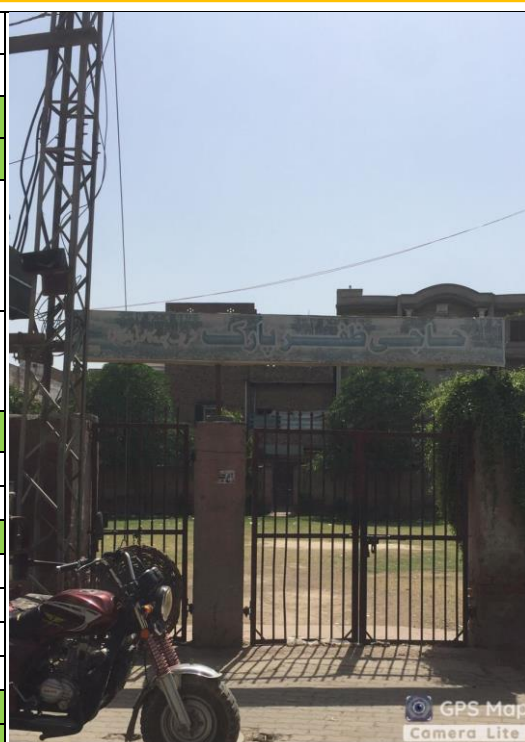
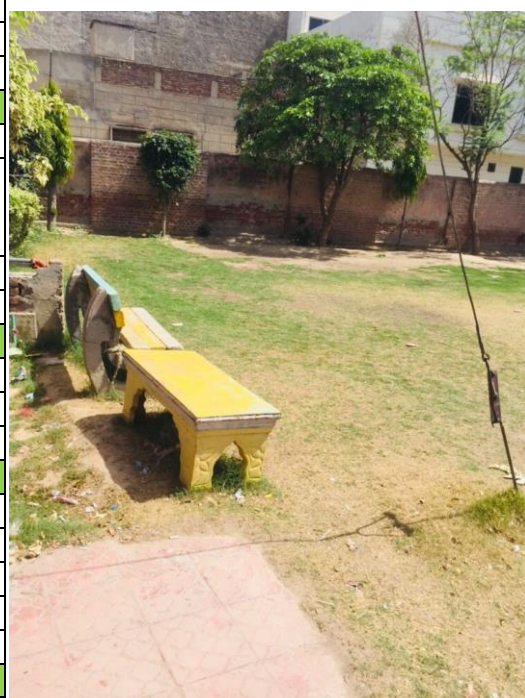
Turfing Condition	Good	Fair	Poor
Approach Road	Good	Fair	Poor
Parking Lots	Yes	No	
Canteen Availability	Yes	No	
Average number of daily visitors (based on the assessment of MC staff)			
Any illegal occupants or encroachments observed-if yes, type			
Security system	Yes	No	
Watering & Irrigation			
Tube Well		Yes	No
Water Supply from Municipal System		Yes	No
Water Tank		Yes	No
Pumping Unit		Yes	No
Distribution Pipe Lines		Yes	No
Valves		Yes	No
Sprinkler System		Yes	No
Ground water storage reservoirs/ponds		Yes	No
Landscaping & Plantation			
Grass Beds		Yes	No
Flower Beds		Yes	No
Hedges		Yes	No
Plants		Yes	No
Number of trees and species (based on readily available information at MC)			
Lights			
Total Number			
Poles		Yes	No
Cables		Yes	No
Brackets And Lights		Yes	No
Bulbs And Tubes		Yes	No
Control Units		Yes	No
Structures			
No. of Toilets	Gents	0	
	Ladies	0	
Condition of Toilets	Gents		
	Ladies		
Buildings		Yes	No
Fountains & Water Fall Structure		Yes	No

Walkways		Yes	No
Jogging tracks		Yes	No
Ramps at entry gates for wheel chairs		Yes	No
Bridges & Culverts		Yes	No
Play Area		Yes	No
Gazebos		Yes	No
Benches/ sitting arrangements		Yes	No
Boundary Wall & Gate		Yes	No
Toilets		Yes	No
Lakes & Brooks		Yes	No

Mechanical Equipment					
Pumping Units	Yes	No			
Swings	Yes	No			
Children Games	Yes	No			
Fixtures	Yes	No			
Benches	Yes	No			
Sanitation & Water Supply					
Litter Bins	Yes	No			
Condition of SWM	Poor				
Toilet Fixtures	Yes	No			
Sewerage System	Yes	No			
Vegetation Cuttings & Disposal	Yes	No			
Drinking water availability and quality (based on availability of water quality test reports)					
Water Pipes	Yes	No			
HR					
Security Guards	Yes	No			
Landscape Experts	Yes	No			
Mali / Beldaar (Number)	Yes	No			
Overall Rating					
Average Score	1	2	3	4	5
Asset Condition	Excellent	Good	Fair	Poor	Failing
Category	A	B	C	D	E
Remarks / Requirements					
•					
Data Collected By: Mr. Haroon		Designation: Team Member

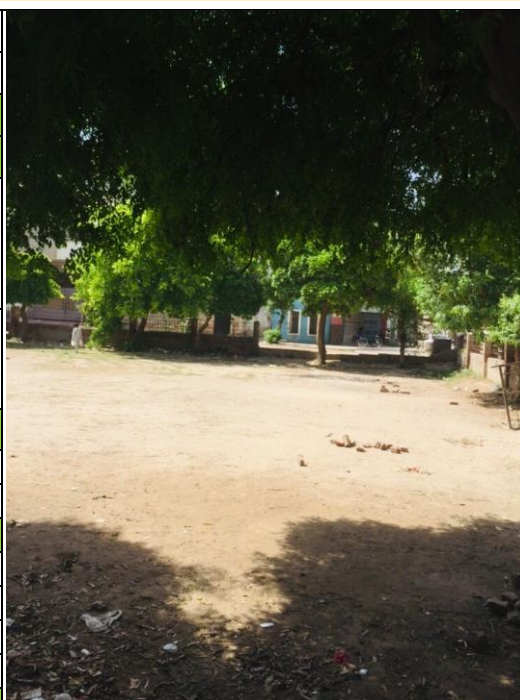
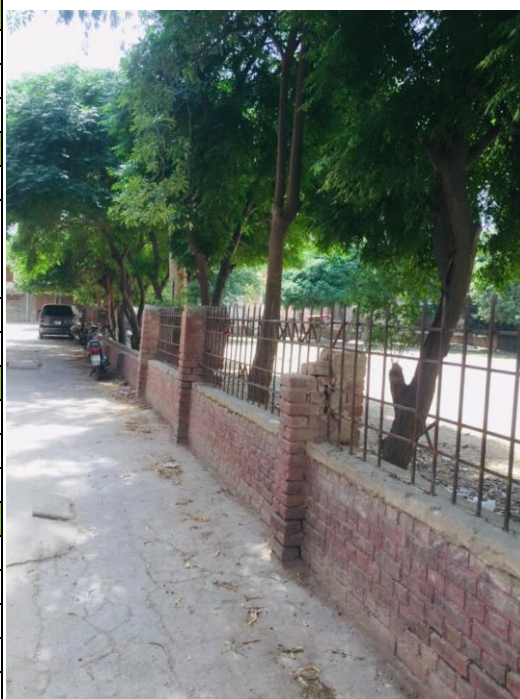
Municipal Committee Okara						
Form: IDAMP-A10		Park Asset Condition Assessment			Asset Code: _____ Date: 06-05-2023	
Name		Qari Colony Park		Pictures		
Location	Latitude	30.8074				
	Longitude	73.4365				
Area In Acres		0.25				
Ownership-Owned by MC or possession allocated to MC by any other department (documents available)

Mechanical Equipment					
Pumping Units	Yes	No			
Swings	Yes	No			
Children Games	Yes	No			
Fixtures	Yes	No			
Benches	Yes	No			
Sanitation & Water Supply					
Litter Bins	Yes	No			
Condition of SWM	Poor				
Toilet Fixtures	Yes	No			
Sewerage System	Yes	No			
Vegetation Cuttings & Disposal	Yes	No			
Drinking water availability and quality (based on availability of water quality test reports)					
Water Pipes	Yes	No			
HR					
Security Guards	Yes	No			
Landscape Experts	Yes	No			
Mali / Beldaar (Number)	Yes	No			
Overall Rating					
Average Score	1	2	3	4	5
Asset Condition	Excellent	Good	Fair	Poor	Failing
Category	A	B	C	D	E
Remarks / Requirements					
•					
Data Collected By: Mr. Haroon		Designation: Team Member

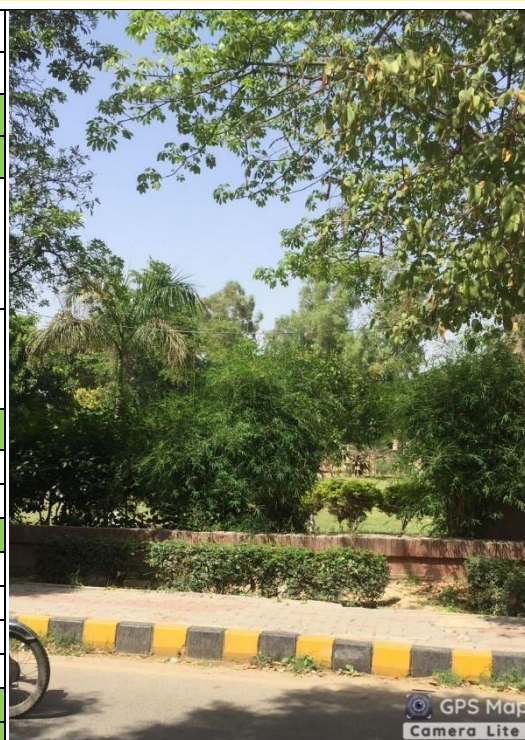
Municipal Committee Okara						
Form: IDAMP-A10		Park Asset Condition Assessment			Asset Code: _____ Date: 06-05-2023	
Name		Ladies Park		Pictures		
Location	Latitude	30.8010				
	Longitude	73.4274				
Area In Acres		0.25				
Ownership-Owned by MC or possession allocated to MC by any other department (documents available)

Mechanical Equipment					
Pumping Units	Yes	No			
Swings	Yes	No			
Children Games	Yes	No			
Fixtures	Yes	No			
Benches	Yes	No			
Sanitation & Water Supply					
Litter Bins	Yes	No			
Condition of SWM	Poor				
Toilet Fixtures	Yes	No			
Sewerage System	Yes	No			
Vegetation Cuttings & Disposal	Yes	No			
Drinking water availability and quality (based on availability of water quality test reports)					
Water Pipes	Yes	No			
HR					
Security Guards	Yes	No			
Landscape Experts	Yes	No			
Mali / Beldaar (Number)	Yes	No			
Overall Rating					
Average Score	1	2	3	4	5
Asset Condition	Excellent	Good	Fair	Poor	Failing
Category	A	B	C	D	E
Remarks / Requirements					
•					
Data Collected By: Mr. Haroon		Designation: Team Member

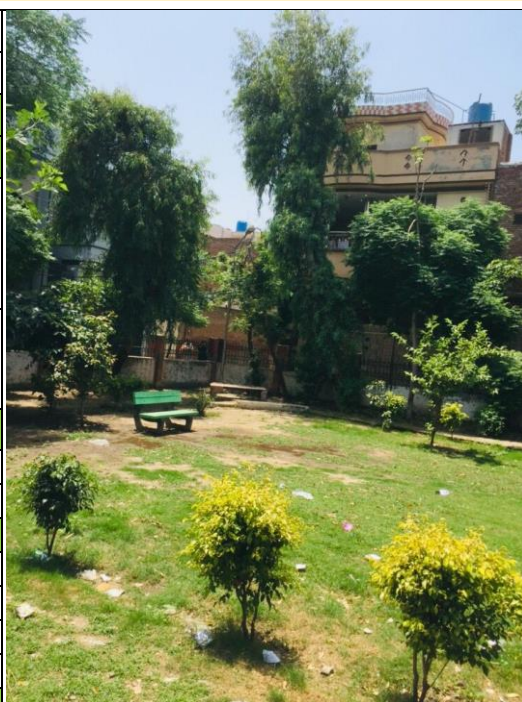
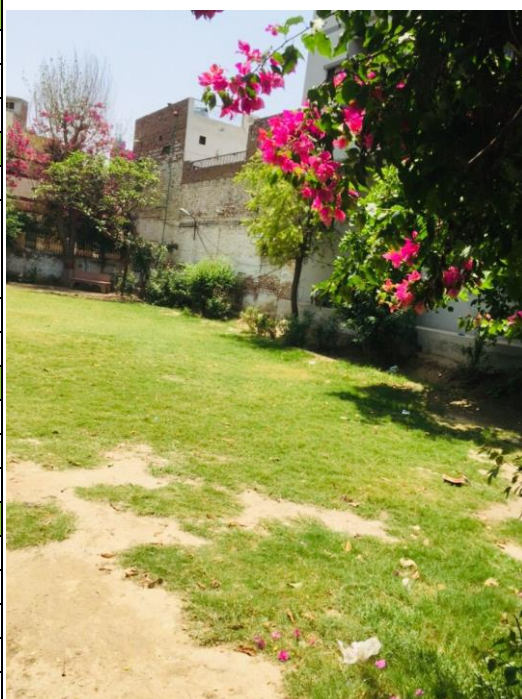
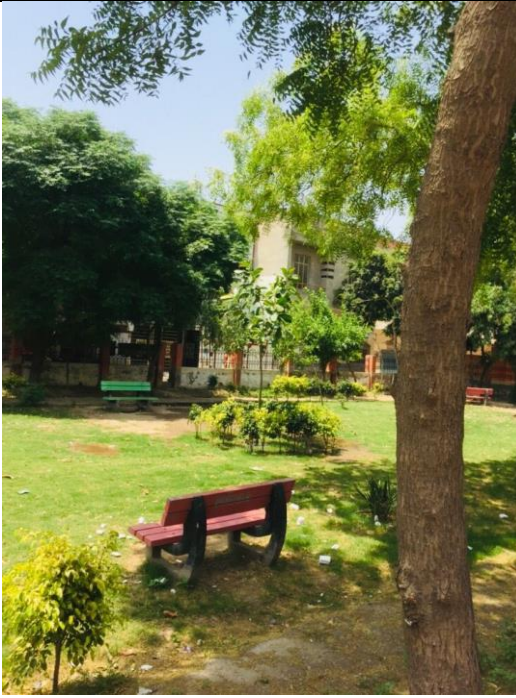
Municipal Committee Okara					
Form: IDAMP-A10		Park Asset Condition Assessment		Asset Code: _____ Date: 06-05-2023	
Name		Fateh Town Park No.2		Pictures	
Location	Latitude	30.819217			
	Longitude	73.453186			
Area In Acres		0.25			
Ownership-Owned by MC or possession allocated to MC by any other department (documents available)

Overall Rating		
			Average Score	1	2
Asset Condition	Excellent	Good	Fair	Poor	Failing
Category	A	B	C	D	E
Remarks / Requirements					
•					
Data Collected By: Mr. Haroon		Designation: Team Member

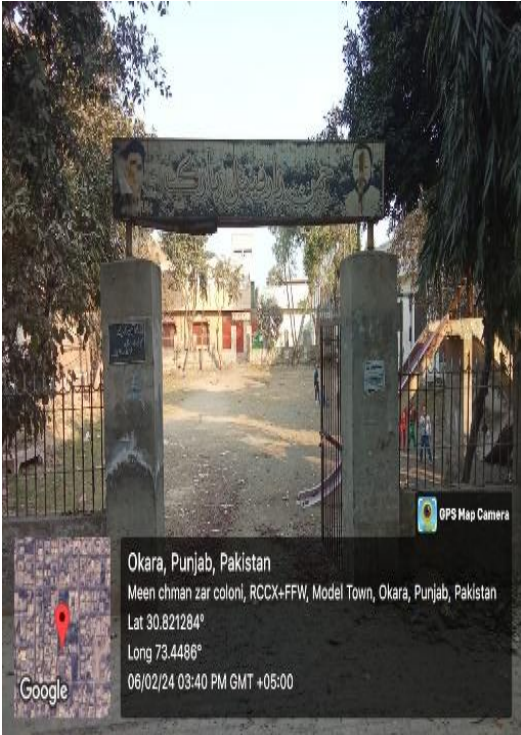
Municipal Committee Okara					
Form: IDAMP-A10		Park Asset Condition Assessment		Asset Code: _____ Date: 06-05-2023	
Name		Chaman Zar Colony Park

Asset Condition	Excellent	Good	Fair	Poor	Failing
Category	A	B	C	D	E
Remarks / Requirements					
•					
Data Collected By: Mr. Haroon		Designation: Team Member		 Sign & Date: 30-May-2023	
Data Checked By: Mr. Muddasir Alvi		Designation: Team Lead		 Sign & Date: 30-May-2023

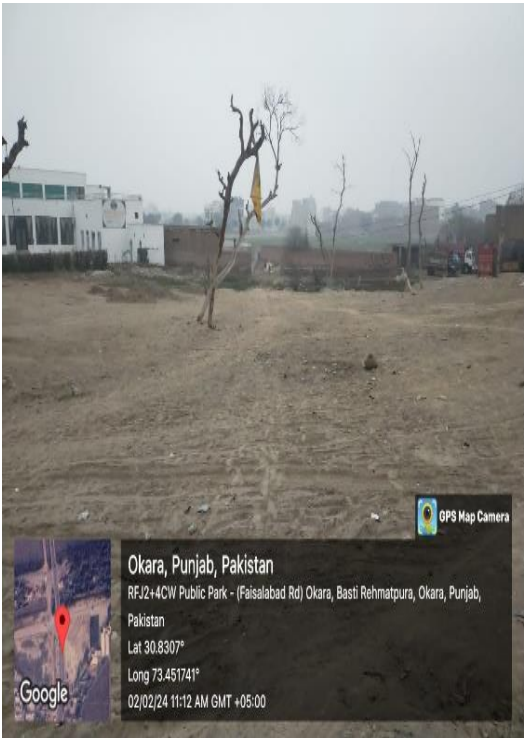
Municipal Committee Okara					
Form: IDAMP-A10		Park Asset Condition Assessment		Asset Code: _____ Date: 06-05-2023	
Name		Pakistan Public Park

Asset Condition	Excellent	Good	Fair	Poor	Failing
Category	A	B	C	D	E
Remarks / Requirements					
•					
Data Collected By: Mr. Haroon		Designation: Team Member

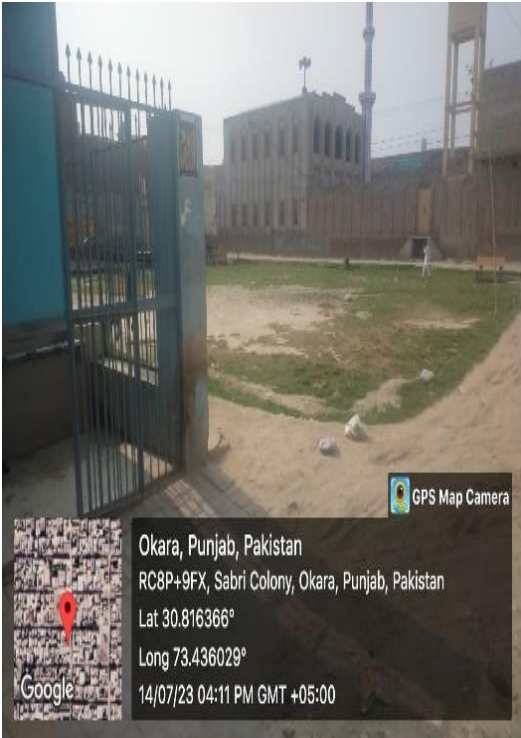
Municipal Committee Okara					
Form: IDAMP-A10		Park Asset Condition Assessment		Asset Code: _____ Date: 06-05-2023	
Name		Fateh Noor Town Madina Park

Asset Condition	Excellent	Good	Fair	Poor	Failing
Category	A	B	C	D	E
Remarks / Requirements					
•					
Data Collected By: Mr. Haroon		Designation: Team Member

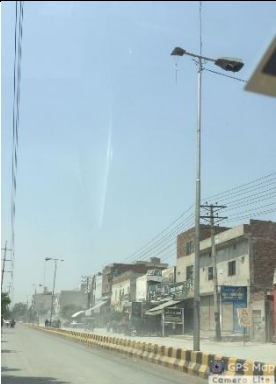
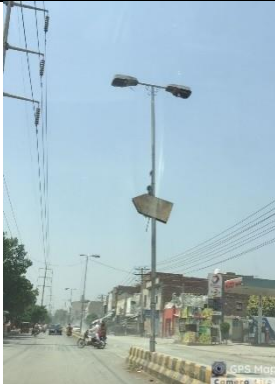
Integrated Development and Asset Management Plan (IDAMP)								
Municipal Committee Okara								
Form: IDAMP-A9	Street Lights Asset Condition Assessment					Asset Code: _____	Date: 05-05-2023	
Pictures

Ward	Type of Luminaries				Total	Operational Status	Poles Type (WAPDA Pole / MC Pole)	
	Sodium	Led (100w)	Tube Light (40 W)	Energy Saver / Light Bulb				
Ward no. 1					10	8		
Ward no. 2					15	11		
Ward no. 3					15	12		
Ward no. 4					25	21		
Ward no. 5					39	33		
Ward no. 6					25	19		
Ward no. 7					30	25		
Ward no. 8					30	24		
Ward no. 9					35	30		
Ward no. 10					40	32		
Ward no. 11					60	50		
Ward no. 12					35	29		
Ward no. 13					38	32		
Ward no. 14					38	32		
Ward no. 15					20	16		
Ward no. 16					45	38		
Ward no. 17					26	20		
Ward no. 18					65	53		
Ward no. 19					18	15		
Ward no. 20					16	11		
Ward no. 21					34	30		
Ward no. 22					48	38		
Ward no. 23					32	24		
Ward no. 24					28	23

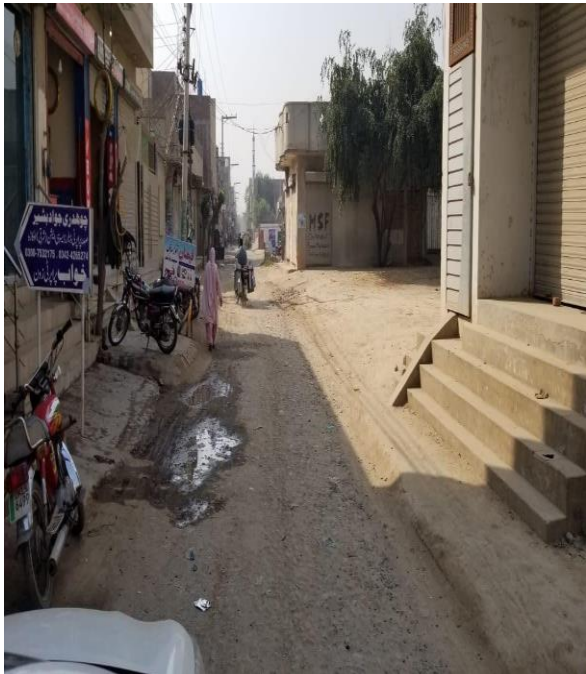
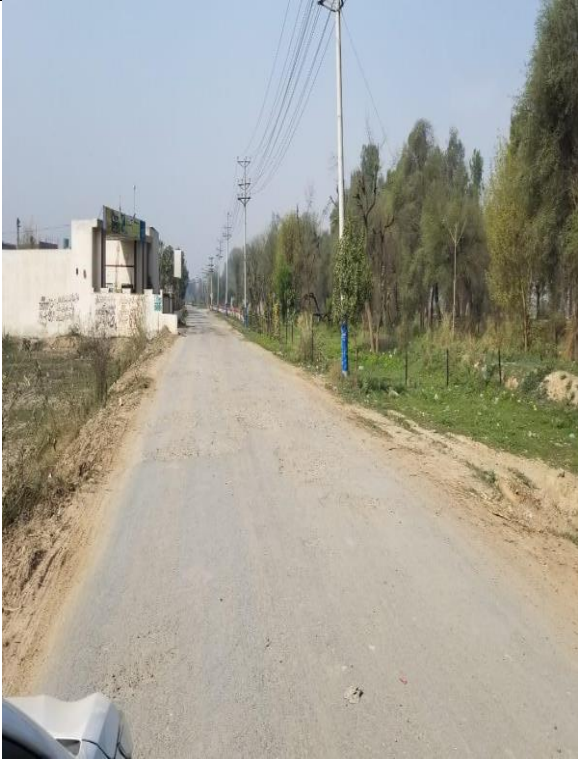
Integrated Development and Asset Management Plan (IDAMP)		
Municipal Committee Okara		
Form: IDAMP-A8	Road Asset Condition Assessment	Asset Code: _____ Date: 06-05-2023
Pictures

Sr. No.	Road Name	Ownership	TST, Asphalt Or Concrete Pavers	Row (Ft)	Paved Width (Ft)	Approx. Length (Km)	Condition
1	Markzi Graveyard Chowk to Distributory 4L		TST	22-25		2.0	Poor
2	Link road M.A Jinnah road to Benazir road (Imran Akram villas)		TST	58		0.5	Poor
3	Faisalabad road to Akbar road bank 4L distributory		Asphalt	40		1.6	Poor
4	Chamra Mandi (chamra Mandi water works)road to G.T road		Concrete Pavers	20		0.6	Poor
5	Sardar Chowk to graveyard 1/4L main road		Asphalt	28		1.4	Poor
6	G.T road to Irshad town (27 wala road)		Concrete Pavers	25		0.4	Poor
7	Internal road General Bus stand		TST	35-40		0.3	Poor
8	4L School road		TST	30		3.9	Poor
9	New Lalazar Gilani road		TST	30		0.4	Poor
10	M.A Jinnah road		TST	60		1.3	Poor

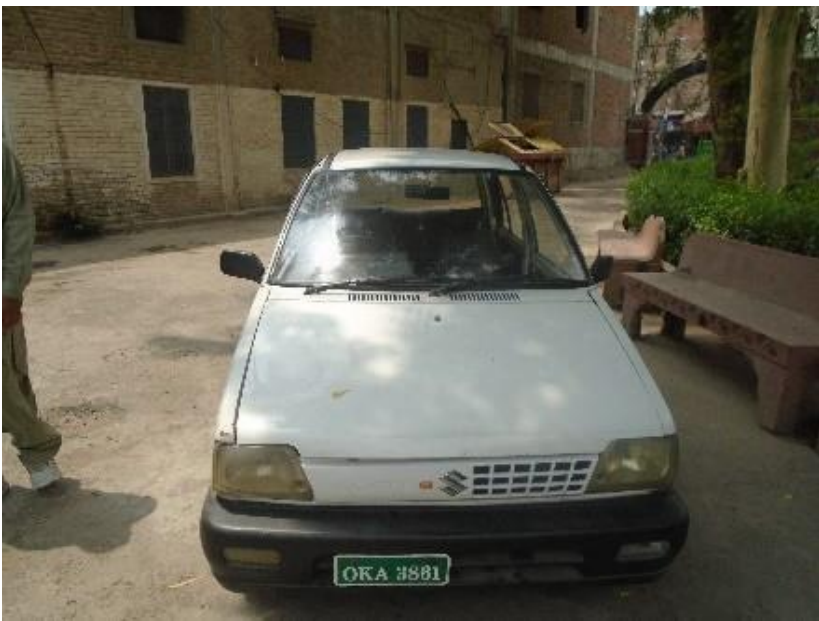
Integrated Development and Asset Management Plan (IDAMP)					
Municipal Committee Okara					
Form: IDAMP-A16	Moveable Asset Asset Condition Assessment			Asset Code: _____	Date: 05-05-2023
Type of Vehicle / Machinery	Pictures				
Cars

Suzuki	Suzuki	Suzuki	Suzuki	Suzuki
Capacity	1000 CC	1000 CC	800 CC	800 CC	1000 CC
Purpose	Staff	Staff	Staff	Staff	Staff
Year of Manufacturing	2002	1983	1992	1992	2000
Model	Cultus	Potohar	Mehran	Mehran	Potohar
Capital Cost	Not available	Not available	Not available	Not available	Not available
Fuel Consumption (Liters/Month)	316	295	Not in use	91	Not in use
Condition	Fair	Poor	Poor	Poor	Fair
Engine Capacity	1000 CC	1000 CC	800 CC	800 CC	1000 CC
Maintenance Cost	Not available	Not available	Not available	Not available	Not available
Oiling /Fitness	Yes	Yes	Yes	Yes	Yes
Fitness Certificate	No	No	No	No	No
Registered	OKC 7876	OK 996	OKA 3861	OKA 6733	LXO 7047
Overall Rating	Fair	Poor	Poor	Poor	Fair

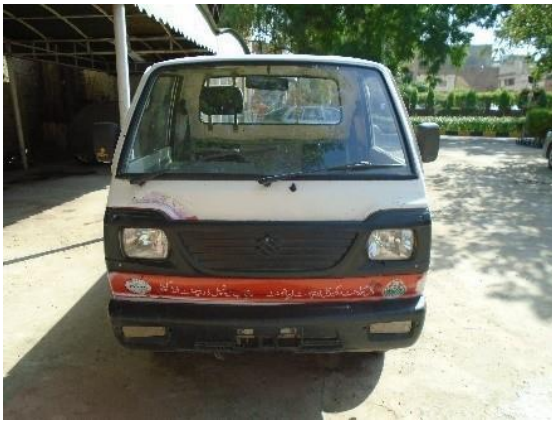
Integrated Development and Asset Management Plan (IDAMP)		
Municipal Committee Okara		
Form: IDAMP-A16	Moveable Asset Asset Condition Assessment	Asset Code: _____ Date: 05-05-2023
Type of Vehicle / Machinery	Pictures	
Cars

Suzuki	Suzuki
Capacity	800 CC	1600CC
Purpose	Staff	Staff
Year of Manufacturing	1992	1990
Model	FX	Nissan Sunny
Capital Cost	Not available	Not available
Fuel Consumption (Liters/Month)	Not in use	Not in use
Condition	Poor	Poor
Engine Capacity	800 CC	1600CC
Maintenance Cost	Not available	Not available
Oiling /Fitness	Yes	Yes
Fitness Certificate	No	No
Registered	KSA 4913	OKA 8800
Overall Rating	Poor	Poor
Remarks / Requirements		
<ul style="list-style-type: none"> No remarks 		
Data Collected By: Mr. Haroon	Designation: Team Member
